| Subject:<br><br>EXTERIOR LIGHT WARNING WITH DTC B10A3:86 | Bulletin No.: 09-019/25 |
| | Last Issued : 04/15/2025 |

2024-2025 CX-90 with VINS lower than JM3KK\*\*\*\*\*241940 (produced before April 11, 2025)  
2025 CX-70 with VINS lower than JM3KJ\*\*\*\*\*129500 (produced before April 11, 2025)

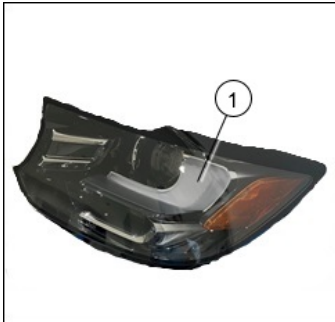
Exterior light warning light

Some vehicles equipped with the Adaptive Front lighting System (AFS) may exhibit the exterior light warning light/ exterior light warning indication on while driving or when the ignition is turned on and DTC B10A3:86 (Error signal received from swivel actuator (LH)) stored in memory.

Combination light with AFS  
(1): Parking light/daytime running light (DRL)

**NOTE:** The combination light with AFS can be distinguished if it is equipped with the parking light/daytime running light (DRL) that illuminates while the ignition is turned on. This may be caused by the AFS Control Module detecting a false headlight malfunction. This concern will likely occur when the light returns to the center position after swiveling. To eliminate this concern, the control software of the AFS control module has been further modified. Customers having this concern should have their vehicle repaired using the following repair procedure.

2. Reprogram the **AFS** with the Mazda Modular Diagnostic System (M-MDS), using Mazda Diagnostic And Repair Software (MDARS). Refer to MDARS ECU Reprogramming Procedure.

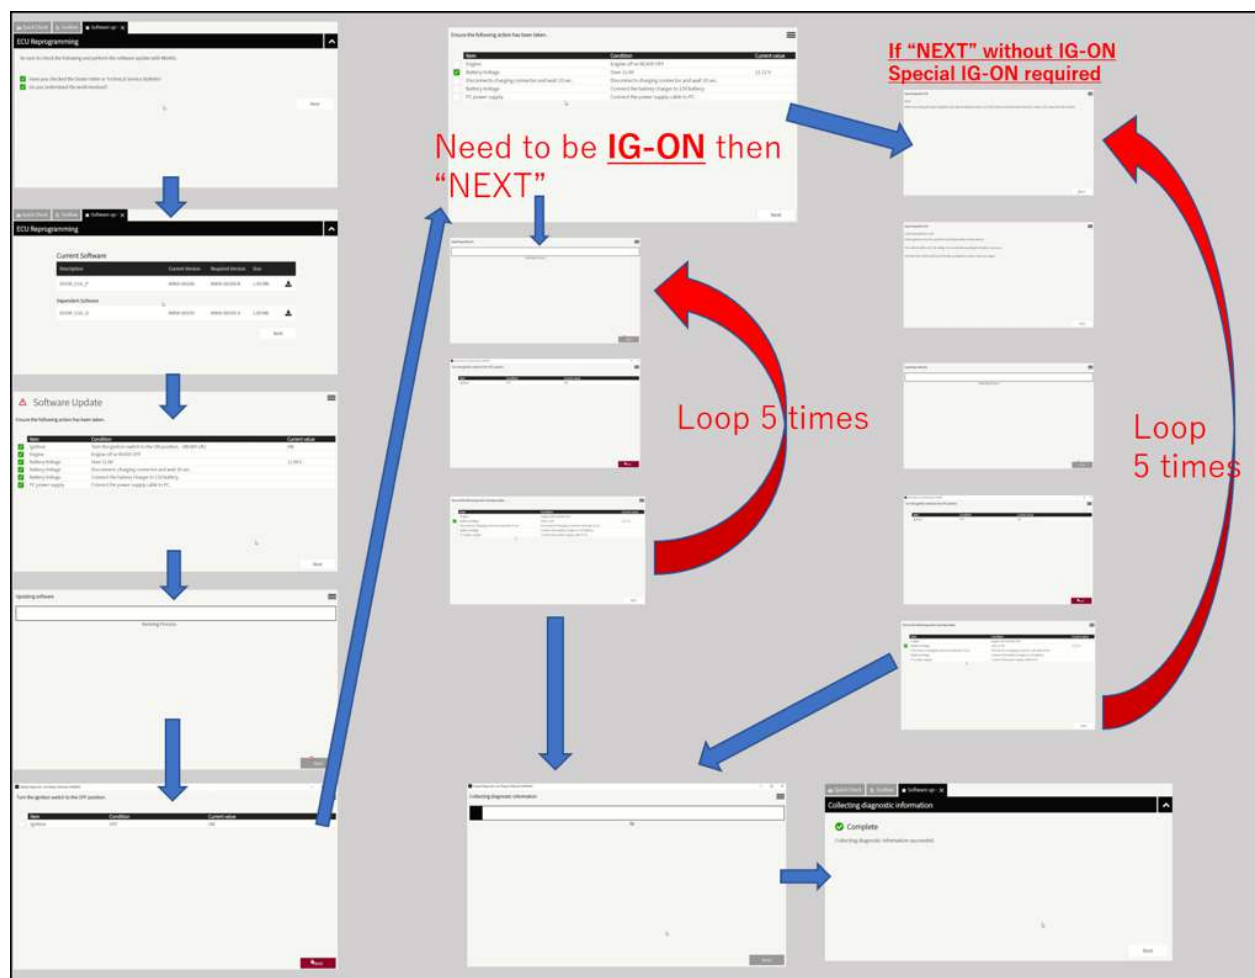
**CAUTION:** MDARS reprogramming may require looping IG-ON 5 times.
