### Check engine light with reduced power with fault codes P300A6D, P300974, P300DFB, or P300DE8

| Topic number | LI09.40-N-079144 |
| Function group | 09.40 - Turbocharger |
| Validity | Model 907 with OM654 |

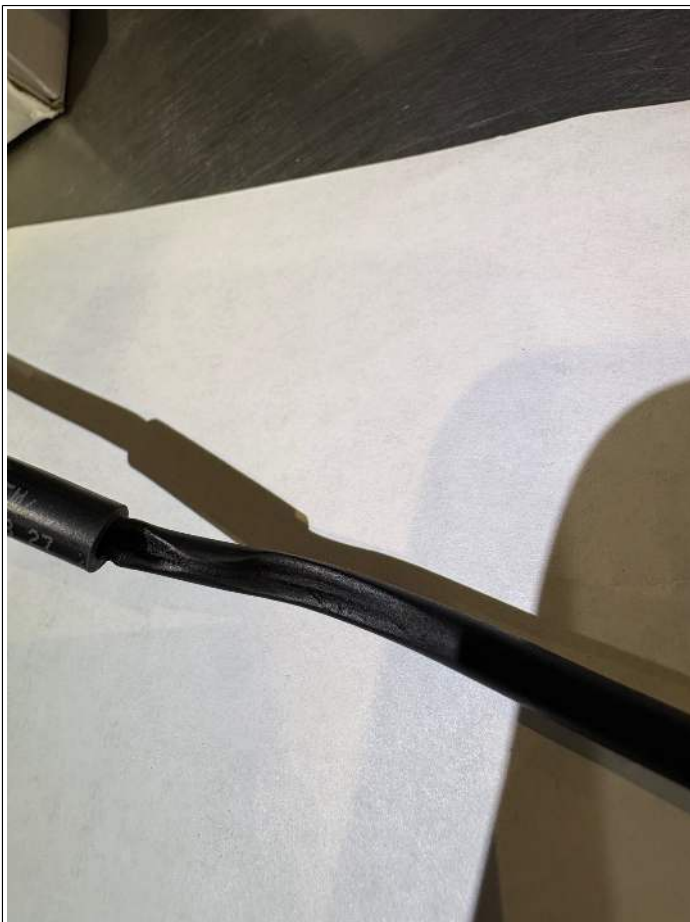
| Attachments | |
|---|---|
| <a href="#">Melted line.jpg</a> | Vacuum Line melted under Low Pressure EGR Cooler |

1. Check the Vacuum:
  - Check the vacuum at all vacuum components (such as the Wastegate and Boost Pressure Control Y77, Y100/2) while driving, and compare it to the source vacuum.
  - Thoroughly inspect all vacuum lines and connections for signs of wear, cracks, or disconnections.
  - Refer to the Attachments for the OM654 Vacuum diagram.
2. Ensure Components Hold Vacuum:
  - Ensure each component holds a vacuum when actuated.
  - Replace any failed component and retest.

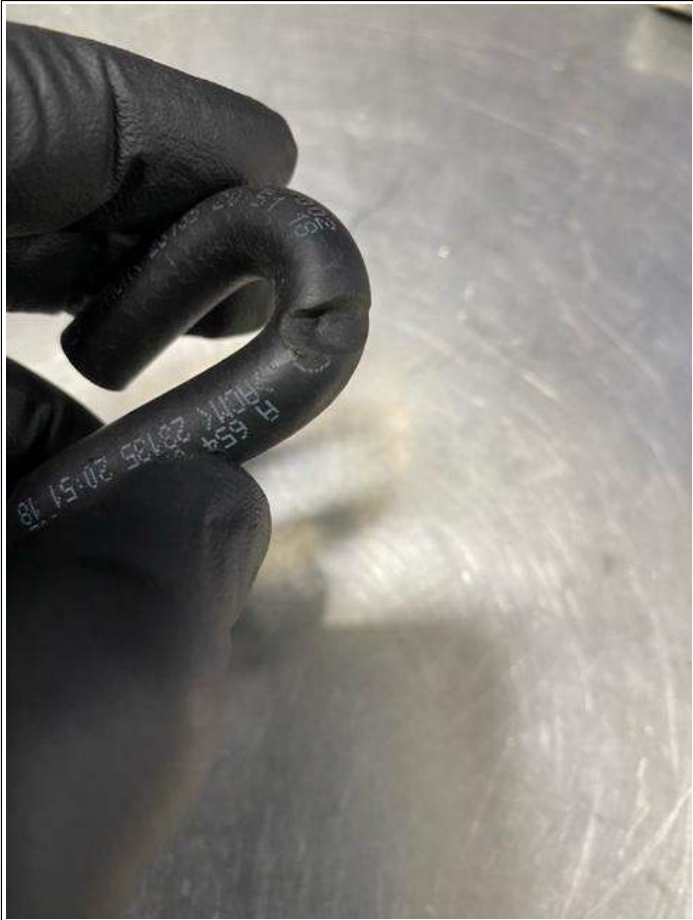
[Vacuum Line A654 070 23 32.jpeg](#)

Vacuum Line at High Pressure EGR Cooler Bypass Valve

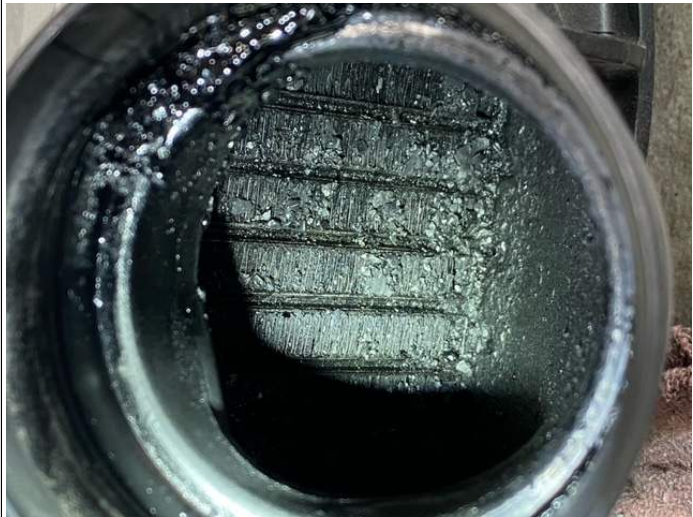
Inlet Side Of Charge Air Cooler.jpeg

Debris within the Charge Air Cooler

- Check the outlet of the turbocharger (high-pressure side), the charge air pipe at the back of the engine, and the charge air cooler inlet near the firewall for any debris or blockages.
- If oil, debris, or sludge is found in the Charge Air System, Turbocharger Outlet, or Charge Air Cooler Inlet:
- Replace the Turbocharger and the Charge Air Cooler.
- Clean or replace the Charge Air Pipe between them.
- Perform an oil and filter change.

Note: If it is determined that the Charge Air Cooler is obstructed by debris, please use damage code 50301 B2 when submitting your warranty repair claims.

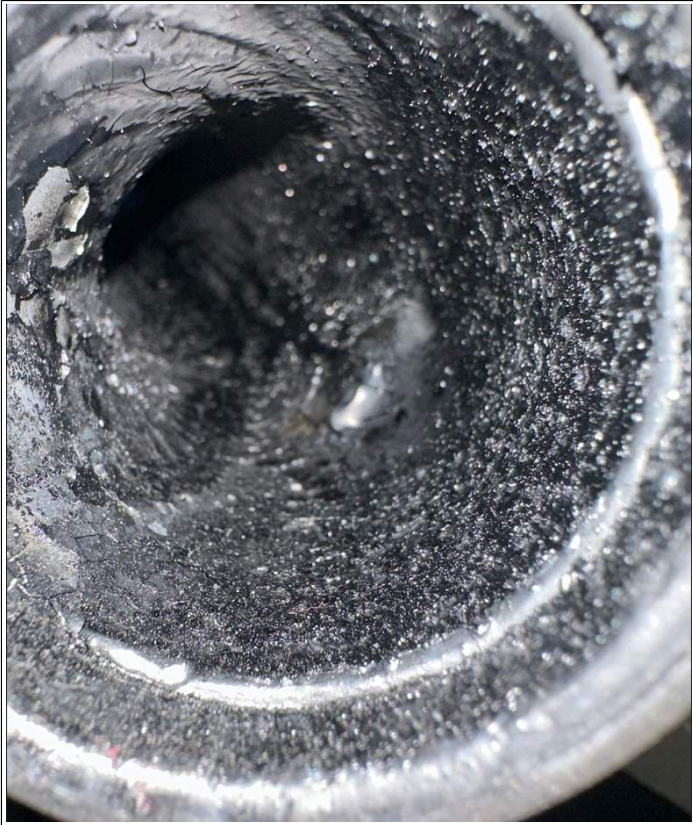
Charge Air Pipe.png

Debris within the Charge Air Pipe
