## Low Coolant Warning, Potential Misfire, and Absence of External Coolant Leaks

| Topic number | LI09.41-N-079165 |
| Function group | 09.41 - Charge air pipe/charge air cooling |
| Validity | OM654 |

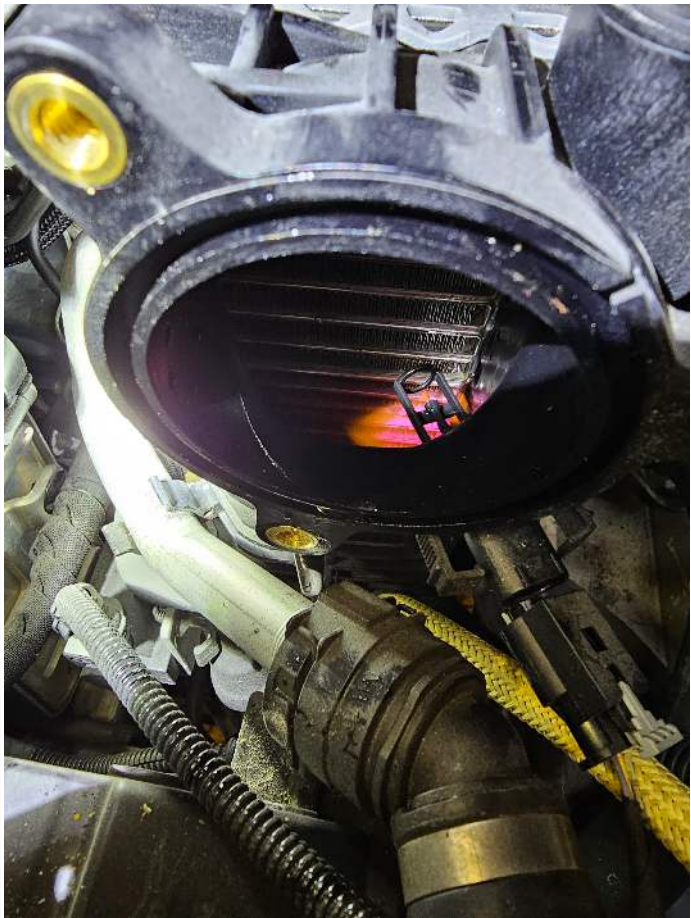
| Attachments | |
|---|---|
| <a href="#">Charge Air Cooler 1.jpg</a> | Coolant found in the Charge Air Cooler |

- Remove either the Throttle Valve or Charge Air Temperature Sensor to inspect for coolant loss. See attachments for the failed Charge Air Cooler.
- If coolant is found inside the Charge Air Cooler:
- Perform a manual compression test to confirm the absence of internal engine failures per WIS Doc AR01.00-D-1201TSM - Check compression pressure.
- Remove and clean any coolant present in the Charge Air System, Intake System, and Cylinders.

- Replace the Charge Air Cooler, the glow plugs, and then conduct an oil and filter change. Refer to AR09.41-D-6817TSM - Remove/install charge air cooler.
- Note: Ensure the new Charge Air Cooler is dated post clean point 05/10/2023. See the attachment for the date code.
- Note: If the installed Charge Air Cooler is found to be leaking after the clean point on 05/10/2023, please open a TIPS case directed to the Powertrain inbox.
- If coolant is not found inside the Charge Air Cooler, proceed to Step C.

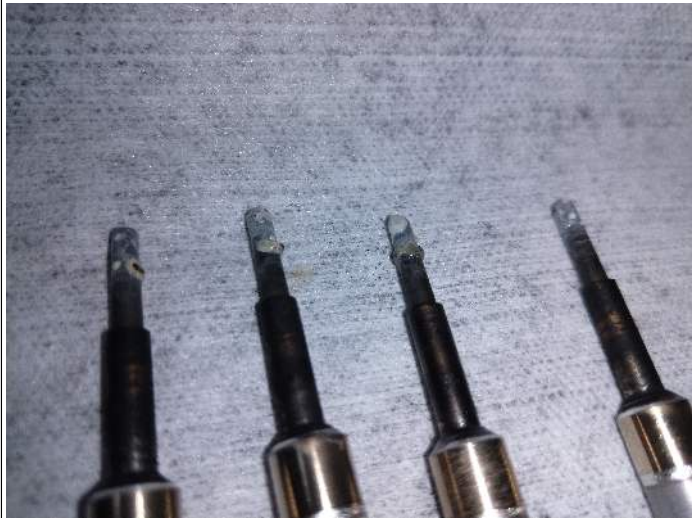
Coolant on Glow Plugs.jpg

Dried coolant on tips of the Glow Plugs

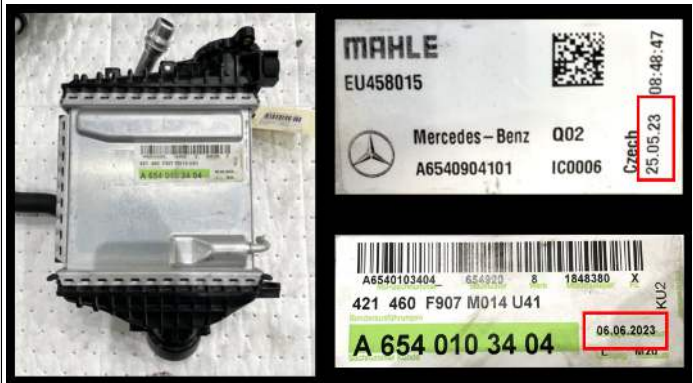
Charge Air Cooler Date Code.png

Location of the date codes on the Charge Air Cooler

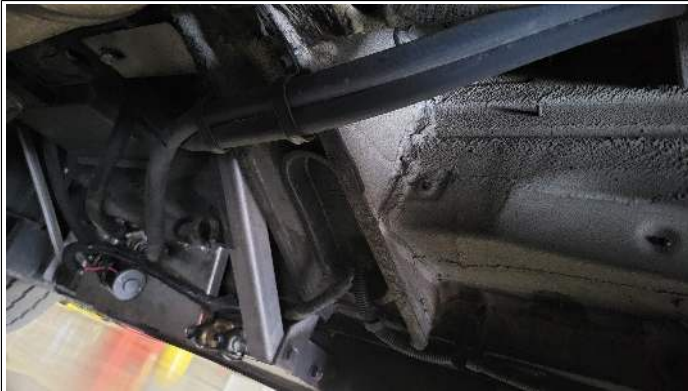
Aftermarket Coolant Heater.jpg

1. Inspect the Coolant system for any unapproved/aftermarket upfits or modifications:
- See the Attachments for examples of non-approved upfits or modifications.
  - Note: The OM654 cannot have any aftermarket modifications made to the coolant system per the Body and Equipment Guidelines (BEG) under 4.4.3 Engine Cooling, "Do not make modifications to the cooling system (cooler components, air ducting, hose, and other detachable parts that are part of the cooling system)".
  - If there are modifications made to the coolant system that violate the BEG, do not complete any repairs on the system under warranty until either your Vans Aftersales Business Development Manager (VABDM) or facing Field Service Engineer (FSE) reviews the vehicle.

Non-approved Aftermarket Coolant Heater

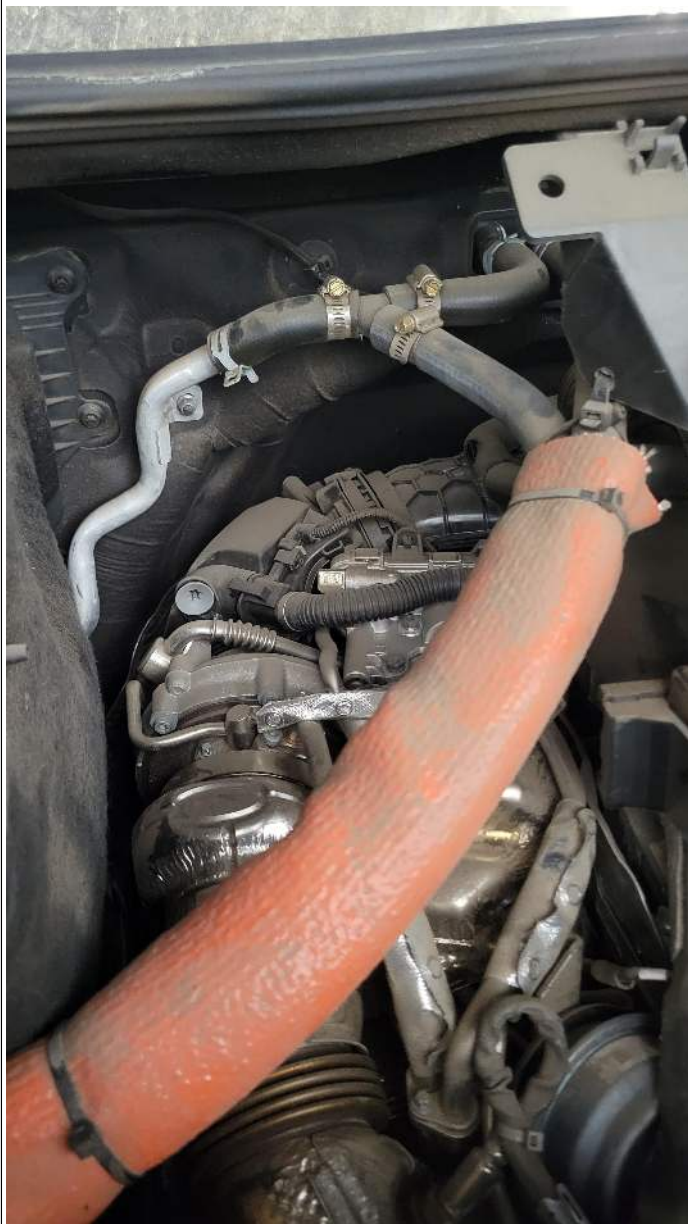
[Aftermarket Coolant Circuit.jpg](#)

Non-approved Aftermarket Coolant Circuit
