## Technical Service Bulletin

| <b>Topic</b> | 93 "Electrical system fault" is displayed in the instrument cluster, DTC: P18F100, P0A1B00, U140500 |

### Audi Q4 e-tron

93 "Electrical system fault" is displayed in the instrument cluster, DTC: P18F100, P0A1B00, U140500

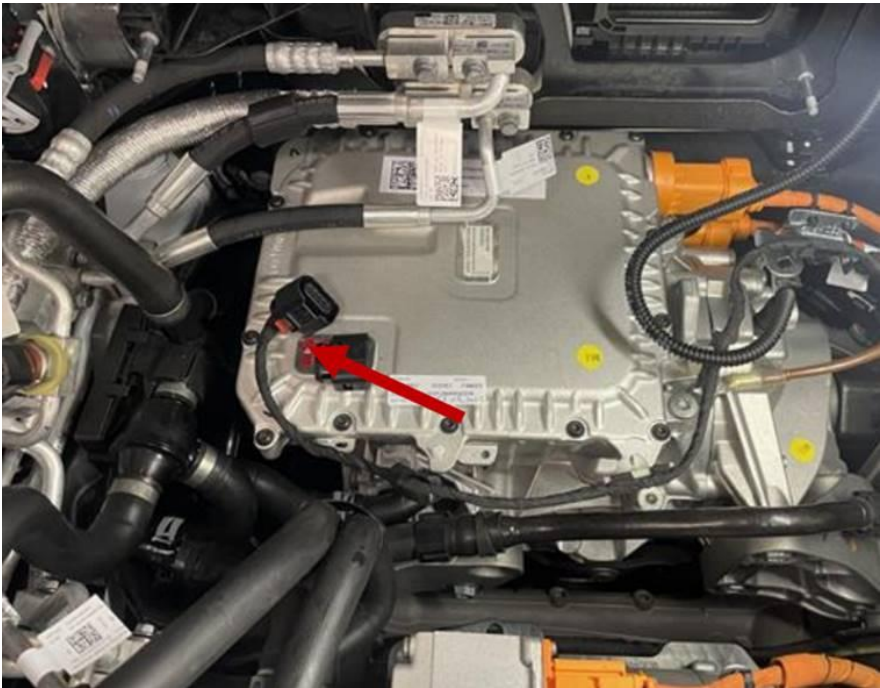
**Figure 1:** 10 Pin connector.

Pins may have become damaged during the end-of-line check during production.

Inspect connector T10 at power electronics 2 for electric drive JX4 for spread or damaged contacts:

If you find at least one widened contact, please replace the 10-pin connector including all contacts and approx. 5cm of the wires. Repair the damaged location using wiring harness repair set **VAS 1978B** and the individual wires listed below.
