Preview Solution CBR-2408-7

## Volvo Chassis - VN (4) - Air Production Modulator (APM) DTC C10129B - High/Excessive Flow

Published 16 April 2025

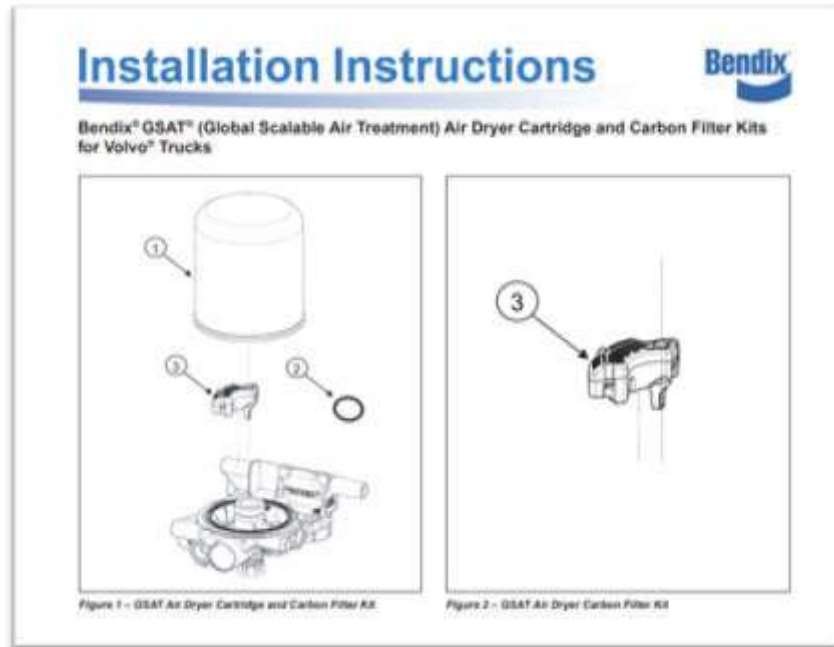
- Verify that the o-ring (2, pictured below) is present. It should be located on the air dryer housing.

- If this o-ring is missing, replace the entire filter.
- Once the filter is replaced, allow the truck to run for 15-20 minutes.
- Verify that the fault code has been cleared.
- If the fault code remains, proceed to the following steps. If fault code cleared return the truck to service.
