# Field campaign

| Topic | Software Update BJB and HV ECUs Continental GT/GTC/Flying Spur 25MY (SC25/10) |
| Campaign number | ED40 |

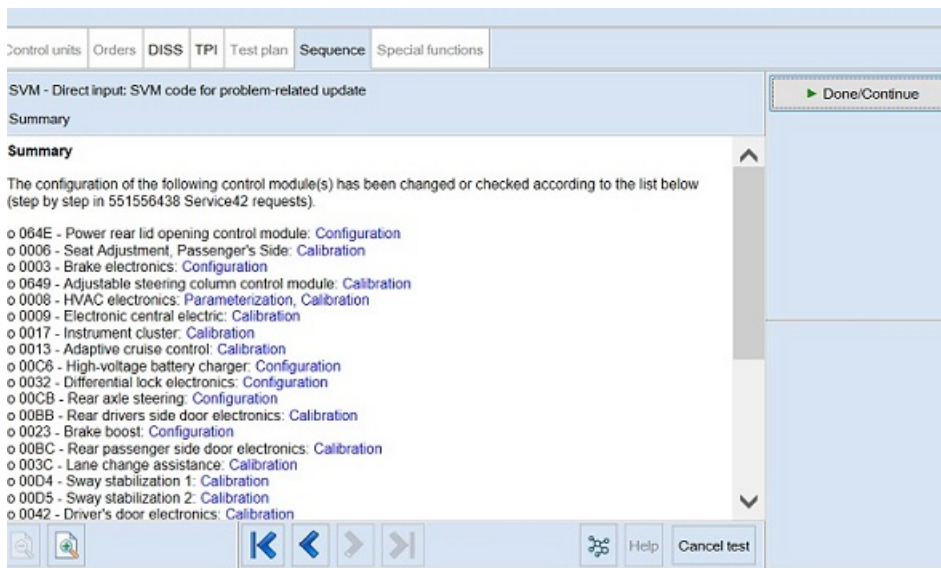
Fig 3

8. Follow the on-screen instructions to completion.
9. If you are presented with this screen (Fig 3) at the end of the update, the update was successful. Please continue to step 11.

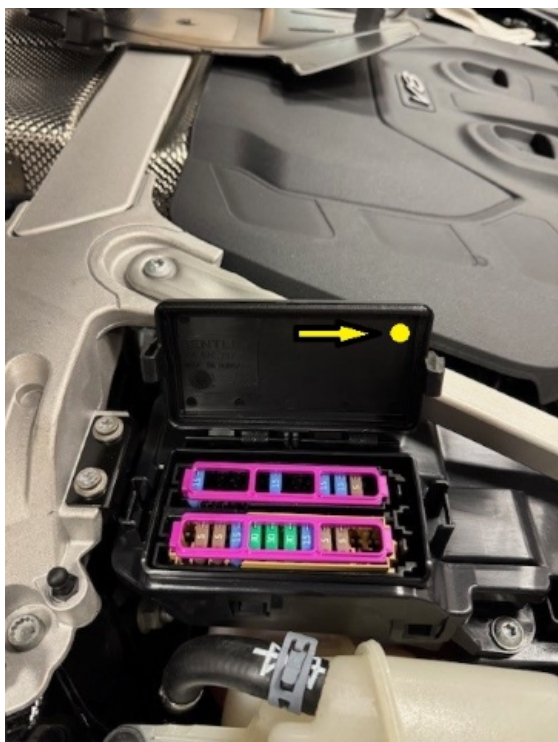
You must also add a yellow paint mark to the underside of the Fusebox cover as per the picture below.
