| Topic | Software Update BiL 5.3.1 v1 to v2 Flying Spur 25MY (SC25/11) |
| Brand | Bentley |
| Transaction No. | 2077583/2 |
| Campaign number | ED42 |

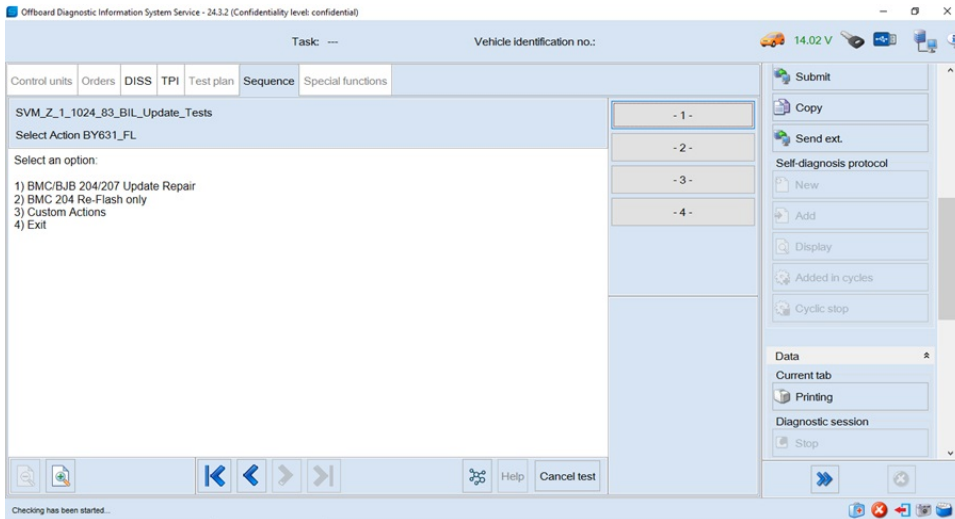
1. After de-energisation, Refer to ElsaPro Repair Group 70 'Boot carpet – To remove and fit'. Remove the boot floor and gain access to the earth cable from the 12v battery negative and the body in white (This access will be required later in the test plan).
2. Navigate to 'Special functions' and select 'SVM – Pre 372BIL5201 Hotfix Routines', then 'Perform test'.
3. Switch to 'DoIP' when prompted.
4. Select '1) BMC/BJB 204/207 Update Repair' and follow the on-screen instructions.
  - When the tester attempts to flash '008C - Battery regulation control module' you may receive a message informing you that the pre-conditions have not been met. Select 'done/continue'.
  - On the following screen (shown below) select option 2 to attempt to flash the ECU – this should allow the '008C - Battery regulation control module' to flash successfully.

- If the flash fails, perform the below actions.

1. Exit the test.
2. Allow the car to sleep for 5 minutes.
  - a. Turn off the ignition.
  - b. Remove all equipment from the car (Diagnostic tester/dongle, battery charger, keys).

- c. Close all doors, windows, bonnet and boot lid.
  - d. Lock the vehicle to perform a CAN-BUS sleep (wait 5 minutes).
3. Clear DTCs from '008C - Battery regulation control module'.

- 3a. To do this, right click on control unit 008C, click Guided Functions and then click 'Clear Fault Memory'.
4. Return to 'Special functions' and run the test plan 'SVM – Pre 372BIL5201 Hotfix Routines'.

5. Within this test plan, select option 2 and run until completion.
6. Once the test has been completed, right click on control unit 008C and select guided functions. Then, read ECU Identification and ensure that the 06D0 (Battery Junction Box) appears as a subsystem within the read identification test plan.

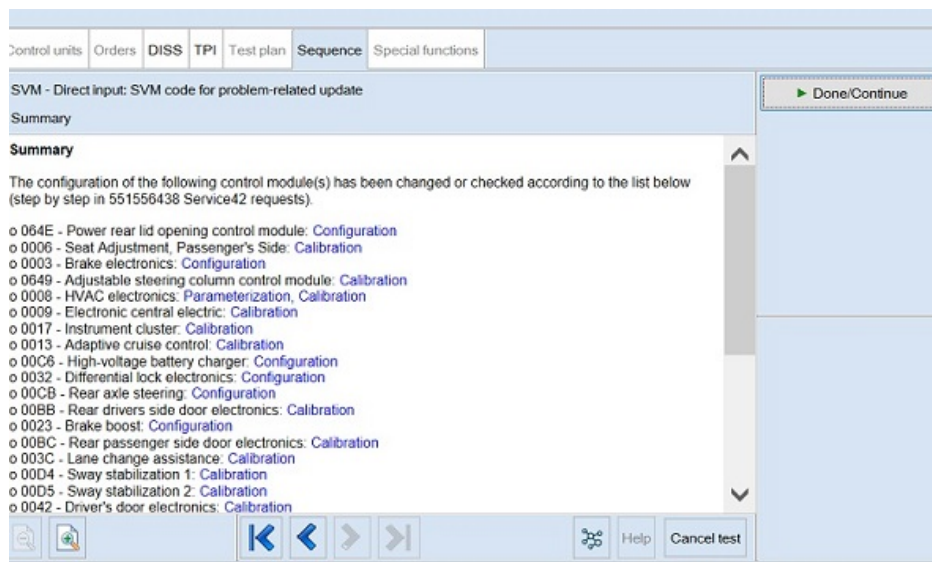
Fig 3

3. On the next screen, ensure that the SVM code displayed is correct.
4. You will be shown the communication type. **This MUST be set to "DoIP"**.
  - a. If "DoIP" is not selected, select option 3 until the communication type is set to "DoIP".
5. After ensuring DoIP is selected, and a suitable battery charger is connected, select Option 1 – "Yes".
  - a. From here, all control modules will be interrogated and the SVM action will take place.
6. Ensure that the diagnostic device remains connected for the duration of the update.
7. Follow all on-screen prompts until the program ends.
  - a. If you have a prompt stating there is no communication established with 00CC, select done/continue.
8. Follow the on-screen instructions to completion.
9. If you are presented with this screen (Fig 3) at the end of the update, the update was successful. Please continue to step 11.

10. If you encounter any errors during the update, please raise a FULL TECHNICAL DISS query.
  - a. Customer Statement: "ED42 Support"
  - b. Workshop Findings: Give a summary of the error encountered and ensure that the latest Guided Fault Finding log is submitted online.

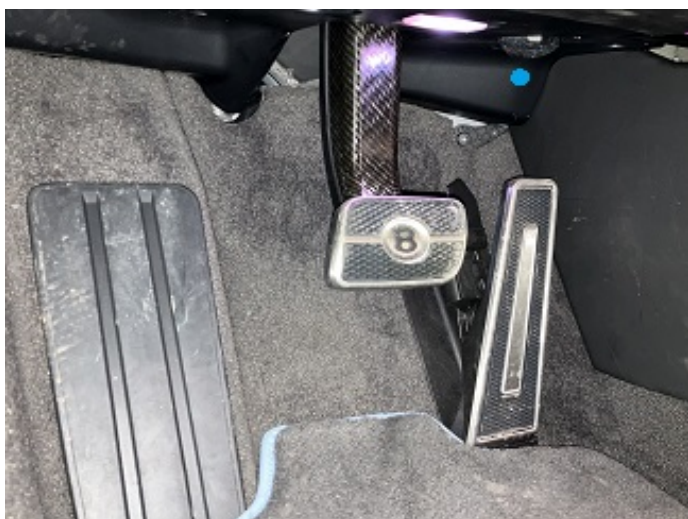
You must also add a blue paint mark as per the picture below.
