## Reduced Engine Power/Fault Memory Entry "P048E00" in the DME Control Unit: Check Electric Wire Harness for Exhaust Flap (Bank 1) Actuator (19/25)

Model Line: **Cayenne (9YA/9YB)**

Model Year: **As of 2019 up to 2024**

Concerns: **Exhaust flap actuator (Bank 1)**

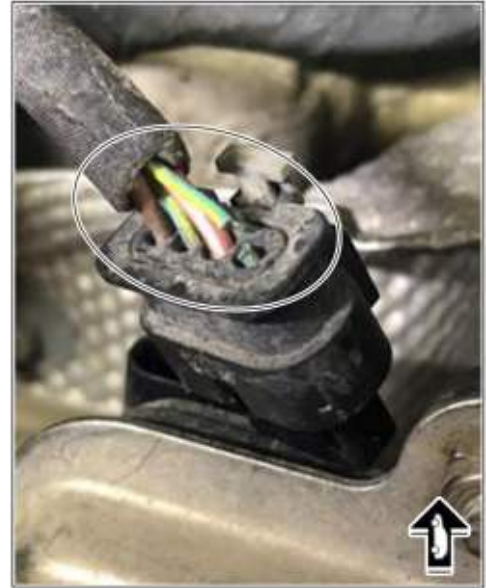
- 2 Check electric wire harness for exhaust flap bank 1 (at right in direction of travel) for damage in the area of the electric plug connection. ⇒ *Electric wiring harness for exhaust flap actuator*

| Assessment | | Action |
|---|---|---|
| (✗) | Electric wire harness for exhaust flap actuator <b>is damaged</b> . | Repair electric wire harness for exhaust flap actuator.<br>Then continue with Step ⇒ 3. |

- 3 Lower the vehicle.
- 4 **Only if the electric wire harness for the exhaust flap actuator has been repaired:**  
Read out and delete all control unit fault memories.
