# Technical Service Bulletin

| Topic | Front or rear door(s) - Soft close function failure - DTC B122D29 Bentayga 22MY - 25MY |

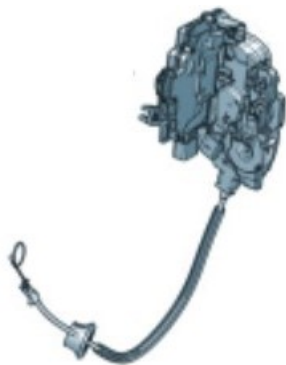
**Note:** For reference purposes Figure 1 shows an example of a door latch

- Request permission via DISS to replace the applicable door latch **IMPORTANT:** Attach a short video confirming the issue is still evident
- Referring to Rep.Gr 57 (front) or Rep.Gr 58 (rear) replace the applicable door latch

Take a clear photograph of the original door latch Tip: Ensure the photograph clearly shows the Part number / serial
