**RSU With Additional Sleep Cycles for HV Battery Integrity Check  
- Flash: Battery Pack Control Module (BPCM) Updates 11A1**

| REFERENCE: | TSB: 08-071-25 REV. B<br>GROUP: 08 - Electrical | Date: | April 30, 2025 | REVISION: | 08-071-25 REV. A |
| VEHICLES AFFECTED: | 2024 (LB) Dodge Charger<br>This bulletin applies to vehicles equipped with 400V G2500 FR/RR Elec Drive Motors (Sales Code ELD). | | | MARKET APPLICABILITY:<br><div><input type="checkbox"/> NA<input type="checkbox"/> MEA</div> <div><input type="checkbox"/> SA<input type="checkbox"/> IAP</div> <div><input type="checkbox"/> EE<input type="checkbox"/> CH</div> | |

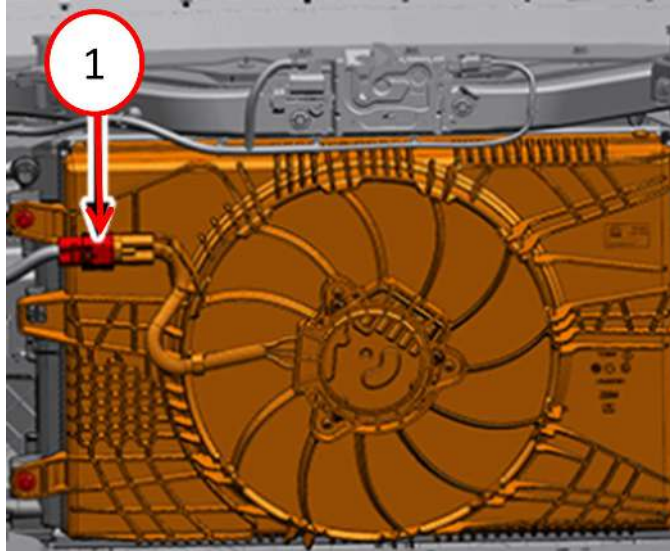
**Fig. 1**  
Cooling Fan Assembly

1 - Wire Harness To Disconnect/Connect

4. Disconnect the cooling fan wire harness connector [Fig. 1](#).

26. Connect the cooling fan wire harness connector [Fig. 1](#).
