## Technical Service Bulletin (TSB)

### RSU With Additional Sleep Cycles for HV Battery Integrity Check - Flash: Motor Control Processor A (MCP A) Updates 11A1

| REFERENCE: | TSB: 08-070-25 REV. A<br>GROUP: 08 - Electrical | Date: | April 29, 2025 | REVISION: | 08-070-25 |
| VEHICLES AFFECTED: | 2024 (LB) Dodge Charger<br>This bulletin applies to vehicles equipped with 400V G2500 FR/RR Elec Drive Motors (Sales Code ELD). | | | MARKET APPLICABILITY:<br><div><input checked="" type="checkbox"/> NA<input checked="" type="checkbox"/> MEA</div> <div><input checked="" type="checkbox"/> SA<input checked="" type="checkbox"/> IAP</div> <div><input checked="" type="checkbox"/> EE<input checked="" type="checkbox"/> CH</div> | |

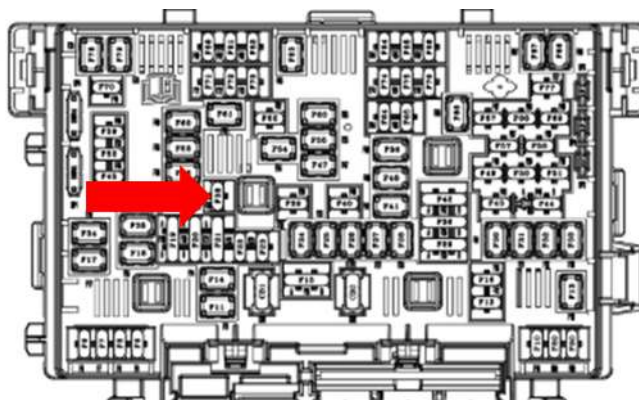
**Fig. 3**  
#38 AGSM Fuse Location

**Failure to remove the #38 AGSM fuse will result in damage to the shifter.**

6. Remove the PDC cover, locate and remove the #38 AGSM fuse [Fig. 3](#).\*\*

24. \*\*Install the #38 AGSM fuse [Fig. 3](#) and the PDC cover [Fig. 2](#).
