| REFERENCE: | TSB: 08-025-25 REV. B<br>GROUP: 08 - Electrical | Date: | April 29, 2025 | REVISION: | 08-025-25 REV. A |
| VEHICLES AFFECTED: | 2025 (LB) Dodge Charger<br>This bulletin applies to vehicles built on or before **April 03, 2025 (MDH 0403XX)** equipped with 400V G2500 FR/RR Elec Drive Motors (Sales Code ELD). | | | MARKET APPLICABILITY:<br><div><input type="checkbox"/> NA<input type="checkbox"/> MEA</div> <div><input type="checkbox"/> SA<input type="checkbox"/> IAP</div> <div><input type="checkbox"/> EE<input type="checkbox"/> CH</div> | |

| <b>CAUSE:</b> | <b>BPCM software update</b> |

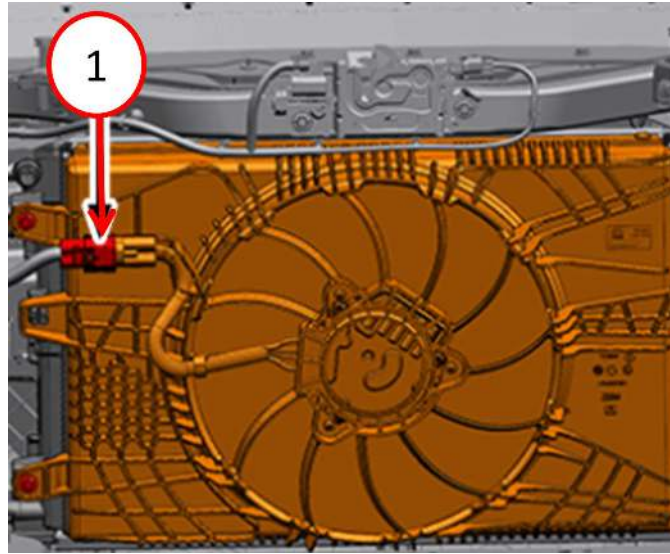
**Fig. 1**  
Cooling Fan Assembly

1 - Wire Harness To Disconnect/Connect

**NOTE: The cooling fan must be disconnected to prevent it from powering on, which may interrupt/ abort the flash process.**
4. Disconnect the cooling fan wire harness connector [Fig. 1](#).

26. Connect the cooling fan wire harness connector [Fig. 1](#).
