## Technical Service Bulletin (TSB)

### Multiple Systems Repair Bundle Campaign

| REFERENCE: | TSB: 23-019-25 REV. A<br>GROUP: 23 - Body | Date: | April 26, 2025 | REVISION: | 23-019-25 |
| VEHICLES AFFECTED: | **2024** - 2025 (JL) Jeep Wrangler<br>This bulletin applies to vehicles built on or after July 01, 2024 (MDH 0701XX) and on or before February 28, 2025 (MDH 0228XX). | | | MARKET APPLICABILITY:<br><div><input type="checkbox"/> NA<input type="checkbox"/> MEA</div> <div><input type="checkbox"/> SA<input checked="" type="checkbox"/> IAP</div> <div><input type="checkbox"/> EE<input type="checkbox"/> CH</div> | |

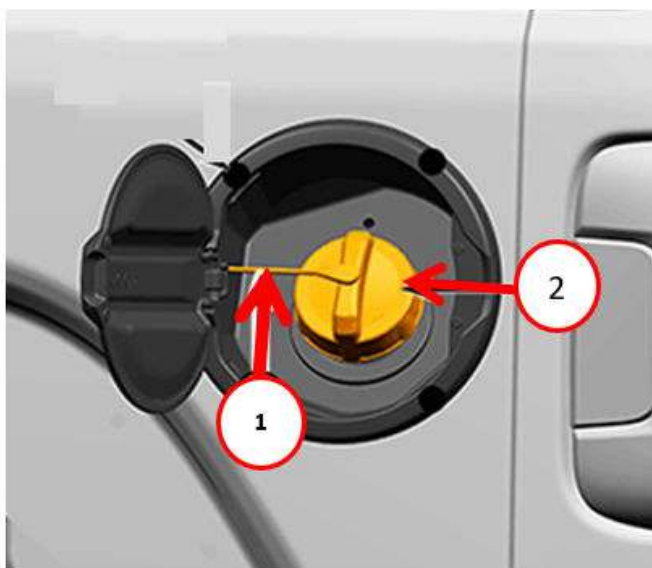
**Fig. 1**  
Fuel Cap Replacement

13. Is the fuel cap tether strap broken?

14. Remove the fuel cap tether strap fastener securing the strap to the fuel door housing [Fig. 1](#).

15. Replace the fuel cap tether strap and the fuel cap assembly.
