## Technical Service Bulletin (TSB)

### Radio U37.23 USB Software Update

| REFERENCE: | TSB: 08-152-25<br>GROUP: 08 - Electrical | Date: | May 9, 2025 | REVISION: | – |
| VEHICLES AFFECTED: | 2024 - 2025 (KM) Jeep Wagoneer S<br>This bulletin applies to vehicles built on or before May 09, 2025 (MDH 0509XX) equipped with one of the following radios: <ul style="list-style-type: none"><li>Uconnect 5 Nav W 12.3" Display (USA) (Sales Code UBX).</li><li>Uconnect 5 Nav W 12.3" Display (CAN) (Sales Code UEX).</li><li>Uconnect 5 Nav W 12.3" Display (MEX) (Sales Code UFX).</li></ul> | | | MARKET APPLICABILITY:<br><div><input checked="" type="checkbox"/> NA<input type="checkbox"/> MEA</div> <div><input type="checkbox"/> SA<input type="checkbox"/> IAP</div> <div><input type="checkbox"/> EE<input type="checkbox"/> CH</div> | |

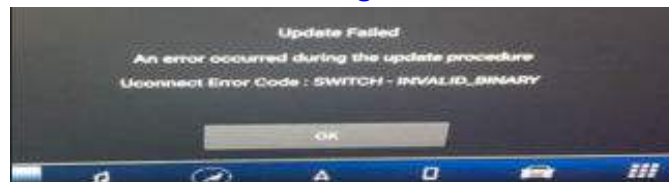
**NOTE:** Sometimes the radio throws an error pop up "Switch-Invalid\_Binary" after successful radio update. Please ignore this error and click ok [Fig. 4](#).

**Fig. 4**  
Switch-Invalid\_Binary Error
