# Service Bulletin

Bulletin No.: PIT6304D

**Subject: Diagnostic Aid: Service Leveling System Message And DTC: C1197 SYM92**

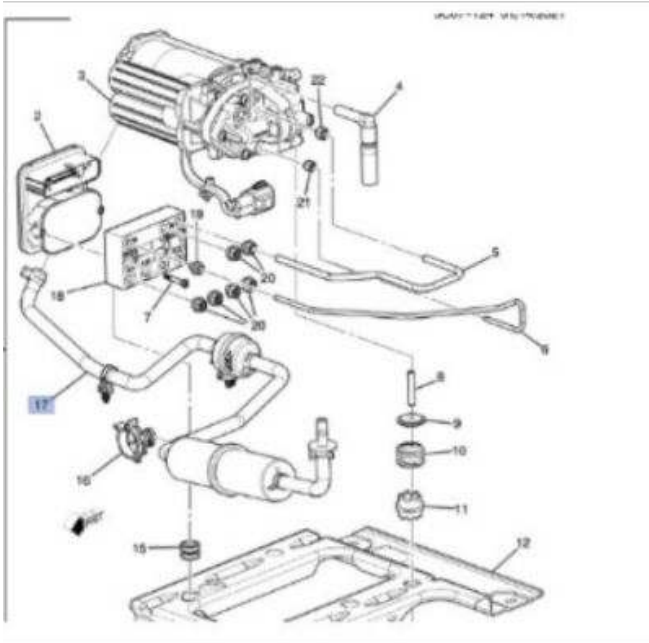
6787471

1) Inspect the air suspension compressor air inlet hose for being pinched or twisted and preventing air from entering the air suspension compressor. The air inlet hose assembly is shown as #17 below. If you find the air inlet hose pinched or twisted, repair as needed.

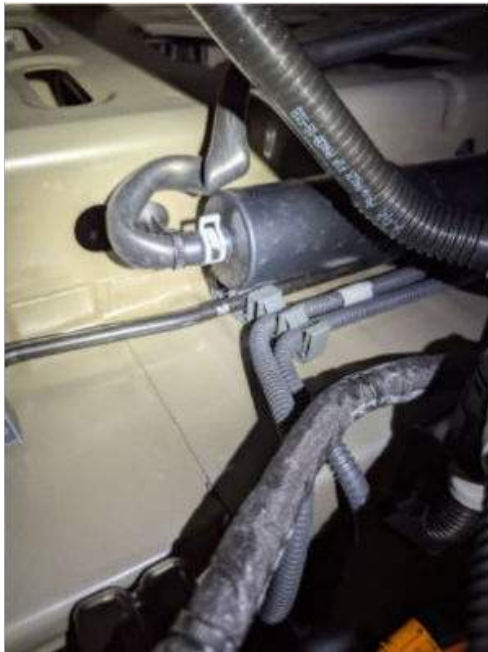
6787464

Silverado RST EV or GMC Denali EV may have a twisted hose near the inline air inlet filter.

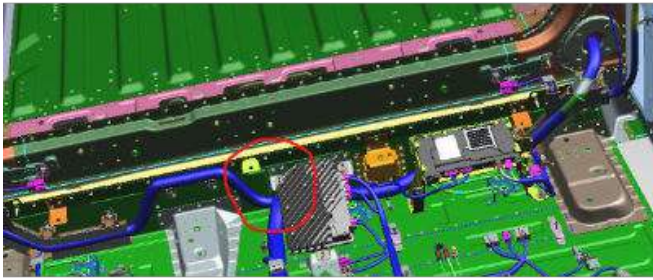
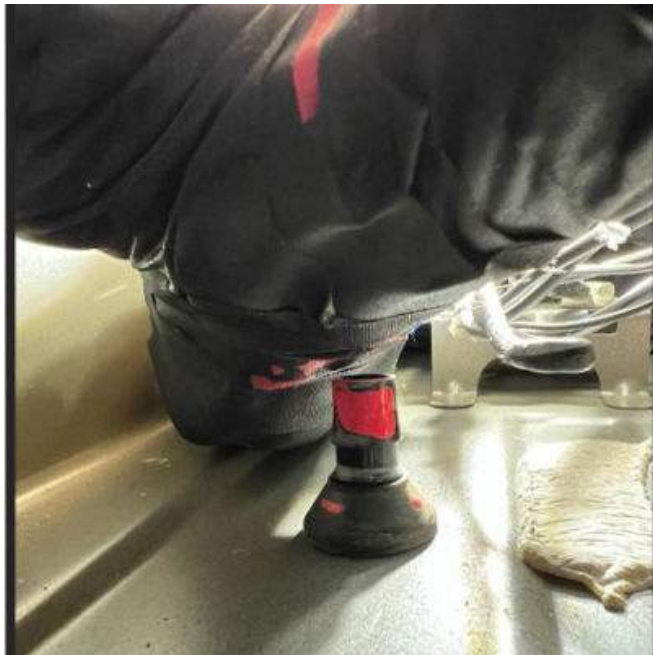
2) Inspect the inlet hose inside of the vehicle (under the rear seat) for being blocked by the rear harness. Check to see if the harness is laying on top of the air inlet hose nipple located to the right of the audio amplifier. See photos below:

If the harness is restricting the air inlet hose, detach the harness retainer from the mounting stud and rotate the harness to provide additional clearance to the air inlet hose. If the harness clip becomes damaged during repair, install a new harness clip PN 13596799 and resecure the harness to the mounting stud.
