## M274 Check engine light, P052E71 Crankcase ventilation valve

| Topic number | LI01.20-P-076894 |
| Function group | 01.20 - Crankcase ventilation, cylinder head cover |
| Validity | Passenger car with engine M274 |

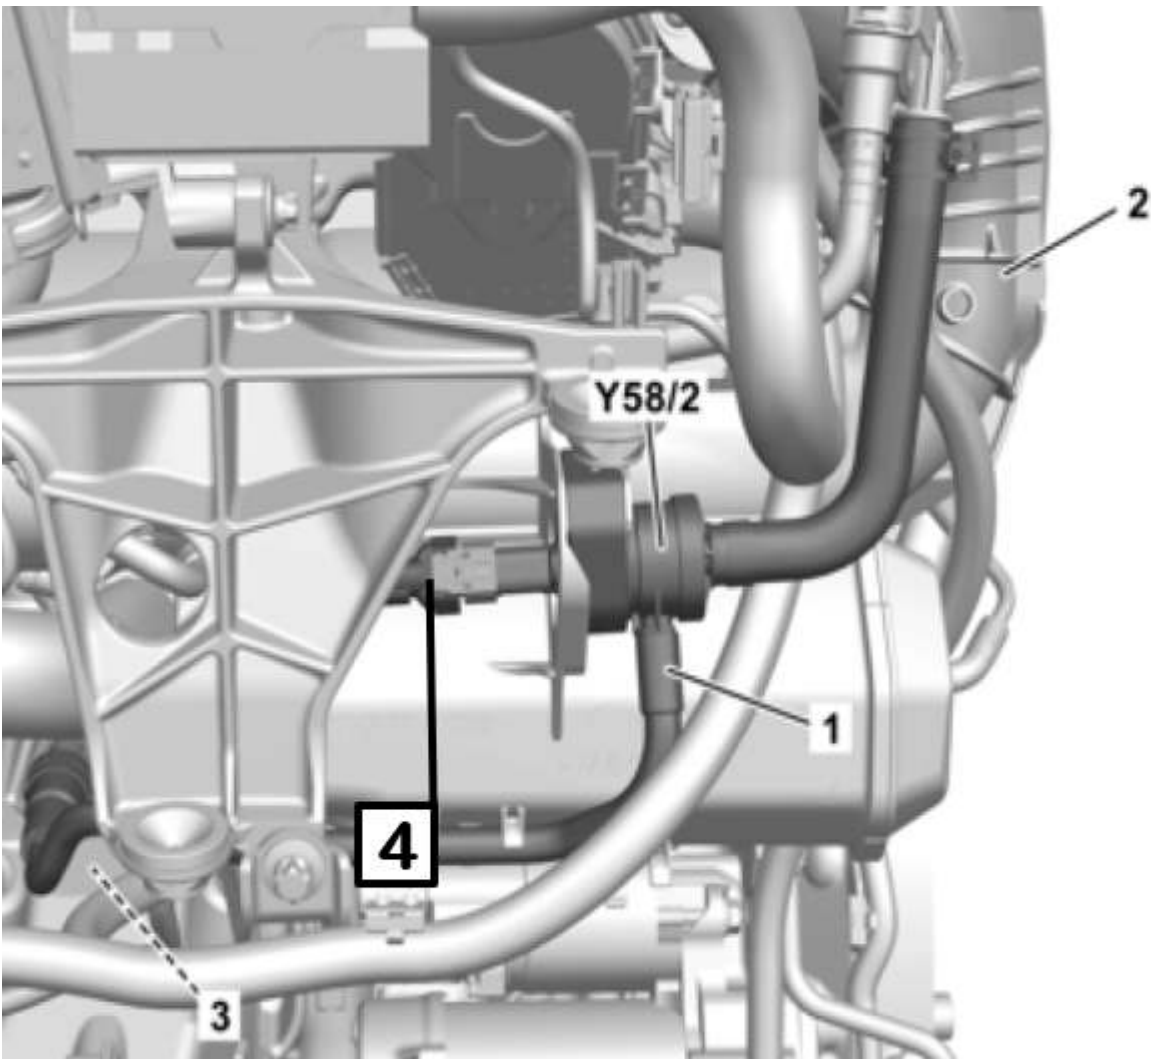
Fault code stored in N3/10 control unit- P052E71 – Positive Crankcase Ventilation Regulator Valve Performance: The valve for crankcase ventilation has a malfunction

The partial-load ventilation valve (a part of the intake line assembly) may not work as intended.

- 1- Perform software update for N3/10 Engine control unit.
- 2- Remove upper engine cover.
- 3- Unclip ME-SFI control unit (N3/10) with bracket and place to one side with connected lines (see AR07.08-P-7013M-RD).
- 4- Release and disconnect electrical connector (4) of partial-load operation crankcase ventilation valve (Y58/2).
- 5- Fit cap A094 545 50 03 on electrical connector (4) of engine wiring harness partial load operation crankcase ventilation valve (Y58/2) and ensure correct seating on plug of electrical connector (4).

6- Strap down electrical line (4) of partial load operation crankcase ventilation system valve (Y58/2) at wiring harness. Ensure that electrical line (4) is routed free of tension.

7- Clip in ME-SFI[ ME] control unit (N3/10) with bracket, ensure control unit is correctly seated at attachment points.
