## Technical Service Bulletin (TSB) Motor Generator Unit (MGU) Replacement

| REFERENCE: | TSB: 08-178-25<br>GROUP: 08 - Electrical | Date: | May 30, 2025 | REVISION: | 08-144-24 |
| VEHICLES AFFECTED: | 2023 - 2024 (JL) Jeep Wrangler<br>2023 - 2024 (WL) Jeep Grand Cherokee / Grand Cherokee L<br>This bulletin applies to vehicles equipped with a 2.0L I4 DOHC DI Turbo PHEV Engine (Sales Code ECX). | | | MARKET APPLICABILITY:<br><div><input checked="" type="checkbox"/> NA<input type="checkbox"/> MEA<br/><input type="checkbox"/> SA<input type="checkbox"/> IAP<br/><input type="checkbox"/> EE<input checked="" type="checkbox"/> **CH**</div> | |

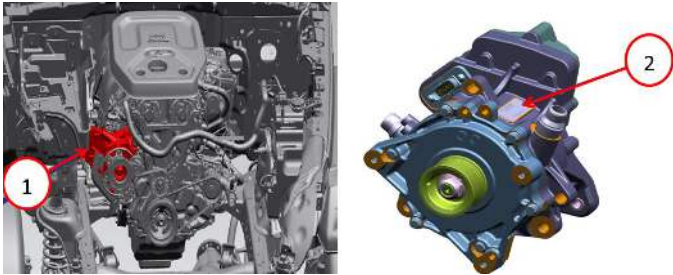
Fig. 1  
MGU Location

1 - MGU Location  
2 - MGU Label Location

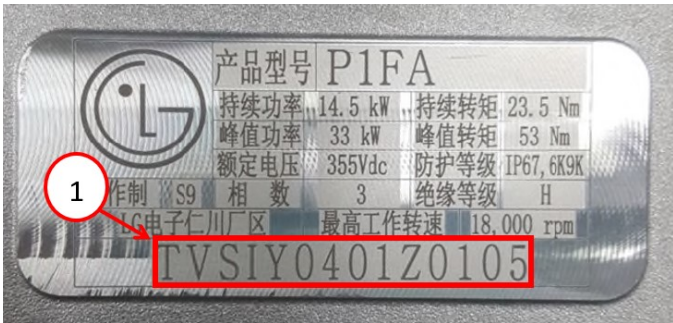
Fig. 2  
MGU Serial Number

1 - MGU Serial Number

## 4. Is the serial number within the following ranges?

| JL | TVSIY0813Z0241 - TVSIY2413Z0005 |
| WL | TVSIY0903Z0714 - TVSIY2383Z0673 |

- YES>>> Replace the MGU. Refer to the detailed service procedures available in DealerCONNECT/ Service Library under: Service Info> 12 - Electrified Powertrain System / Electric Powertrain Control / Motors, Electric Drive / Removal and Installation.
- NO>>> This bulletin does not apply. Follow the DTC P1B0F-00 - Drive Motor A Position Sensor Offset Incorrect diagnostic procedure in Service Library.
