## Field campaign

| Topic | Software Update BiL 5.3.1 v1 to v2 Flying Spur 25MY (SC25/11) |
| Campaign number | ED42 |

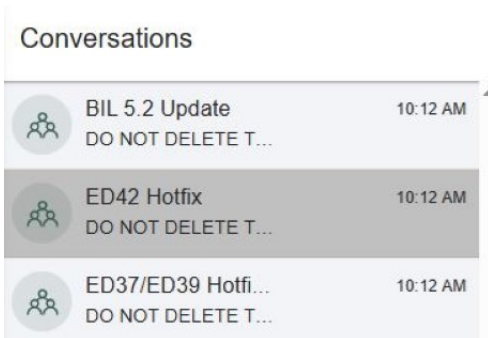
Next, click the conversation named "ED42 Hotfix"

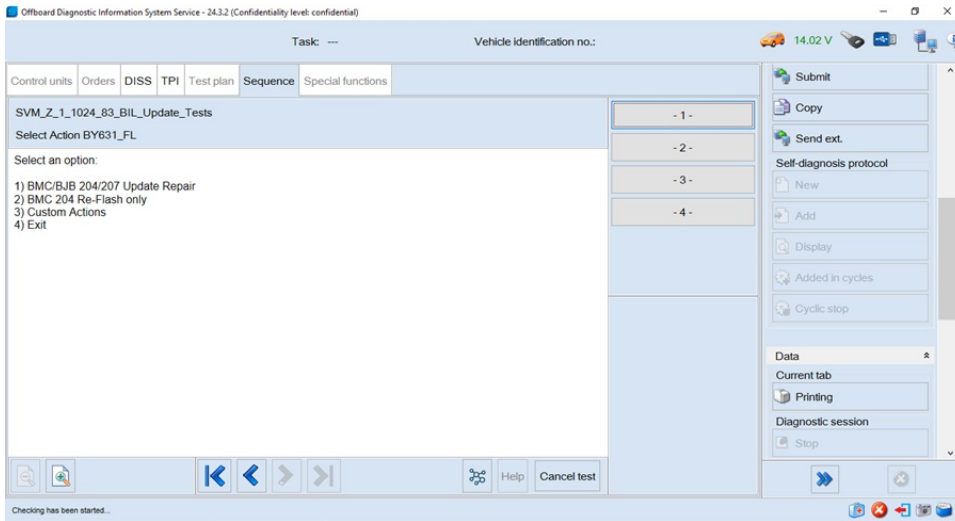
1. After de-energisation, Refer to ElsaPro Repair Group 70 'Boot carpet – To remove and fit'. Remove the boot floor and gain access to the earth cable from the 12v battery negative and the body in white (This access will be required later in the test plan).
2. Navigate to 'Special functions' and select 'SVM – Pre 372BIL5201 Hotfix Routines', then 'Perform test'.
3. Switch to 'DoIP' when prompted.
4. Select '1) BMC/BJB 204/207 Update Repair' and follow the on-screen instructions.
  - When the tester attempts to flash '008C - Battery regulation control module' you may receive a message informing you that the pre-conditions have not been met. Select 'done/continue'.
  - On the following screen (shown below) select option 2 to attempt to flash the ECU – this should allow the '008C - Battery regulation control module' to flash successfully.

- If the flash fails, perform the below actions.

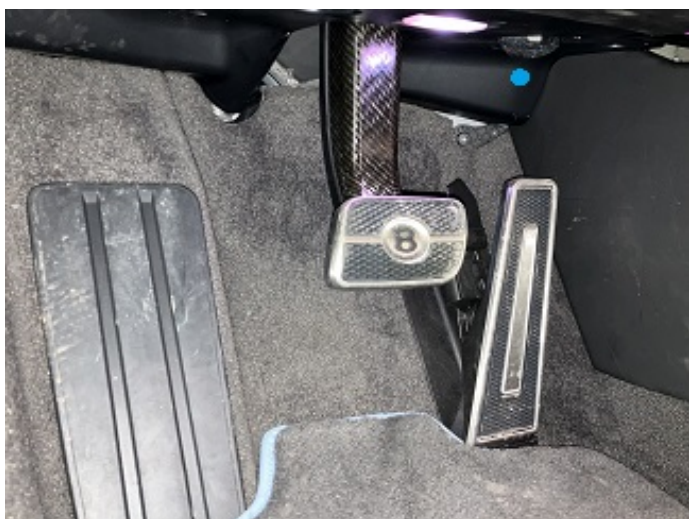
You must also add a blue paint mark as per the picture below.
