## Technical Service Bulletin

| <b>Topic</b> | 57 Various complaints regarding the front or rear door lock, DTC(s) B122D29, B14FF29 or B122B13 |
| <b>Transaction No.</b> | 2063236/9 |
| <b>Release date</b> | May 9, 2025 |

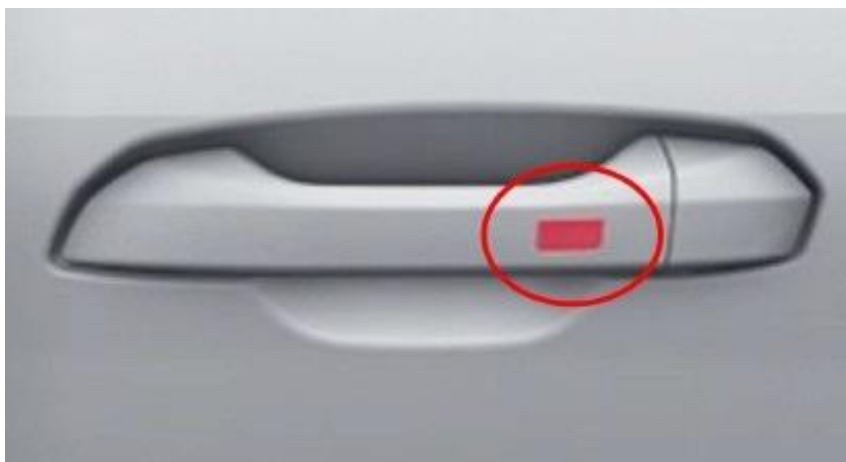
For vehicles with a mechanical exterior door handle and convenience key (Figure 1; sensor on the door handle), be aware of the possibility of incorrect operation by the customer:

When opening the doors, care must be taken not to touch the sensor on the exterior door handle at the same time (e.g. with the thumb), as otherwise the vehicle will be locked again → incorrect operation by the user.

**Figure 1.** Convenience key sensor on door handle.

To lock the vehicle, close the door and touch the sensor on the door handle once. Do not take hold of the door handle when doing so, otherwise the vehicle will not be locked. Once the doors have been locked, they cannot be opened again immediately. This will enable you to check that the doors are properly closed.
