## Technical Service Bulletin

| <b>Topic</b> | 93 e-tron update OBC software when replacing HV wiring harness for charging socket - NTC to PT1000 charging socket |
| <b>Brand</b> | Audi |
| <b>Transaction No.</b> | 2070110/6 |

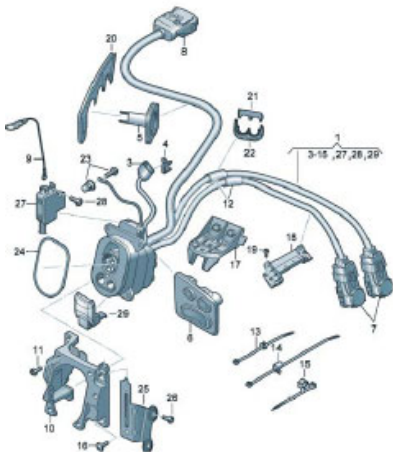
The High Voltage Wiring Harness for the charging socket UX4 or UX5 is replaced as part of any repair work (Figure 1).

Figure 1. High-voltage wiring harness for charging socket.

The charging socket was modified in production.

It is essential to check the part number of the removed original high-voltage wiring harness and of the new replacement high-voltage wiring harness.

If the high-voltage wiring harness for the charging socket is replaced as listed in Table 1.2, an SVM code will need to be performed, *and a replacement test plan performed.*
