## Technical Service Bulletin

| <b>Topic</b> | 01 MIL on, Whistling noise, leaking air Bank 2 - DTC P2ADF00, Engine Crankcase breather |
| <b>Brand</b> | Audi |
| <b>Transaction No.</b> | 2071318/6 |

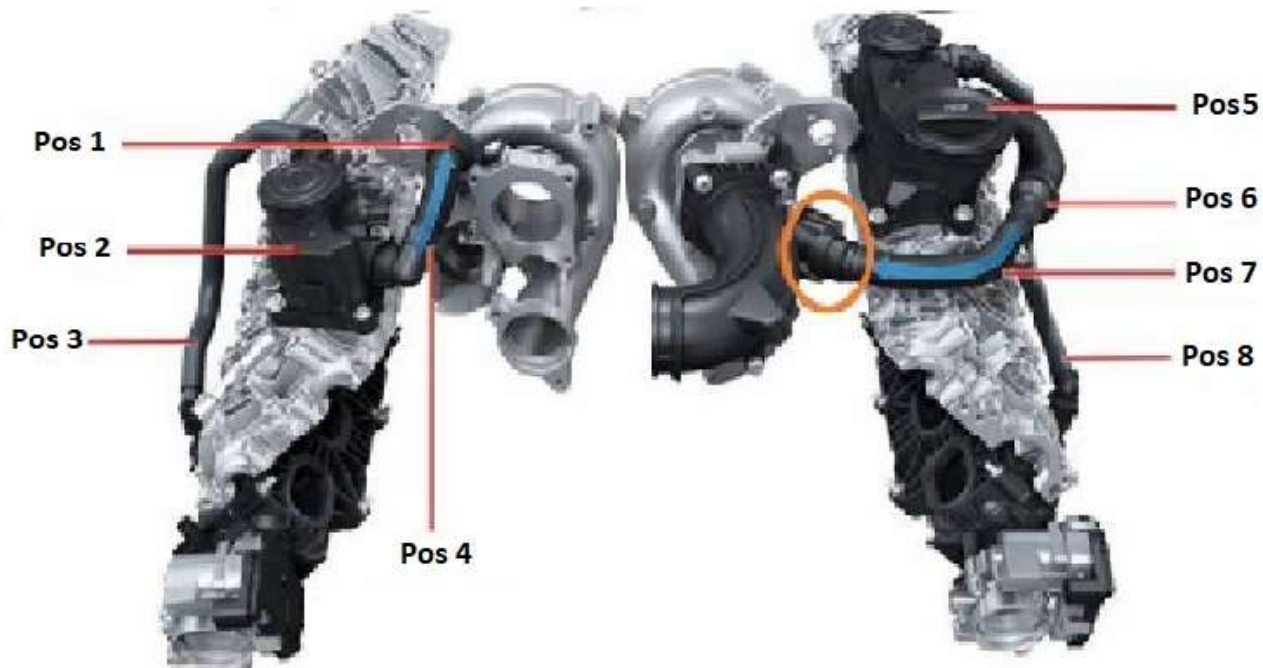
Below is an illustration of the crankcase breather from the SSP 676/ SSP 920493.

- Item 1: Non-return valve
- Item 2: Oil separator for bank 1
- Item 3 Part load breather line for bank 1
- Item 4: Full load breather line for bank 1
- Item 5: Oil separator for bank 2
- Item 6: Non-return valve *(Not applicable for engine codes CWWB, and DWKA, because Non-return valve is integrated into the intake manifold)*
- **Item 7: Full load breather line for bank 2**
- Item 8: Part load breather line

In this case, replace the full load breather line for **cylinder bank 2**. Do not replace the oil separator for bank 1 and bank 2 or the part load breather lines. Please note that the connection for the full load breather line (cylinder bank 2) to the air pipe (see orange marking in illustration below) is a “not to open” connection. This means that the full breather line (bank 2) cannot be detached from the air pipe without being irreparably damaged. Please note the relevant information in the Workshop Manual (chapter: Engine Lubrication/ crankcase breather).
