## Technical Service Bulletin

| <b>Topic</b> | 93 e-tron GE various warning messages in the cluster, electric motor leaking P0AA600 |
| <b>Brand</b> | Audi |
| <b>Transaction No.</b> | 2073858/8 |

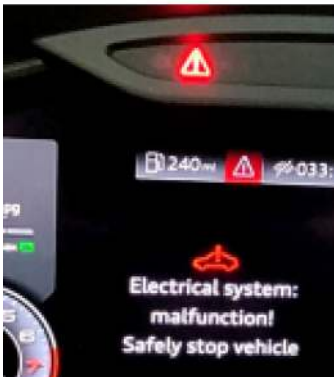
- A Drive System/Electrical System Malfunction message (Figure 1) appears in the in the instrument cluster; the warning may not be present at the time of inspection.

**Figure 1.** Warning lamp associated with message.

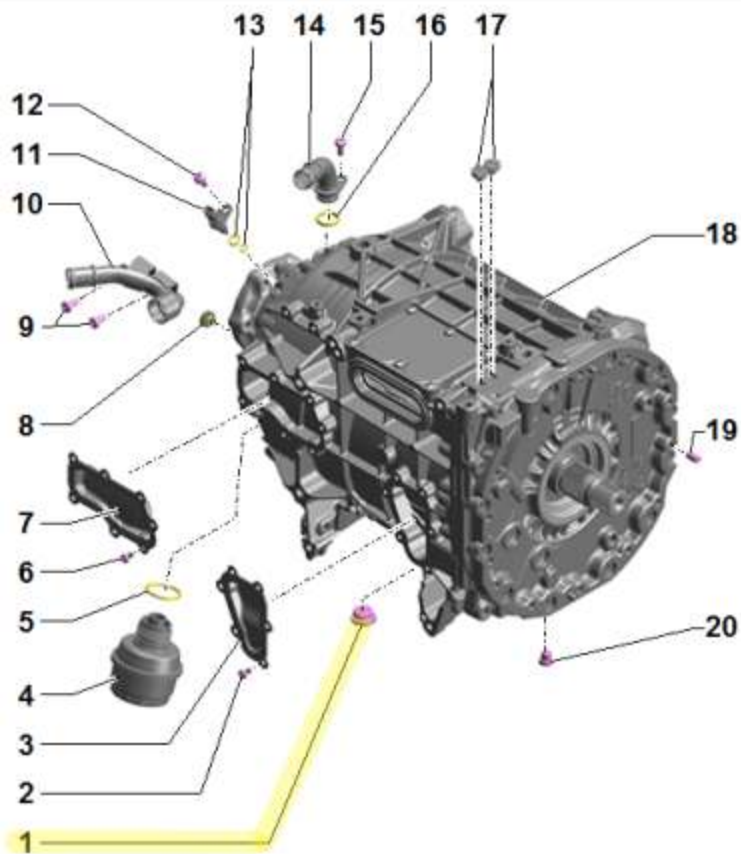
#### **Rear axle (Figure 2):**

Drip container is overflowing:

- Coolant leaking from active chamber.

Drip container is empty:

- Coolant leaking from active chamber, particularly on vehicles with low mileage.

**Figure 2:** (1) Drain plug.

**Caution:**  
**The power electronics must not be replaced if the electric drive motor is leaking.**

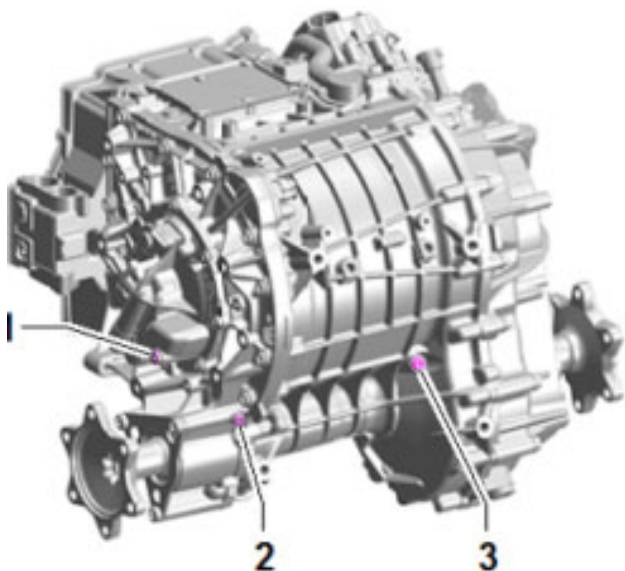
#### **Front axle (Figure 3):**

- Coolant leaking from active chamber.

**Figure 3:** 1) *Resolver cover:* A few milliliters of coolant leakage is not an issue from a technical perspective. 2) *Active chamber:* No coolant may escape from the bores.
