## Technical Service Bulletin

| <b>Topic</b> | 93 Q4 e-tron - electric drive system warning lamp lights up / event memory entry: P0BBD00 in 008C |
| <b>Transaction No.</b> | 2078134/1 |
| <b>Release date</b> | May 29, 2025 |

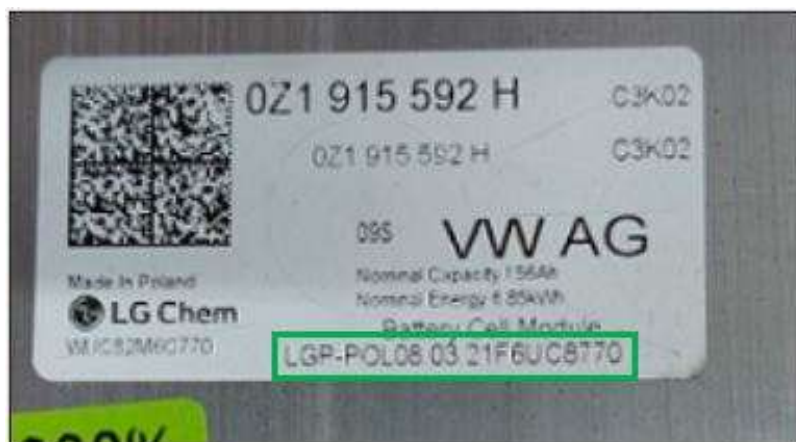
- Remove and open the high-voltage battery as per the Workshop Manual.
- Check the manufacturing date on type plate of the battery module to be renewed (see Figure 1):
  - The consecutive production number (see Figure 1, highlighted in green) also includes the manufacturing date of the battery module. The manufacturing date of the battery module from the example (see image 1, highlighted green): LGP-POL **08.03.21** F6CUC8770 would therefore be **08.03.2021**.

**Figure 1.** Example image of a battery module type plate with production date: 08 03 21 (= 08.03.2021)

- If a battery module with a manufacturing date **prior to 04.12.2023** is installed **and** has one of the following part numbers: 0Z1.915.592.G, 0Z1.915.592.H, 0Z1.915.592.J, 0Z1.915.599.G, 0Z1.915.599.H, 0Z1.915.599.J, 0Z1.915.599.P, the battery module must be replaced according to the Workshop Manual/parts catalogue.
- If a battery module with a manufacturing date **from 04.12.2023 onwards** is installed, a *technical repair query* must be created.
