# Service Bulletin

Bulletin No.: PIC6609

**Subject: Service High Voltage Message - DTC P1C01 and-or U016B**

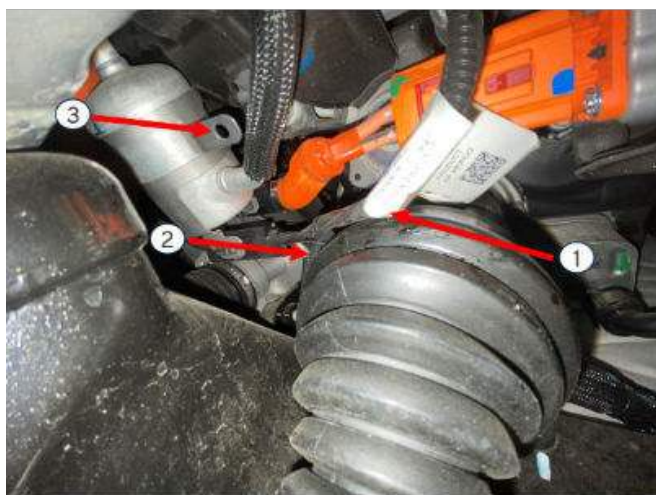
6946483

| <b>Cause</b> | Engine bay low voltage harness to air conditioner compressor rubbing on the right front axle shaft. |

- 1) Harness chaff location, on the clamp of the CV boot of the RF CV axle.
- 2) Harness retainer "Christmas Tree".
- 3) Location harness retainer "Christmas Tree" should be inserted.
