# Technical Service Bulletin

| <b>Topic</b> | BRD Fault Diagnosis - Mechanical Malfunction DTC B140107 Continental GT/GTC/Flying Spur |

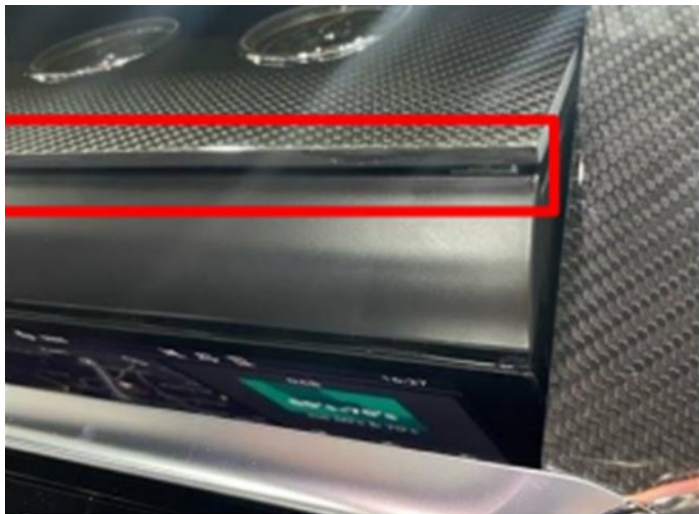
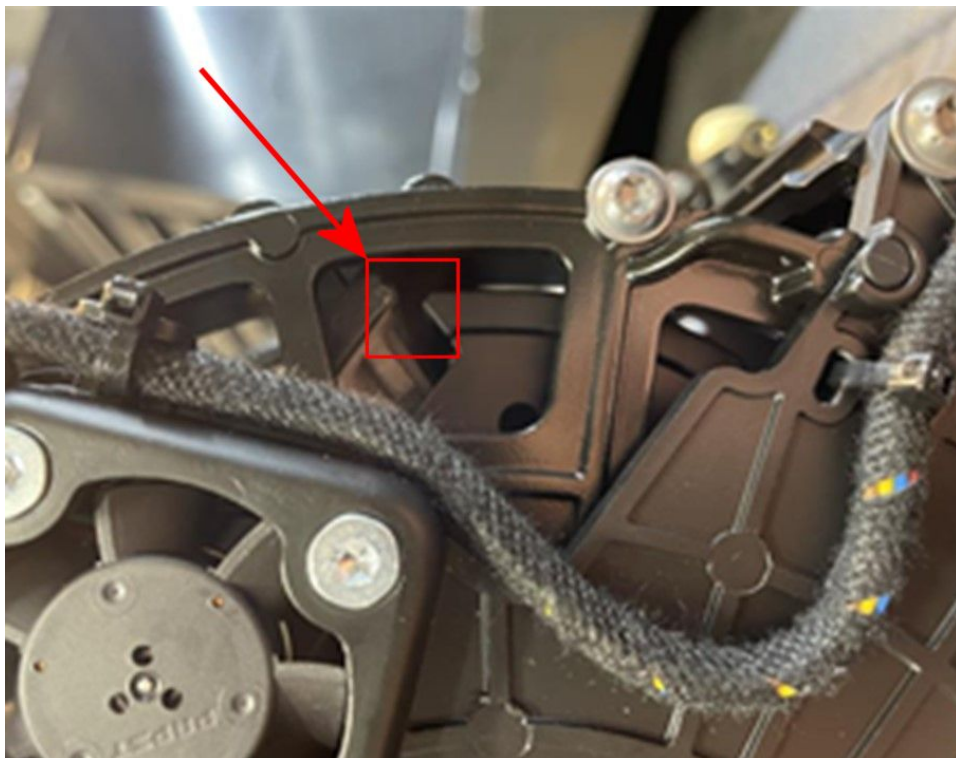
4) Figures 1 and 2 show an example of the display clocks and/or dials fascia unclipped)

**Please note: The BRD must be removed (Rep.Gr 91) to allow visual inspection of the panel at the back of the BRD for signs of unclipping (Figure 2)**

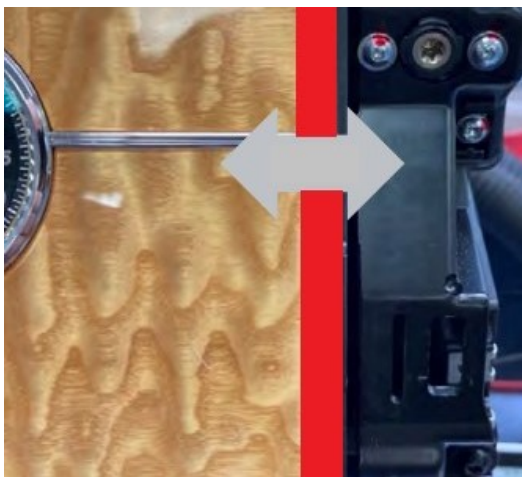
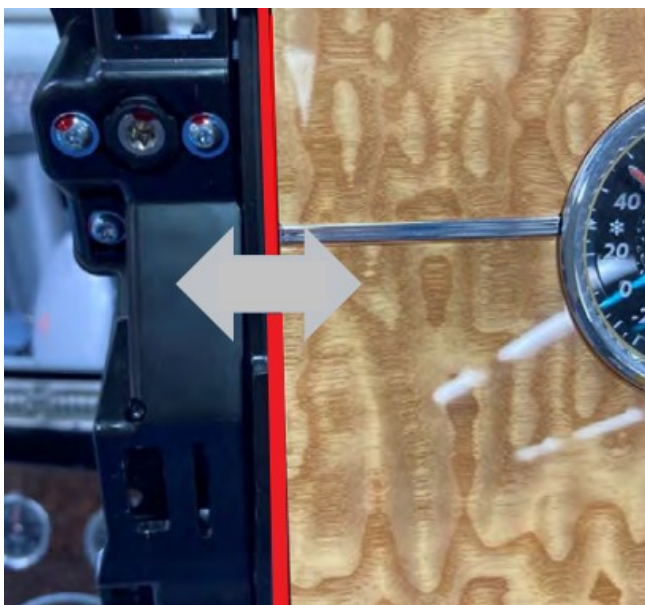
- **HINT: Referring to Figures 4 and 5, if there is a large gap on one side of the fascia panel and a small gap on the opposing side or a report of clashing with driver fascia or clunking the operative should check to confirm the bearings of the unit have not displaced as shown in Figure 6**

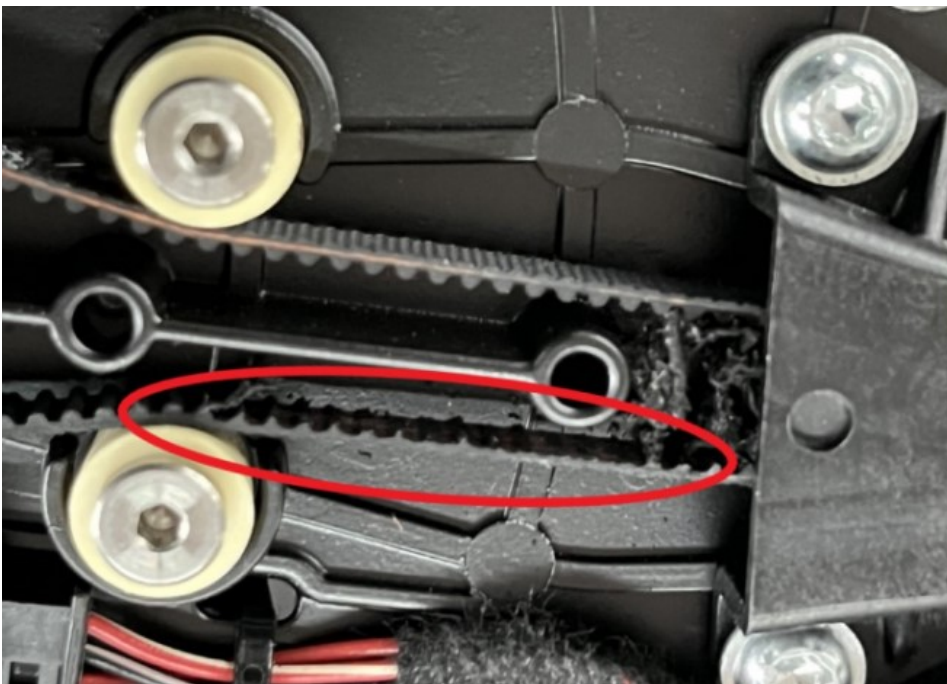
Figure 7

8) Belt drive check (Figure 7)
