| Topic | Software Update BiL 5.3.1 v1 to v2 Flying Spur 25MY (SC25/11) |
| Brand | Bentley |
| Campaign number | ED42 |

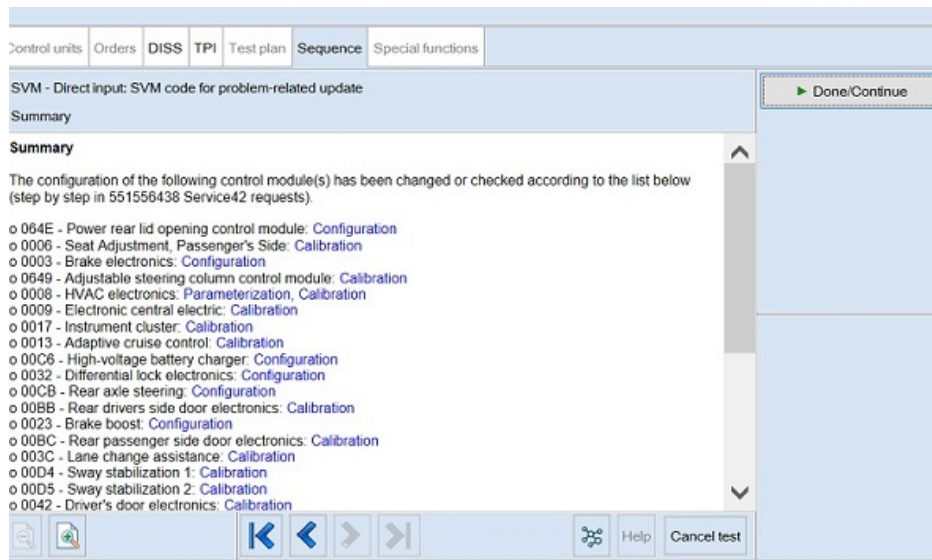
Fig 3

3. On the next screen, ensure that the SVM code displayed is correct.
4. You will be shown the communication type. **This MUST be set to "DoIP"**.
  - a. If "DoIP" is not selected, select option 3 until the communication type is set to "DoIP".
5. After ensuring DoIP is selected, and a suitable battery charger is connected, select Option 1 – "Yes".
  - a. From here, all control modules will be interrogated and the SVM action will take place.
6. Ensure that the diagnostic device remains connected for the duration of the update.
7. Follow all on-screen prompts until the program ends.
  - a. If you have a prompt stating there is no communication established with 00CC, select done/continue.
8. Follow the on-screen instructions to completion.
9. If you are presented with this screen (Fig 3) at the end of the update, the update was successful. Please continue to step 11.

10. If you encounter any errors during the update, please raise a FULL TECHNICAL DISS query.
  - a. Customer Statement: "ED42 Support"
  - b. Workshop Findings: Give a summary of the error encountered and ensure that the latest Guided Fault Finding log is submitted online.
