| Topic | Software Update BiL 5.3.1 v1 to v2 Flying Spur 25MY (SC25/11) |
| Brand | Bentley |
| Campaign number | ED42 |

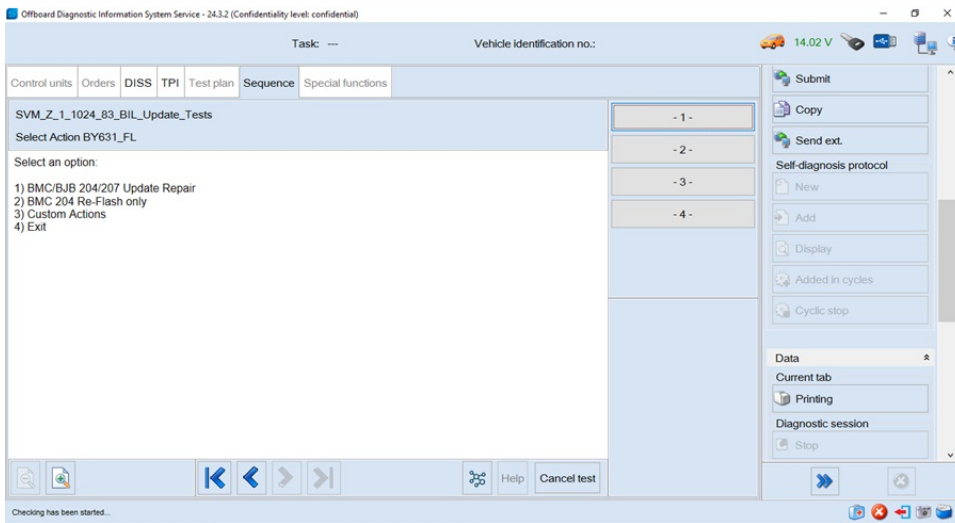
- When the tester attempts to flash '008C - Battery regulation control module' you may receive a message informing you that the pre-conditions have not been met. Select 'done/continue'.
- On the following screen (shown below) select option 2 to attempt to flash the ECU – this should allow the '008C - Battery regulation control module' to flash successfully.

- If the flash fails, perform the below actions.

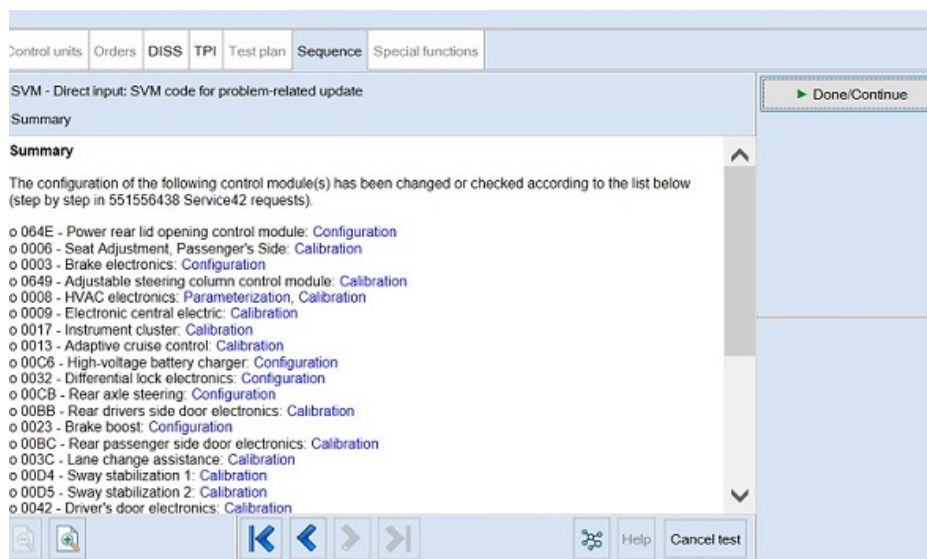
Fig 3

8. Follow the on-screen instructions to completion.
9. If you are presented with this screen (Fig 3) at the end of the update, the update was successful. Please continue to step 11.
