**May 21, 2025**

Version 6

**Warranty Extension: 2017–19 Multi Model 6AT Torque Converter – DTC P0741 Stored**Supersedes 23-078, dated April 18, 2025, to update the information highlighted in **yellow**.**AFFECTED VEHICLES**

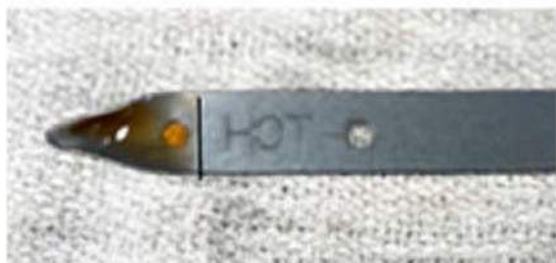
#### COLD CHECK

- Overfilled transmission level can cause an overheat condition.
  - Check the ATF level when the fluid temperature is greater than or equal to **80°C (176°F)**.
  - If the fluid level is checked at a cooler temperature, it will read low or on the bottom dot of the dipstick.
  - If the transmission fluid is filled to the top dot when cold, the transmission will be overfilled, increasing foaming, and contributing to the overheating problem.
2. Check ATF level.
