## Field campaign

| Topic | Software Update BJB and HV ECUs Continental GT/GTC/Flying Spur 25MY (SC25/10) |
| Campaign number | ED40 |

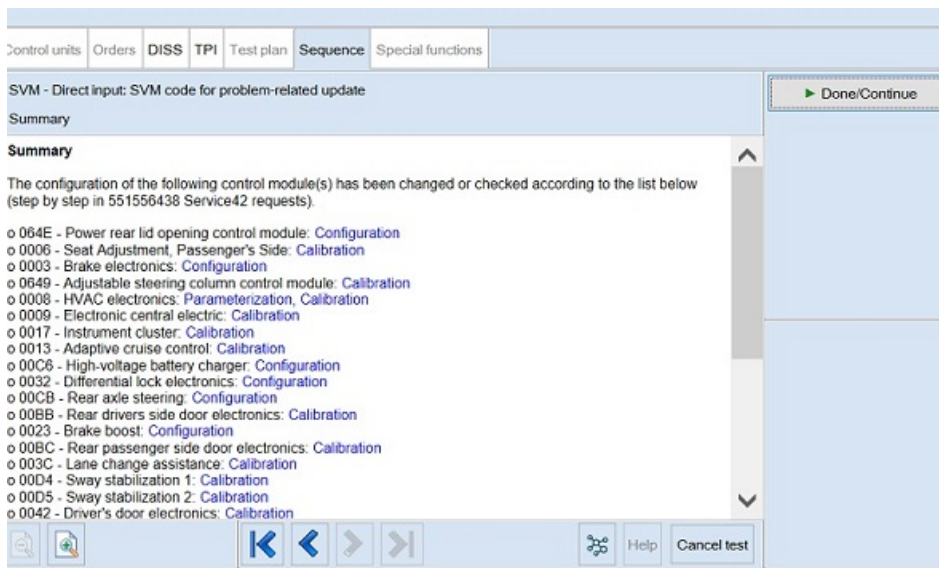
Fig 3

9. If you are presented with this screen (Fig 3) at the end of the update, the update was successful. Please continue to step 11.
