Technical Service Bulletin

| Topic | E-Machine temperature fault DTC P0A2E00 Bentayga and Flying Spur (Hybrid) 20-23MY |
| Transaction No. | 2077783/1 |
| Release date | May 22, 2025 |

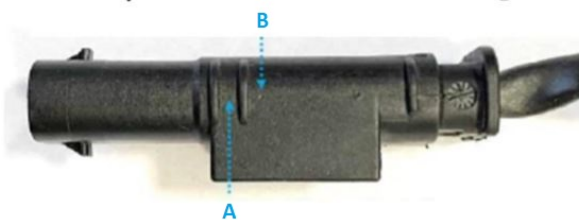
Figure 1

The fault is associated with temperature jumps in the E-Machine temperature sensor. This occurs as a result of sudden changes in resistance in the crimp of the temperature sensor at high temperatures.

Markings shown by **A** (*indentation between the rib*) = New level parts

Markings shown by **B** (*Indentation to the right of the rib*) = Old level parts

3. Install the new level electric drive temperature sensor.

Use figure 1 to help identify old and new level parts. Pay particular attention to the markings shown.
