# Technical Service Bulletin

| Topic | Window Drop Glass Operation Continental GT/GTC 25MY |

Retailer glass reset procedure for New GT/GTC

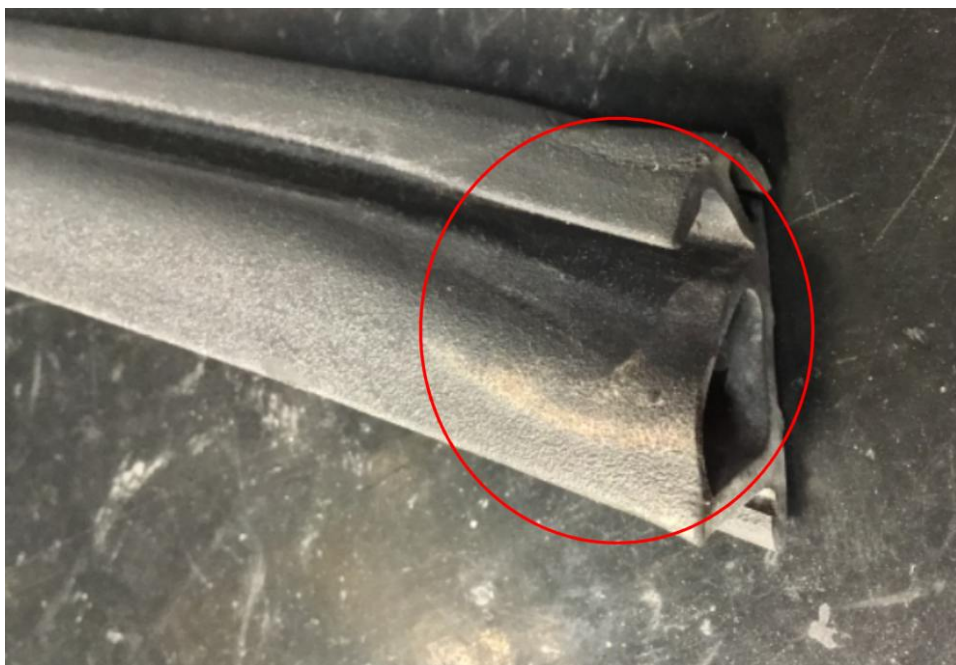
Figure 8

- Damage
- Splits
- Tears
- Misalignment
- Incorrectly fitted / located
- Drop glass seal deformation (see Figures 8 and 9 as examples)

**NOTE:** Any issues found with the window seals must be rectified before conducting the remaining steps

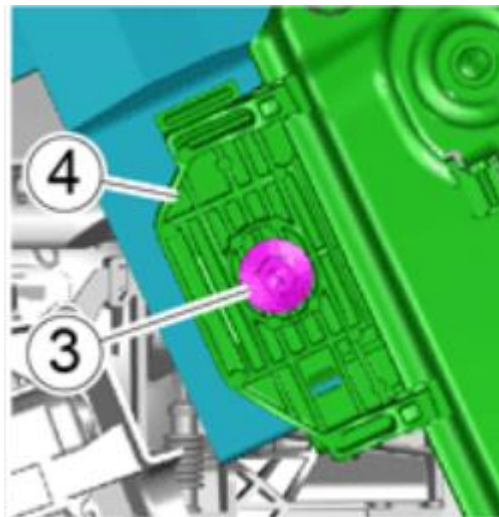
Example: Front drop glass Z axis not adjusted correctly. Bottom of tape was level with waist rail seal, after slackening pinch bolt (3 in bottom left image) front drop glass lowered 14mm to where pen marked line is.

Z-axis adjusters (bottom middle and right images) had not been used, pinch bolt had been slacked and glass lifted out of the regulator to achieve specification. This has a knock on effect of altering the 10mm division bar intrusion seen in previous slide as glass is loose and can be accidentally moved in X-axis.

This also creates a risk that the window will bottom out on the cant rail seals rather than the regulator bump stops meaning that the glass can raise further as the seals soften over time and affect end stop learning.

## Z-Axis height should only be adjusted by the 4mm Allen key adjusters as per ELSAPRO

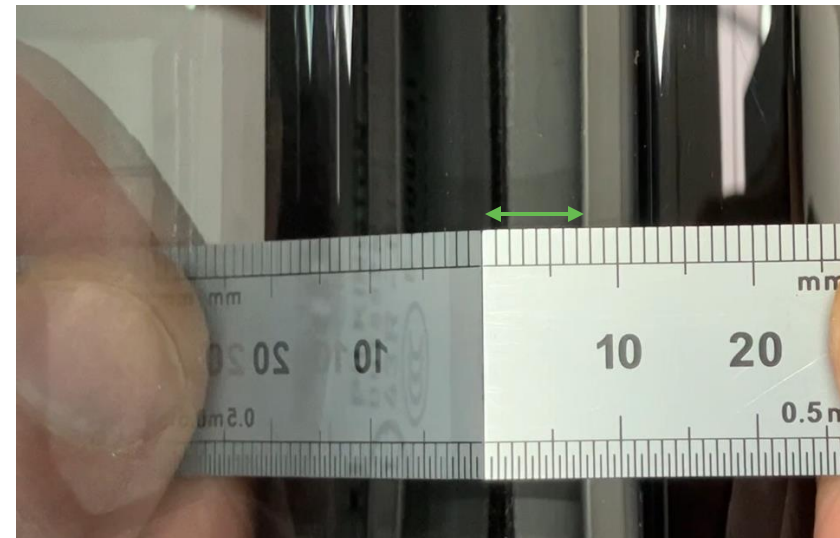
When setting front to rear window profile and waist rail measurements ensure that the front window does not move outboard excessively when the rear window closes as this will increase current draw on the rear motor during the period where it is monitoring for it's end stop, excess current draw in this zone can cause a false anti-trap scenario.

RHF window, front window closed, rear window closed. Note gap, over 0.25mm outboard movement, this is incorrect

If more tension is required to resolve a wind noise or water ingress then aim for no more than 0.25mm of outboard movement.
