## Technical Service Bulletin (TSB)

### Loss Of Power Steering Assist

| REFERENCE: | TSB: 08-185-25<br>GROUP: 08 - Electrical | Date: | June 11, 2025 | REVISION: | — |
| VEHICLES AFFECTED: | 2024 - 2025 (WS) Jeep Wagoneer / Grand Wagoneer | | | <b>MARKET APPLICABILITY:</b><br><div><input checked="" type="checkbox"/> NA<input type="checkbox"/> MEA</div> <div><input type="checkbox"/> SA<input type="checkbox"/> IAP</div> <div><input type="checkbox"/> EE<input type="checkbox"/> CH</div><br><b>NOTE:</b> This bulletin applies to North America market. | |

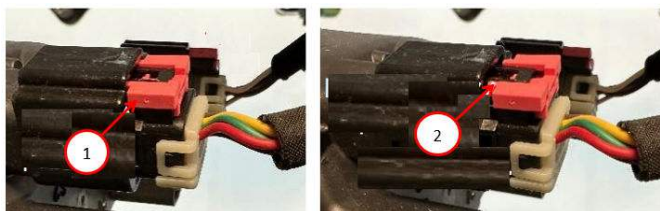
**Fig. 1**  
Connector Tab Locking Feature

1 - Connector Tab Lock Fully Engaged  
2 - Connector Tab Lock Not Fully Engaged

3. Is the connector tab lock feature in the fully engaged position [Fig. 1](#)?
  - YES>>> Proceed to [Step 4](#).
  - NO>>> Proceed to [Step 6](#).
4. Apply a small load to pull the connector by hand in the disengagement direction to confirm that the connector is fully latched.
5. Does the connector come loose or disconnect?
  - YES>>> Proceed to [Step 6](#).
  - NO>>> This bulletin does not apply. Further diagnose should be performed.
6. Fully disconnect the connector.
7. Inspect the inside of the connector to ensure the latching feature is not damaged [Fig. 2](#).

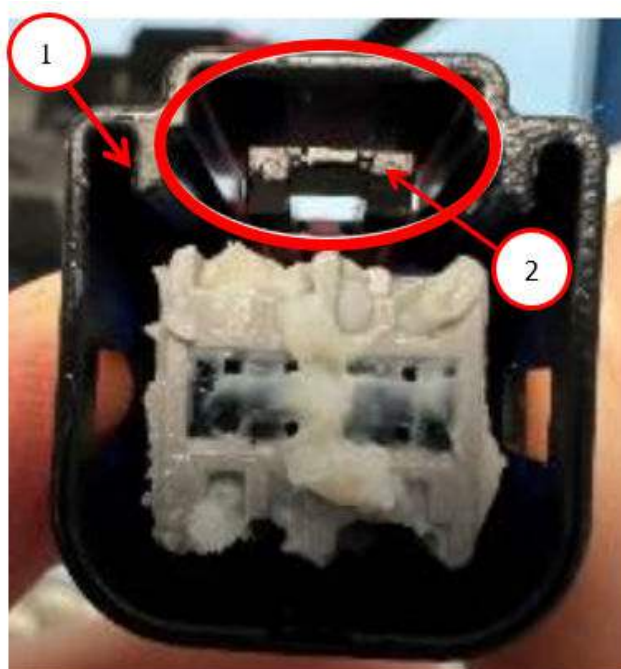
**Fig. 2**  
Inside Connector

1 - Connector Assembly  
2 - Tab Lock Latch

8. Is a damaged connector tab lock latch causing the connector tab lock feature to not be able to fully engage?
- YES>>> Proceed to [Step 9](#).
  - NO>>> Proceed to [Step 10](#).
9. Replace the Electric Power Steering (EPS) gear. Refer to the detailed service procedures available in DealerCONNECT/Service Library under: Service Info> 19 - Steering / Gear / Removal and Installation. After EPS gear replacement, proceed to [Step 16](#).
10. Inspect the grease pattern on both halves of the connector to ensure that grease is present on the connector [Fig. 3](#).

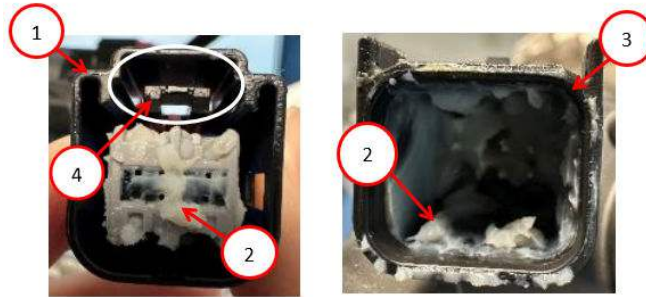
**Fig. 3**  
Connector Halves

- 1 - Connector
- 2 - Grease
- 3 - Connector Mating Header
- 4 - Connector Tab Lock Latch

11. Is grease present on the both halves of the connector?
- YES>>> Proceed to [Step 13](#).
  - NO>>> Proceed to [Step 12](#).
12. Apply a small amount of grease to the marked connectors.
13. Inspect the connector mating header for any excessive grease build up [Fig. 4](#).

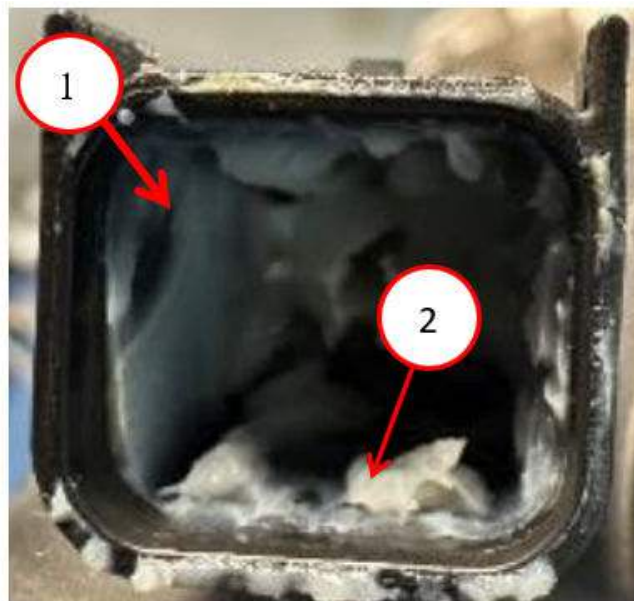
**Fig. 4**  
Connector Mating Header

- 1 - Connector Mating Header
- 2 - Grease

14. Is grease build up seen in the connector mating header [Fig. 3](#)?

15. Move the connector tab lock feature to the pre-latched position.

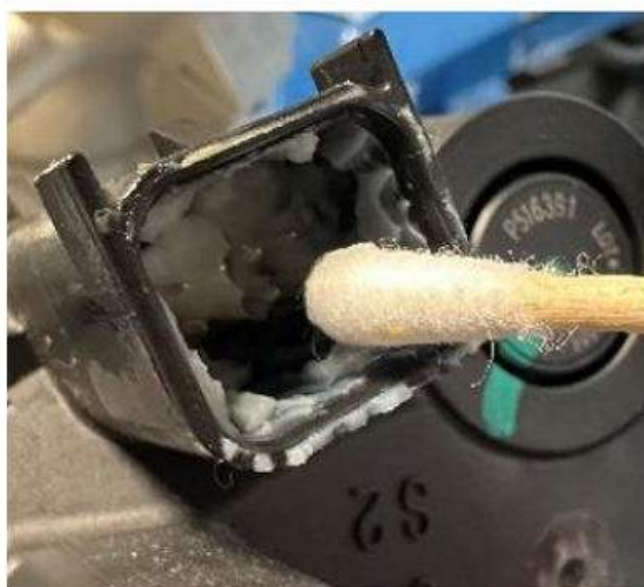
**Fig. 5**

Remove Excess Grease

16. Using a cotton swab, carefully wipe away any grease build up from the inside walls of the mating header near the front face [Fig. 5](#).

**When wiping away grease from the connector walls, avoid touching the metal pins in the header to prevent damage.**
