# Model Series 463 AMG: Active Distance Assist and Active Brake Assist IC Message and DTC U0416FE

| Topic number | LI54.71-P-078112 |
| Validity | 463 AMG |

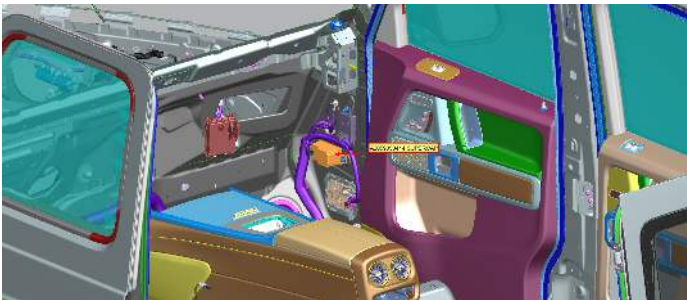
| File | Description |
|---|---|
| <a href="#">Steuergerät+SUPERCAP+Lage+im+Fzg+weit..png</a><br> | Picture 1 - Connection from Supercap to Drive Unit |

Missing wire between Drive Unit (N145) and Supercap (C8).

- Using a red/white cable with cross-section 0.35 mm² and overall length of approximately 2m.
- Connect Drive Unit (N145) plug A pin 18 to the 3-pin plug of the Supercap (C8) terminal 15 pin 2. Reference the new wire routing location as shown by the red line in "Picture 1 - Connection from Supercap to Drive Unit".
- The new wire should be added to the existing wiring harness as shown by the red line "Picture 1 - Connection from Supercap to Drive Unit".
- Z-Splice is the preferred method using A 000 982 91 10.
- Crimp Contact Pin (MLK) for the Drive Unit (N145) is A0485450328.
