## Insufficient Heating Output Due To Broken Refrigerant Line Between Refrigerant Compressor And The condenser (Hot Gas Line)

| Topic number | LI83.20-P-076623 |
| Function group | 83.20 - Heating |
| Validity | EQA (H243), EQB (X243) |

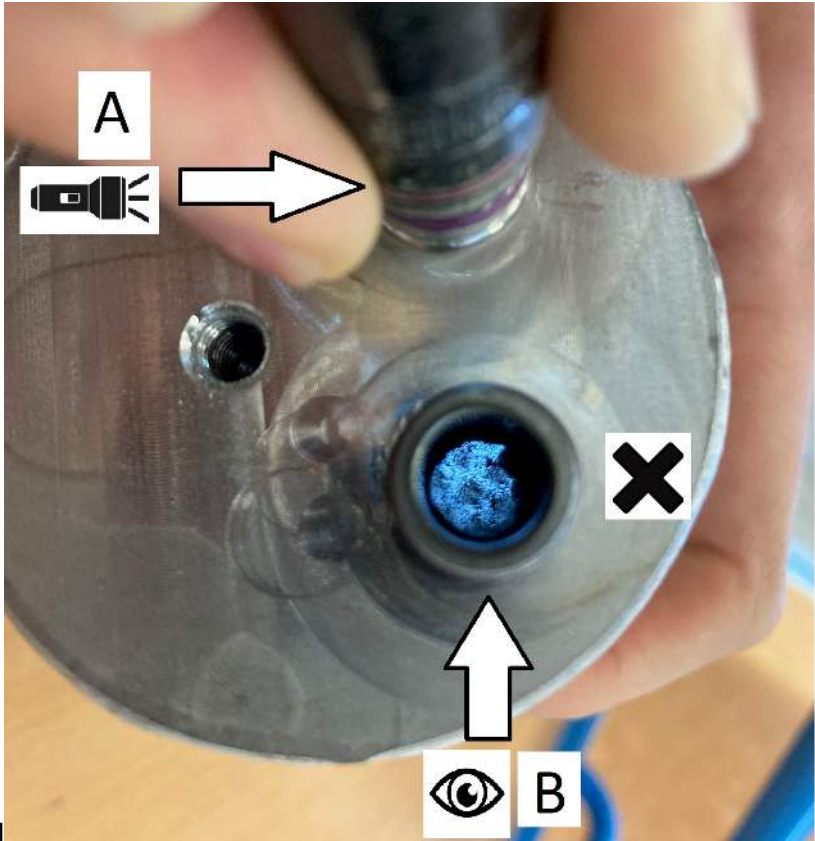
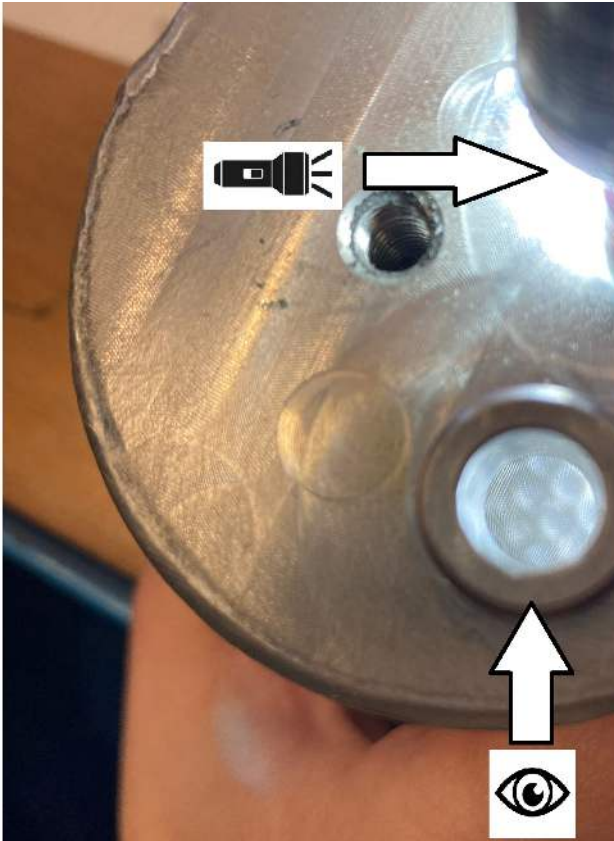
- Refrigerant line between refrigerant compressor and condenser is cracked
- If listed line is cracked, please conduct the following tests

2. Check dryer cartridge at condenser for particles: Remove dryer cartridge, illuminate inlet of dryer cartridge using flashlight (A), and examine filter screen through outlet of dryer cartridge (B) -> see comparison picture bad/good

- Refrigerant level clearly too low (target: 670 g): In this case, please first of all check where a leak is present in the system
- Loud noises from compressor: If loud noises are coming from the compressor, this finding must be validated with the two tests specified above (check the dryer cartridges or the specified fault codes). Loud noises alone are no reason to replace the compressor, since these can be very subjectively perceived in individual cases.

3. Check SAM (N10) for latest software. If necessary, perform software update.
4. Please then check whether all of the heating and cooling functions are active. If not, please create a TIPS case with the following information:
- Detailed description of the customer complaint and the workshop measures carried out
  - Initial quick test
  - Photos of the filter screen of the dryer cartridge
