# TECHNICAL SERVICE BULLETIN

## 400 Watt DC/AC Inverter System Inoperative With B1330:9A In The BCM

**25-2273**  
20 June 2025

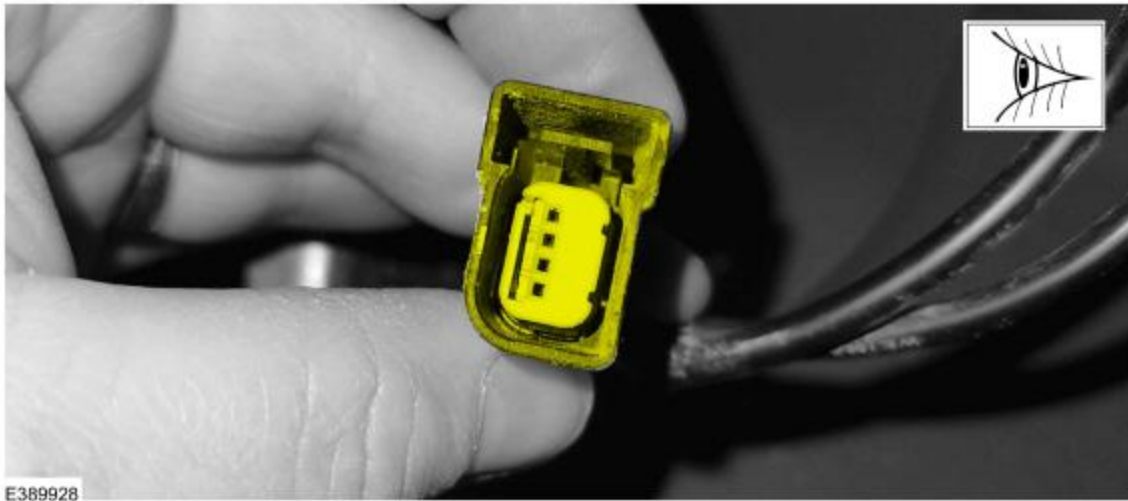
Figure 2

2. Using a suitable tool, carefully cut and remove the pickup bed AC power outlet socket harness retainer from the pickup bed AC power outlet socket harness. Discard the retainer.
3. Is the vehicle a Raptor?
  - (1). Yes - proceed to Step 4.
  - (2). No - proceed to Step 7.
4. For Raptor vehicles, inspect connector C4628 for the presence of corrosion, dirt and/or damage. Is corrosion, dirt and/or damage present in connector C4628? (Figure 2)

7. Inspect connector C4628 for the presence of corrosion, dirt and/or damage. Is corrosion, dirt and/or damage present in connector C4628? (Figure 2)

(1). Yes - replace the pickup bed AC power outlet socket assembly. Refer to WSM, Section 414-05. Replace the body side harness assembly (13A409) of connector C4628. Proceed to Step 8.

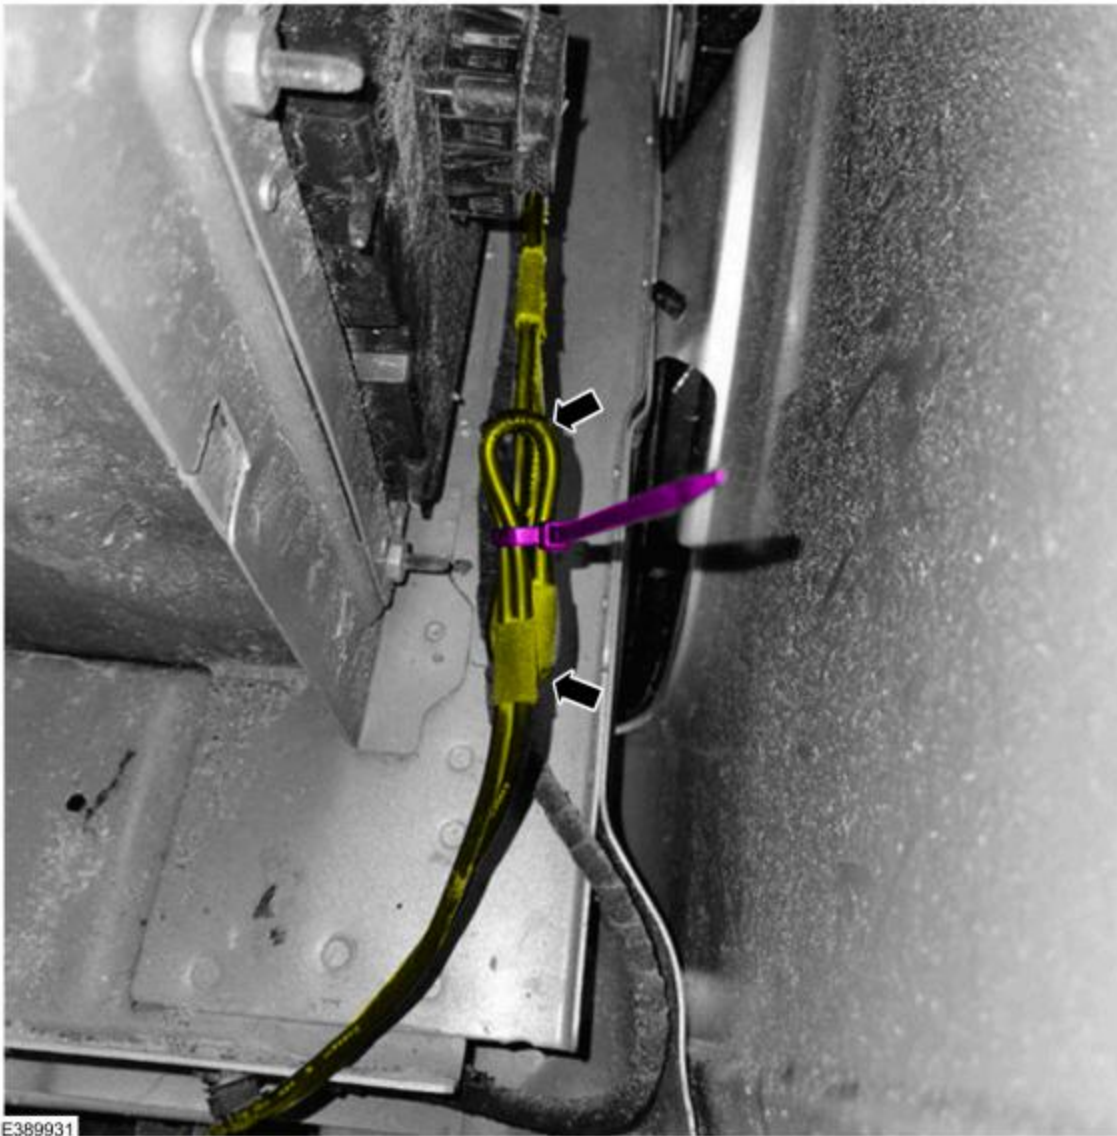
Figure 8

**CAUTION:** The bend radius of the pickup bed AC power outlet socket harness should be no less than 4 mm. Hard kinks and tight bends of the pickup bed AC power outlet socket harness can lead to wire damage.

10. Fold approximately 7 in. (185 mm) of the remaining/loose pickup bed AC power outlet socket harness in 2 bends just behind the pickup bed AC power outlet socket panel. Secure the folded wire with a wire tie. Inspect the routing of the harness to make sure it is not pulled too tight against the body sheet metal near the harness retainer and provides just enough length. (Figure 8)
