## STAR ONLINE PUBLICATION

**Case Number:** S2523000060

**Symptom/Vehicle Issue:** Antilock Brake System (ABS) Lamp on. Diagnostic Trouble Code(s) (DTC) C0037-2F, C003A-2F Left Or Right Rear Speed Sensor Signal Erratic Set.

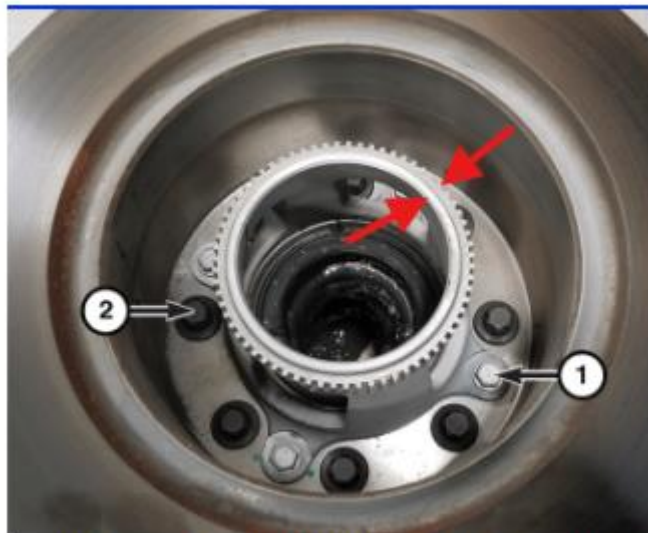
Tone wheel in-between the arrows

- A. Refer to Service Library 05 - Brakes / 05 - Brakes, ABS / Electrical / RING, Tone / Removal and Installation.
- B. Clean and remove any debris including rust dust, particles sticking to the wheel speed sensor or the hub and tone wheel area. See the image below. Reassemble the vehicle.
- C. Perform a test drive. If the condition returns after a test drive, then replace the wheel speed sensor.
- D. If the condition repeats after sensor replacement, please replace the tone wheel.
