## STAR ONLINE PUBLICATION

**Case Number:** S2523000022 Rev. B

**Symptom/Vehicle Issue:** C14A4-00 Sensor Adjustment Required Set In Adaptive Cruise Control Module (ACC).

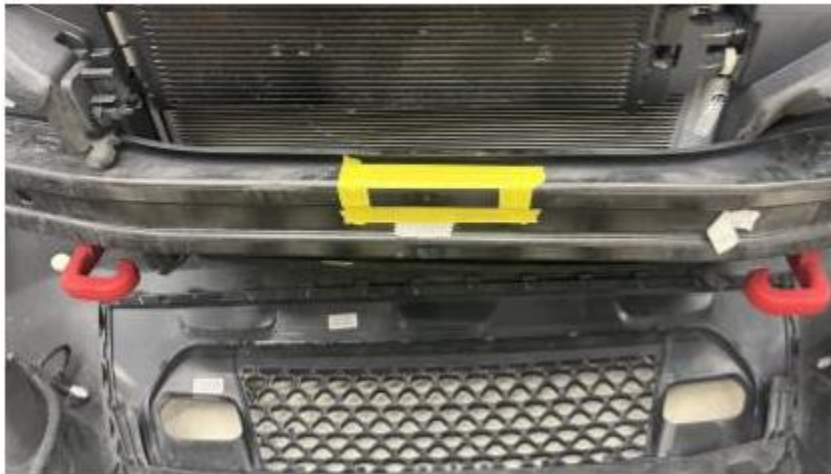
**Discussion:** The ACC module is attached to the front fascia and retrained/ snaps into a bracket. Inspect and confirm ACC bracket is not damaged. Verify the module is fully snapped into the bracket. If the attachment inspects ok, the concern could be the module moving during high winds at freeway speeds (60 to 70 or more mph). If this matches the vehicle/customer concern perform the below procedure.

- 2) Once the fascia is removed, remove any dirt and/or grease using a mild soap and water. Use wax and grease remover to clean the front of the impact beam (rearward of where the ACC module is installed with the fascia installed.)
- 3) Apply masking tape to the top/front portion of the beam to outline an area that is 1" (25mm) x 6" (125mm) as shown below.

- 4) Apply 3M 04274 Dampening Material using the 3M 08571 Manual Cartridge Applicator and 08193 Mixing Tip. Apply Dampening Material as required (layered) to produce a 7mm thickness of the material. Follow the product's instructions for cure time.
