# Service Bulletin

Bulletin No.: PIT6396

**Subject: SES MIL with DTC P2535 / P12A6 / P10DA / C111B / P157A After Fuel Pump Driver Module Replacement 13565642**

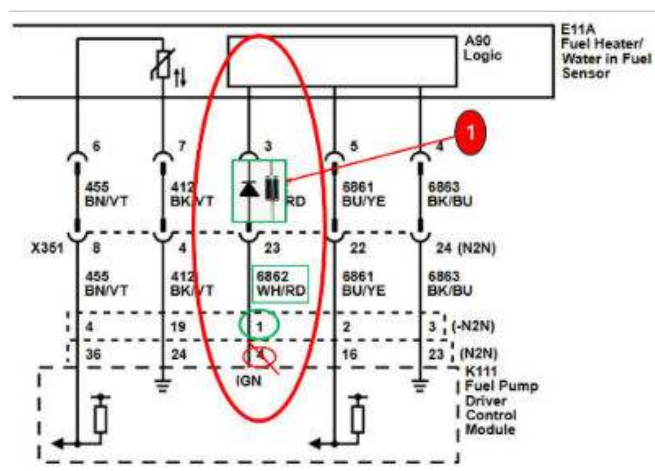
6954816

Engineering is working on design improvements for a new fuel pump driver module. In the meantime, a diode can be installed in line with the water-in-fuel sensor circuit 6862, shown below (1), to correct the issue.

1) Locate either the K111 fuel pump driver module connector terminal 1 OR the E11A Fuel Heater/Water In Fuel sensor connector terminal 3, whichever is the most convenient to install a mini inline fuse holder. Next, cut circuit 6862 a few inches from the connector. Then connect a mini fuse holder, see parts sections for details, in line with circuit 6862 using two salmon splice sleeves, as shown below (3). In the example below, the repair is being done at the K111 fuel pump driver module (2) end, but it could be done at the E11A Fuel Heater/Water In Fuel Sensor connector end, whichever is most convenient.
