**HYUNDAI**  
**Technical Service Bulletin**

NUMBER  
**25-EM-005H**

MODEL(S)  
**SANTA CRUZ (NXT)**

**SUBJECT:** INTEGRATED THERMAL MANAGEMENT (ITM)  
REPLACEMENT & ECU SOFTWARE UPDATE – DTC P218100

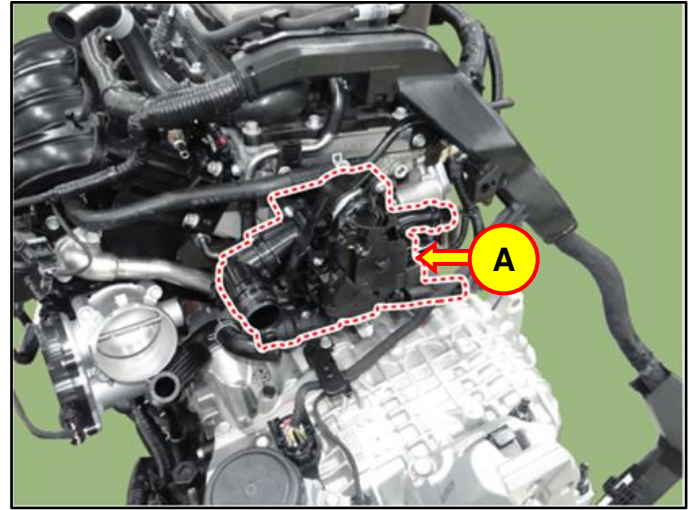
1. Utilize the GDS to detect DTC P218100:  
Cooling System Performance:
  - If DTC P218100 is present, then replace the ITM (A) by referring to the shop manual.
    - **Engine Mechanical System > Cooling System > Integrated Thermal Management > Repair procedures**
  - If DTC P218100 is **NOT** present, then the service procedure is now complete.

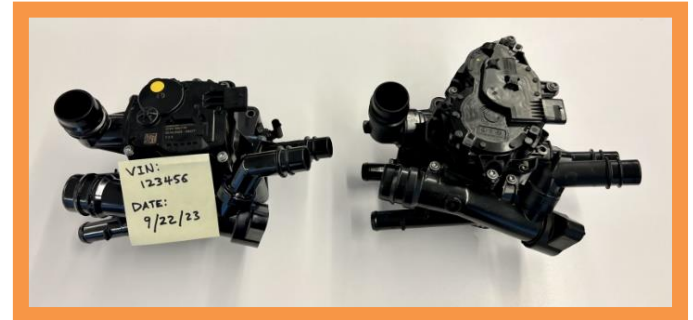
NEW (QQH)

OLD (OE)

**Using STUI, take a photo of the new (QQH) part next to the removed, old part.**
