## SERVICE BULLETIN

**APPLICABILITY:** All Models with Gen 2 & Gen 3 Telematics  
 Except Solterra

**NUMBER:** 15-251-19R

**SUBJECT:** DTC B2A16

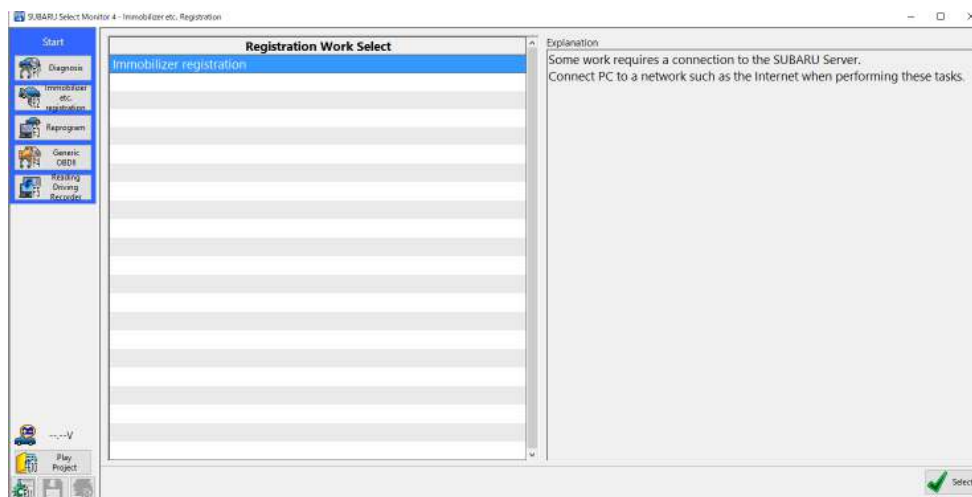
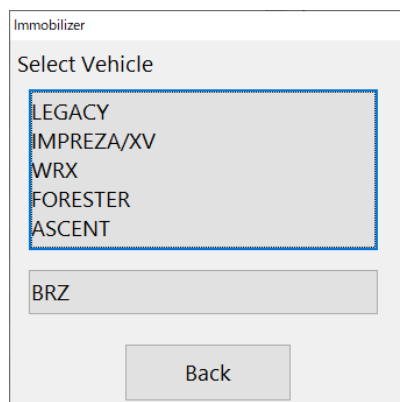
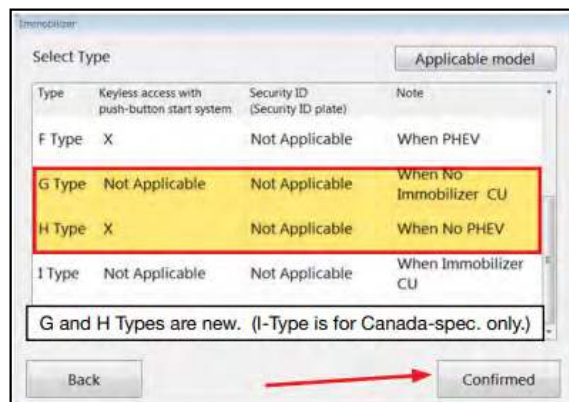
**NOTE:** When selecting G, H, or I Type, the latest SSM4 software (July 2019 version or later) is required along with a secure network connection. Refer to TSB 15-246-19 for additional details.

1. Register the DCM with the immobilizer as outlined in TSB 15-251-19R or 18-226-25R.
2. Cycle the ignition key off and wait 1 minute.
3. Connect the SSM4 and clear all Diagnostic Trouble Codes (DTCs).
4. Cycle the ignition off and wait 1 minute.
5. On a Gen3-equipped model, connect the SSM4 and review the telematics data for all PIDs, verifying that the Immobilizer Key Registration Status equals "Registered."
6. Follow TSB 15-266-20R to request RES verification of the repair.
