### Check engine light active - Fault P3007F1, P3007F2, P300CA8, or P300CA9 present in CDI control unit

| Topic number | LI14.30-N-075882 |
| Function group | 14.30 - Secondary air injection |
| Validity | Model 907 with engine 654 |

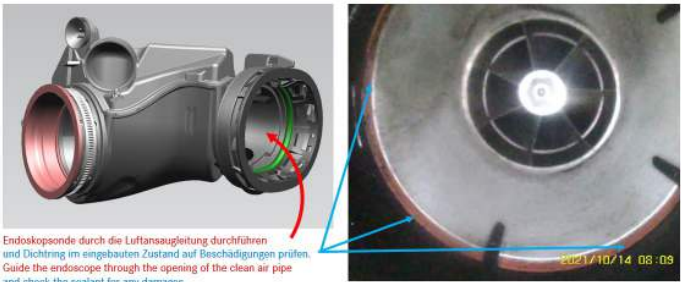
- If there is a leakage upstream of the exhaust gas turbocharger (see "Dichtring\_Sealant.jpg").
- If the housing intermediate flange at the high-pressure EGR valve (where the exhaust back pressure sensor connects) is carbonized or clogged, or if there is carbonization/incomplete sealing of the high-pressure or low-pressure EGR valves. (See "Gehaeusezwischenflansch\_intermediate\_flange.jpg" and "verstopfter\_Gehaeusezwischenflansch\_clogged\_Intermediate\_Flange.jpg".)

| File | Description |
|---|---|
| <div>Dichtring_Sealant.jpg</div> <div><p>Endoskopsonde durch die Luftansaugleitung durchführen und Dichtring im eingebauten Zustand auf Beschädigungen prüfen.<br/>Guide the endoscope through the opening of the clean air pipe and check the sealant for any damages</p></div> | |

- Inspect the sealing ring between the exhaust gas turbocharger and the clean air line for damage with an endoscope (see annex "Dichtring\_Sealant\_nok").
- Repair/replace as needed.

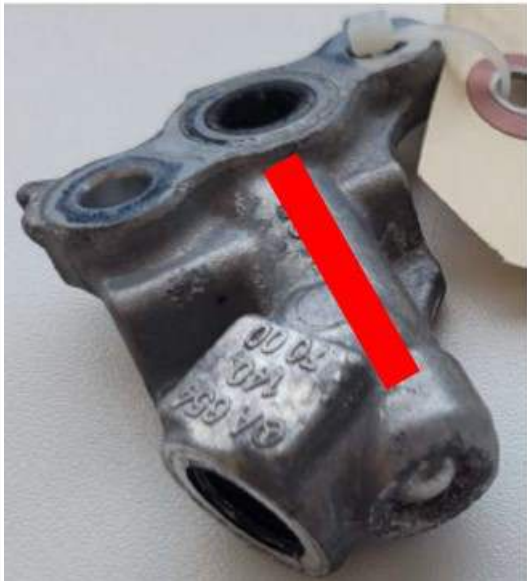
| File | Description |
|---|---|
| <div>Gehaeusezwischenflansch_Intermedidate_Flange.jpg</div> <div></div> | |

- There is carbonization or incomplete closure of the high-pressure exhaust gas recirculation valve, especially in the housing intermediate flange at the EGR valve (linked to the exhaust back pressure sensor).

1) Inspect the housing intermediate flange on the high-pressure exhaust gas recirculation (EGR) valve, specifically at the connection for the exhaust back pressure sensor. Use a flashlight to check for any inconsistencies or carbon buildup.

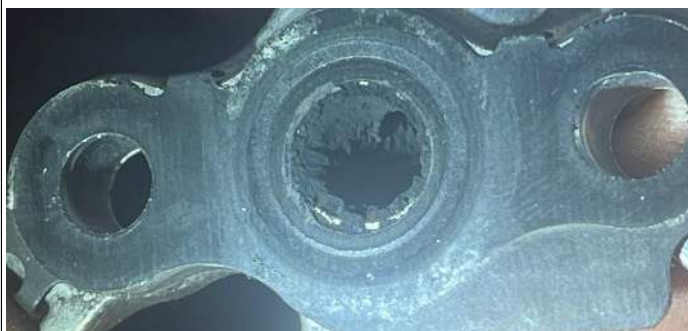
[verstopfter\\_Gehaeusezwischenflansch\\_clogged\\_Intermedate\\_Flange.jpg](#)

- There is a leak downstream of the exhaust gas turbocharger.
- The charge air distribution line (intake manifold) is heavily carbonized (see "Saugrohr\_intake\_manifold.jpg").
- There is carbonization or incomplete closure of the high-pressure exhaust gas recirculation valve, especially in the housing intermediate flange at the EGR valve (linked to the exhaust back pressure sensor).

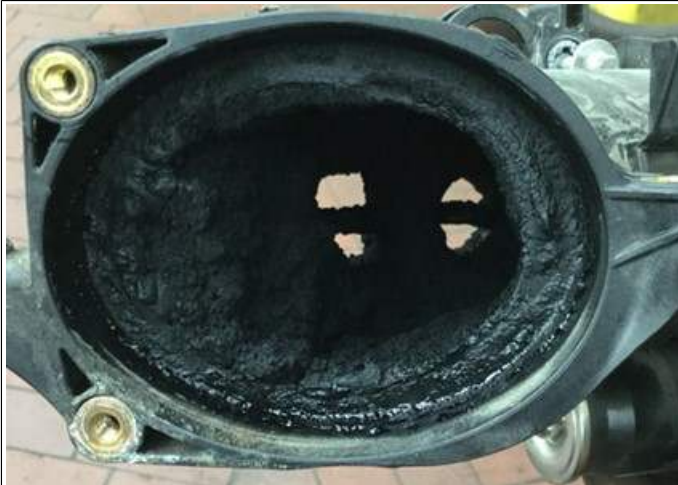
[Saugrohr\\_Intake\\_manifold\\_II.jpg](#)

- Note: Only relevant if correction value in load range 1 is less than -8%.
- If the intake manifold (charge air distribution line) or charge air cooler is carbonized (see "Saugrohr\_intake\_manifold.jpg").

- Inspect the following for severe carbon build-up or other inconsistencies:
- Intake manifold (charge air distribution line) – see "Saugrohr\_intake\_manifold.jpg."
- Housing intermediate flange at the high-pressure EGR valve (exhaust back pressure sensor connection, use a flashlight).
- Only necessary if the air intake correction value in load range 1 is less than -8%.
- Charge air cooler.
- Initiate repairs/cleaning as needed.
- If issues are found in the intake manifold, also check the cylinder head intake ports.
