# Technical Service Bulletin

| Topic | Engine Overheating - Coolant Pump Leaking and Low Coolant Warning W12 |
| Transaction No. | 2071239/3 |

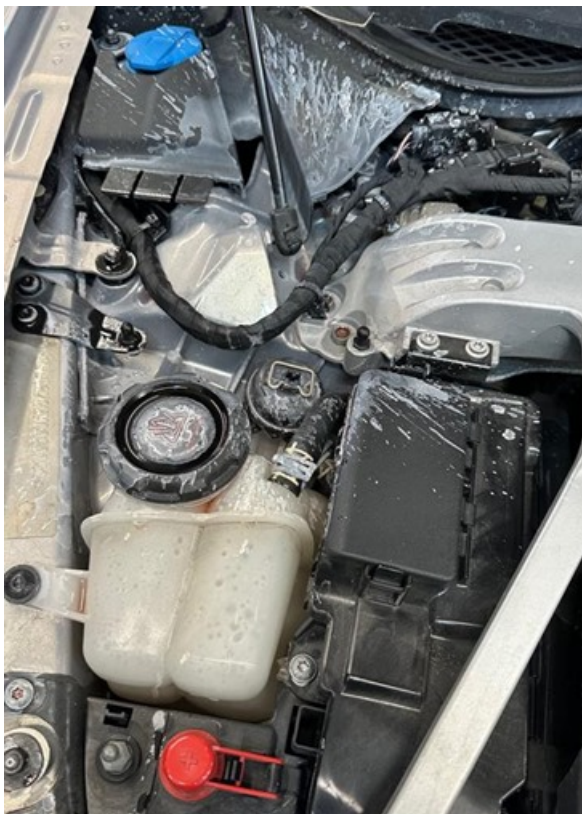
Figure 1

1) On receipt of the vehicle - Take a photograph of the coolant level within the coolant reservoir and inspect the engine bay for any coolant residue (figure 1).

If coolant residue is found in the engine bay, please raise a full technical DISS query and attach a photograph of the coolant residue and a photograph of the coolant level.

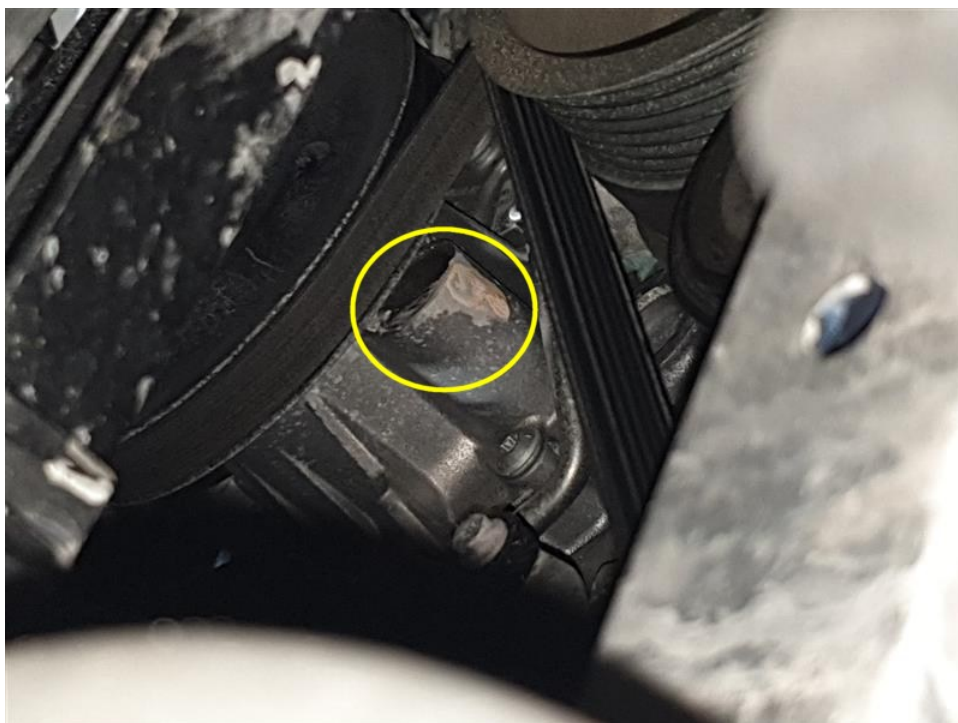
Figure 2

The video shows an example of a coolant pump with no leak, although a small coolant witness mark is evident (Figure 2). In this scenario the coolant witness mark should be cleaned off (using a suitable cleaning agent) to the condition shown in Figure 3

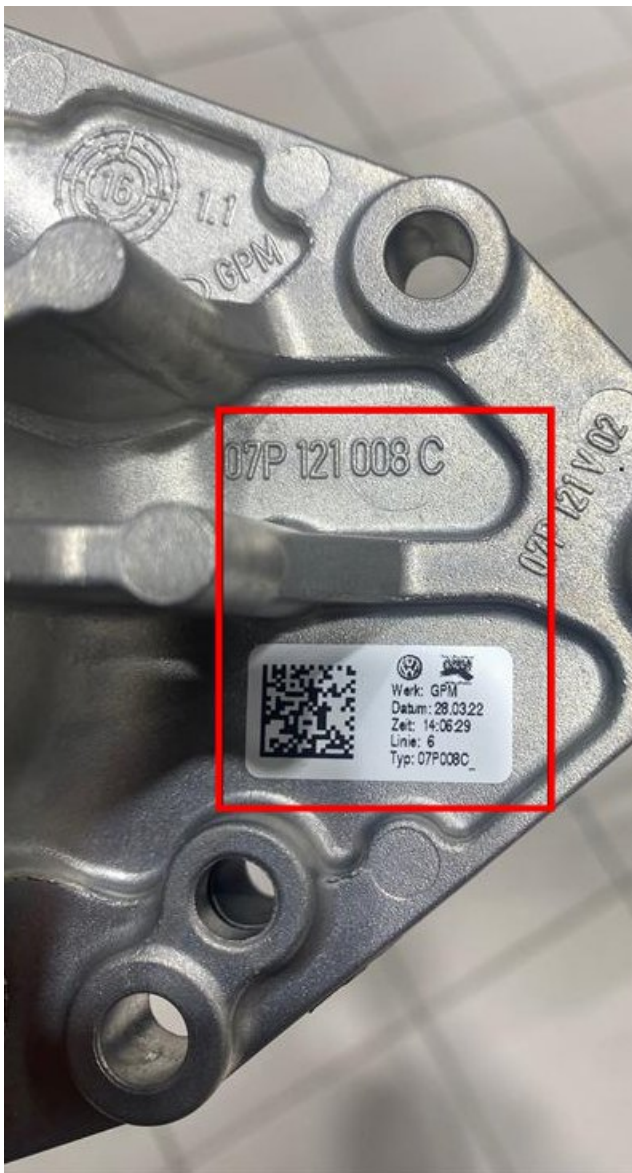
- Clear photo of the coolant level
- Clear photo of the original mechanical coolant pump part number **07P 121 008C** (Figure 5)
- Video of the coolant leak whilst carrying out the pressure test
- Current ODIS log
- Await feedback via DISS before replacing any parts

**NOTE:** The photo shown in Figure 5 is a C level coolant pump (shown removed from the vehicle for photographic purposes) a borescope may have to be used for photographs of the coolant pump when fitted

9) Replace the following

- Mechanical coolant pump - Rep.Gr 19
- Solenoid for coolant circuit N492 assembly - Rep.Gr 19
