Technical Service Bulletin

| Topic | Engine Overheating - Warning in the DIP V8 Kovomo |
| Brand | Bentley |
| Transaction No. | 2061369/10 |

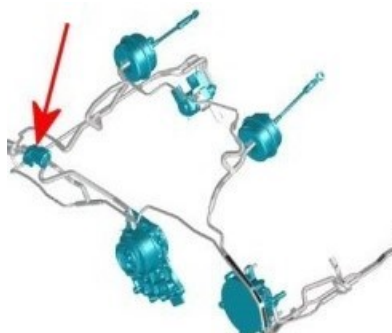
To allow the engine coolant to heat as quickly as possible (from cold start) coolant delivery from the mechanical coolant pump is interrupted by switch valve N649

Figure 1 - Bentayga

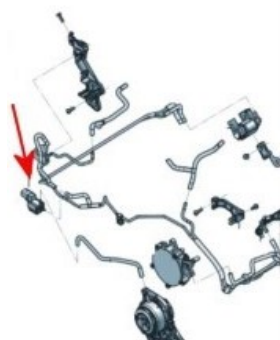
Figure 2 - New Continental GT/ GTC and Flying Spur

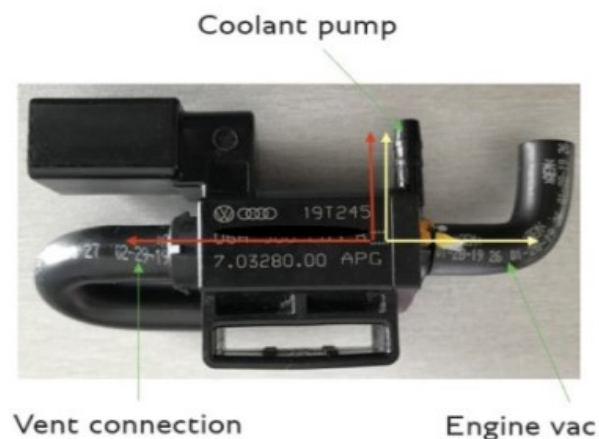
Figure 3

The correct operation of N649 (Figure 3) is as follows

Un-energised state (Ignition off) - Coolant pump connected to vent connection (red arrows)

Energised state (Ignition on) - Engine vacuum connection to coolant pump (yellow arrows)

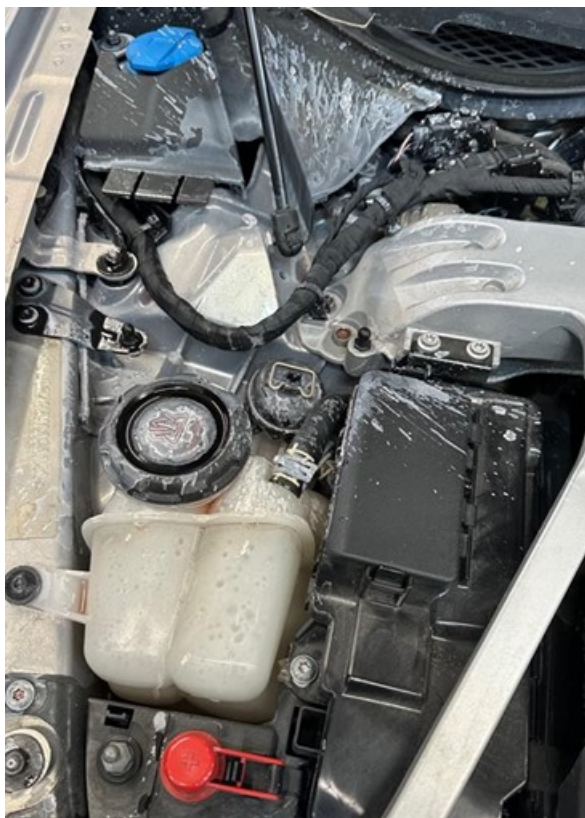
Figure 4

When inspecting the engine bay coolant residue can sometimes be seen around the reservoir when the engine has overheated (figure 4).

If this condition is found, the coolant may also be below the minimum level.

**If coolant residue is found in the engine bay, please raise a full technical DISS query and attach a photograph of the coolant residue. If the coolant level is below the minimum level please also attach photographic evidence of this.**
