## Customer statement / workshop findings

Customer states MIL-ON with P0456 found in the Engine/Motor Control Module -J623-.

| DTC | Description |
|---|---|
| P0456 | EVAP Emission Contr. Sys. (very small leak) Leak Detected |

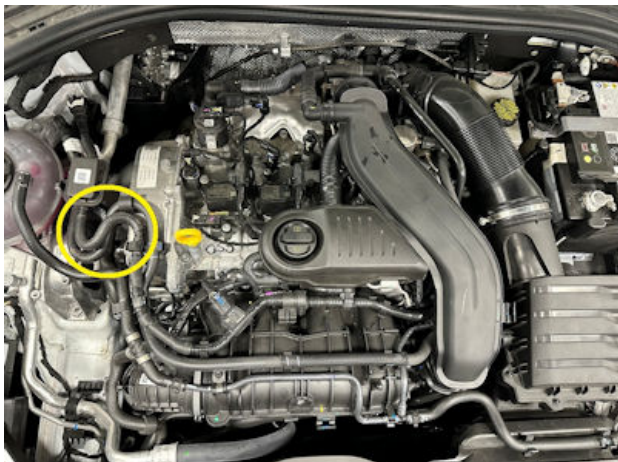
**Figure 1:**

Focus special attention to the area circled in Figure 1.

### **STEP 4: Inspect, and if necessary, replace purge line with -N80-**

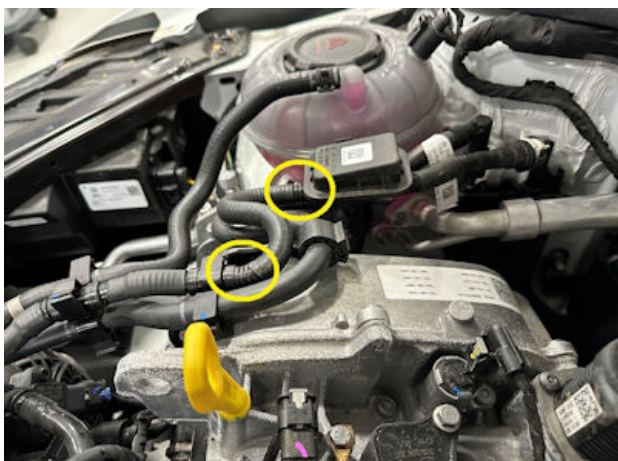
**Figure 2:**

Figure 2 highlights two sections of the purge line from figure 1 that are prone to cracking.

If a leak is found from the corrugated purge line (shown above) remove and replace the component.

If a leak is not identified from the corrugated purge line, further diagnosis is required. In this case, this TSB no longer applies.
