## Customer statement / workshop findings

Customer states MIL-ON with P0456 found in the Engine/Motor Control Module -J623-.

| DTC | Description |
|---|---|
| P0456 | EVAP Emission Contr. Sys. (very small leak) Leak Detected |

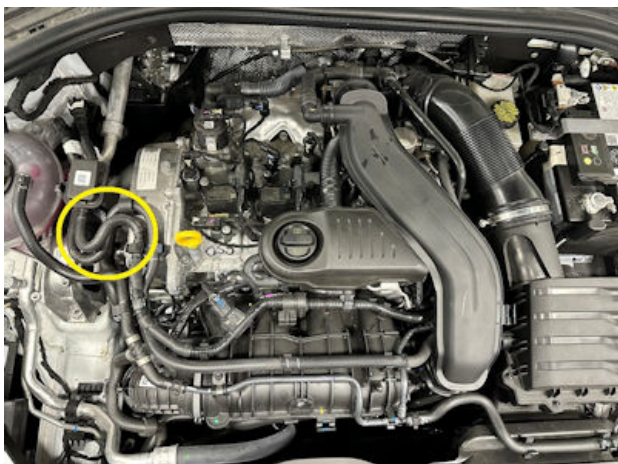
**Figure 1:**

Focus special attention to the area circled in Figure 1.

### **STEP 4: Inspect, and if necessary, replace purge line with -N80-**
