## Technical Service Bulletin

| <b>Topic</b> | 19 Engine: cooling system - red coolant temperature/coolant level warning lamp on - 4.0 ltr. V8 TFSI |
| <b>Transaction No.</b> | 2074303/8 |

19 Engine: cooling system - red coolant temperature/coolant level warning lamp on -  
4.0 ltr. V8 TFSI

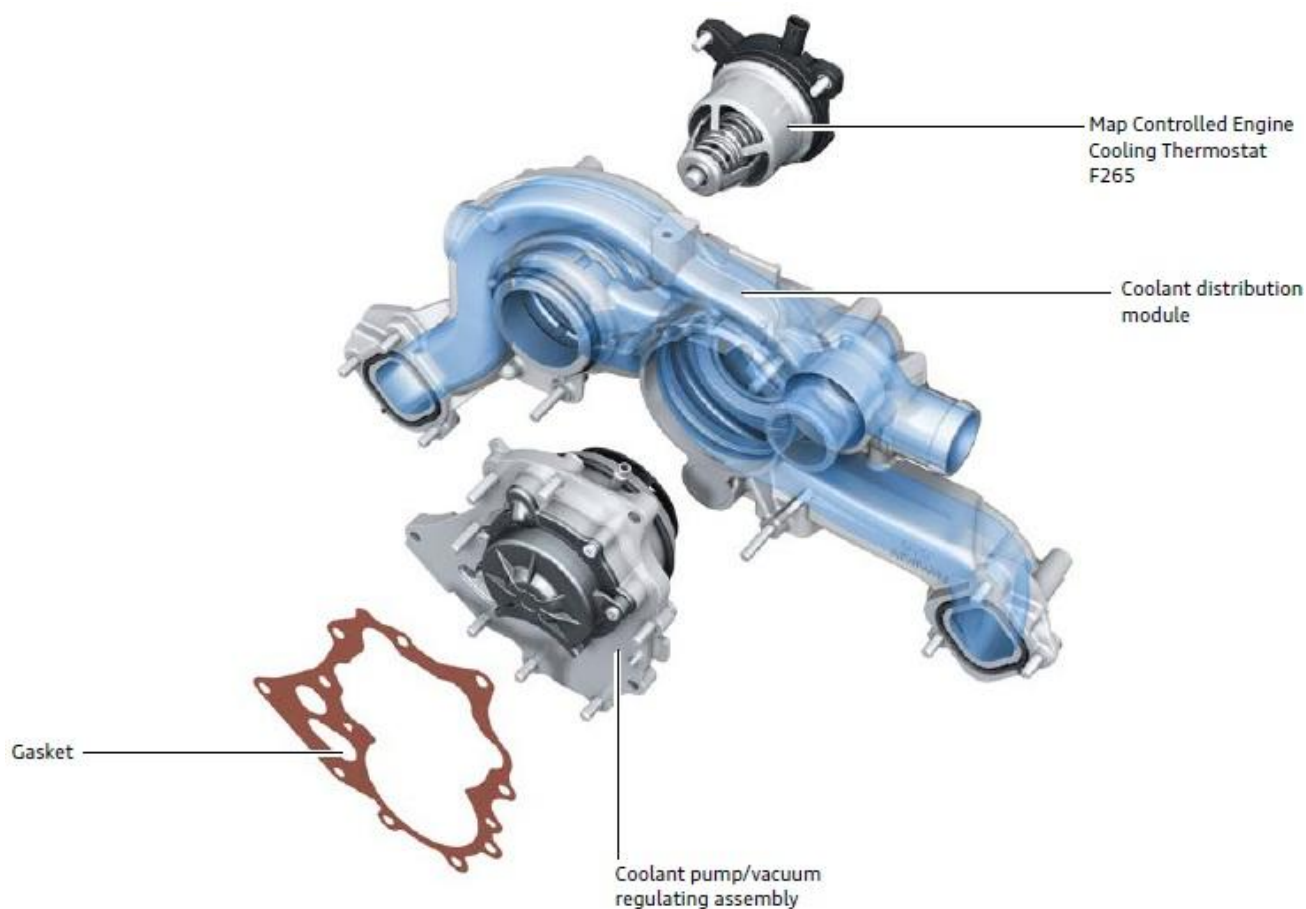
**Figure 1.** Coolant distribution

A fresh coolant leak in the area of the mechanical coolant pump can take the form of fresh drops on the underside of the coolant distributor or the leakage reservoir (See figures 1 and 2 or attachment “Overview of coolant distributors”). If necessary, perform a pressure test of the cooling system according to ELSA.

**If a fresh leak is detected**, please note that it is not necessary to replace the coolant distributor. In this case, replacing the mechanical coolant pump, per the workshop manual, is sufficient.

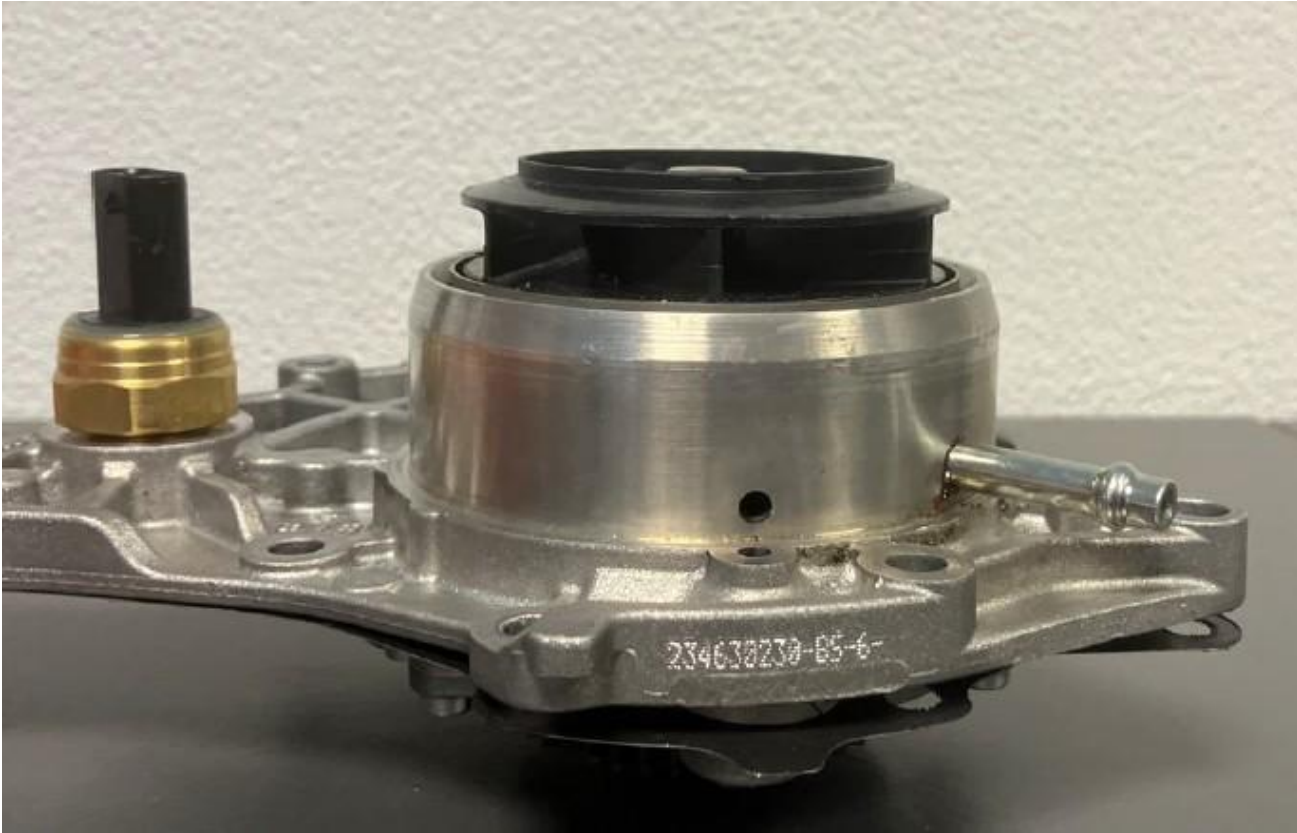
- If there is no vacuum applied to the vacuum connection of the mechanical coolant pump, the modulating piston (orifice panel) must be fully retracted into the pump housing.

**Figure 3.** *Modulating piston moved back correctly (starting position, not actuated)*

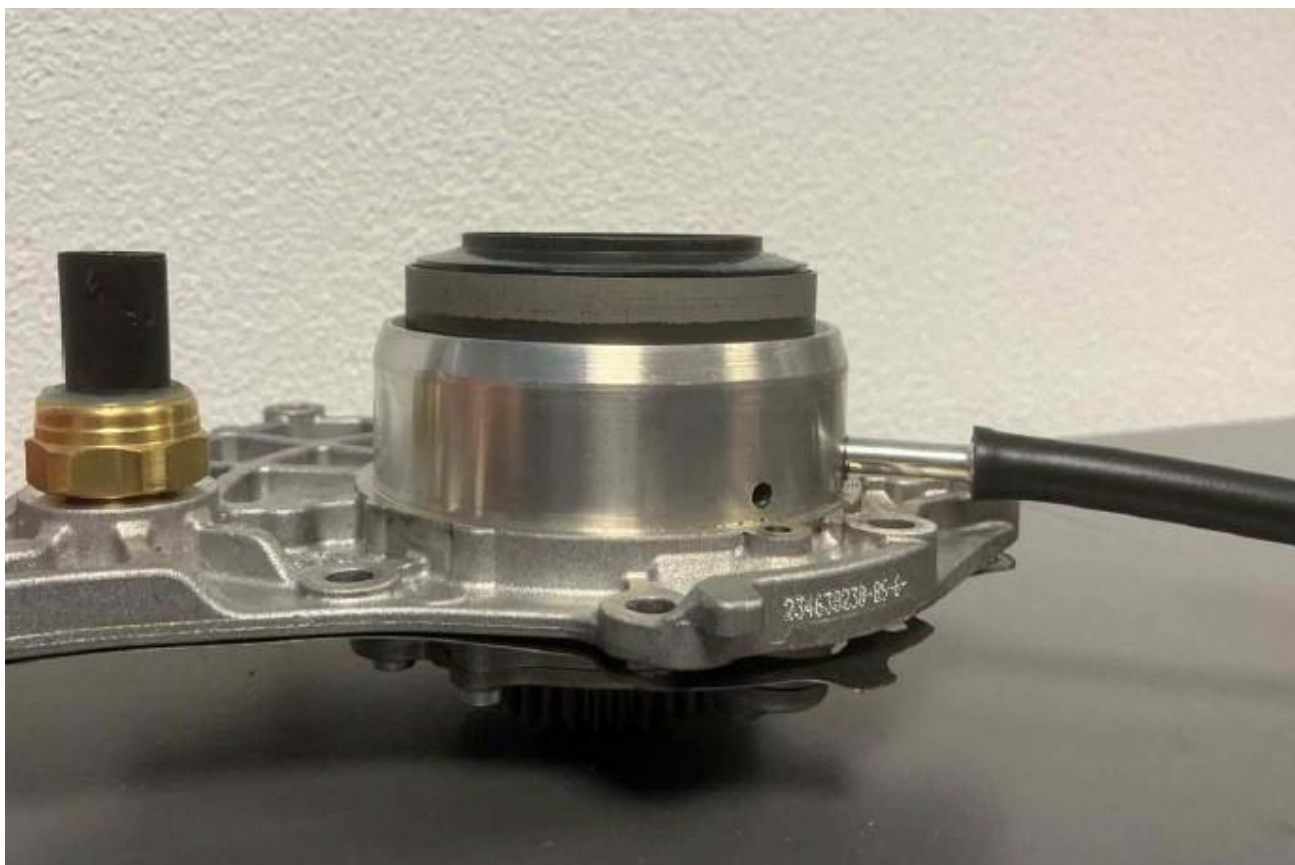
- The modulating piston (orifice panel) must completely cover the pump impeller when a vacuum (maximum: ~600mbar) is applied at the vacuum connection of the mechanical coolant pump. The vacuum must be maintained throughout the functional test.

**Figure 4.** *Modulating piston correctly deployed (end position, actuated)*

**Note:** The modulating piston tilting while it is moving out is not a reason for complaint if the end positions (as pictured above) are reached correctly.

If the end positions are not reached correctly, replace the mechanical coolant pump.

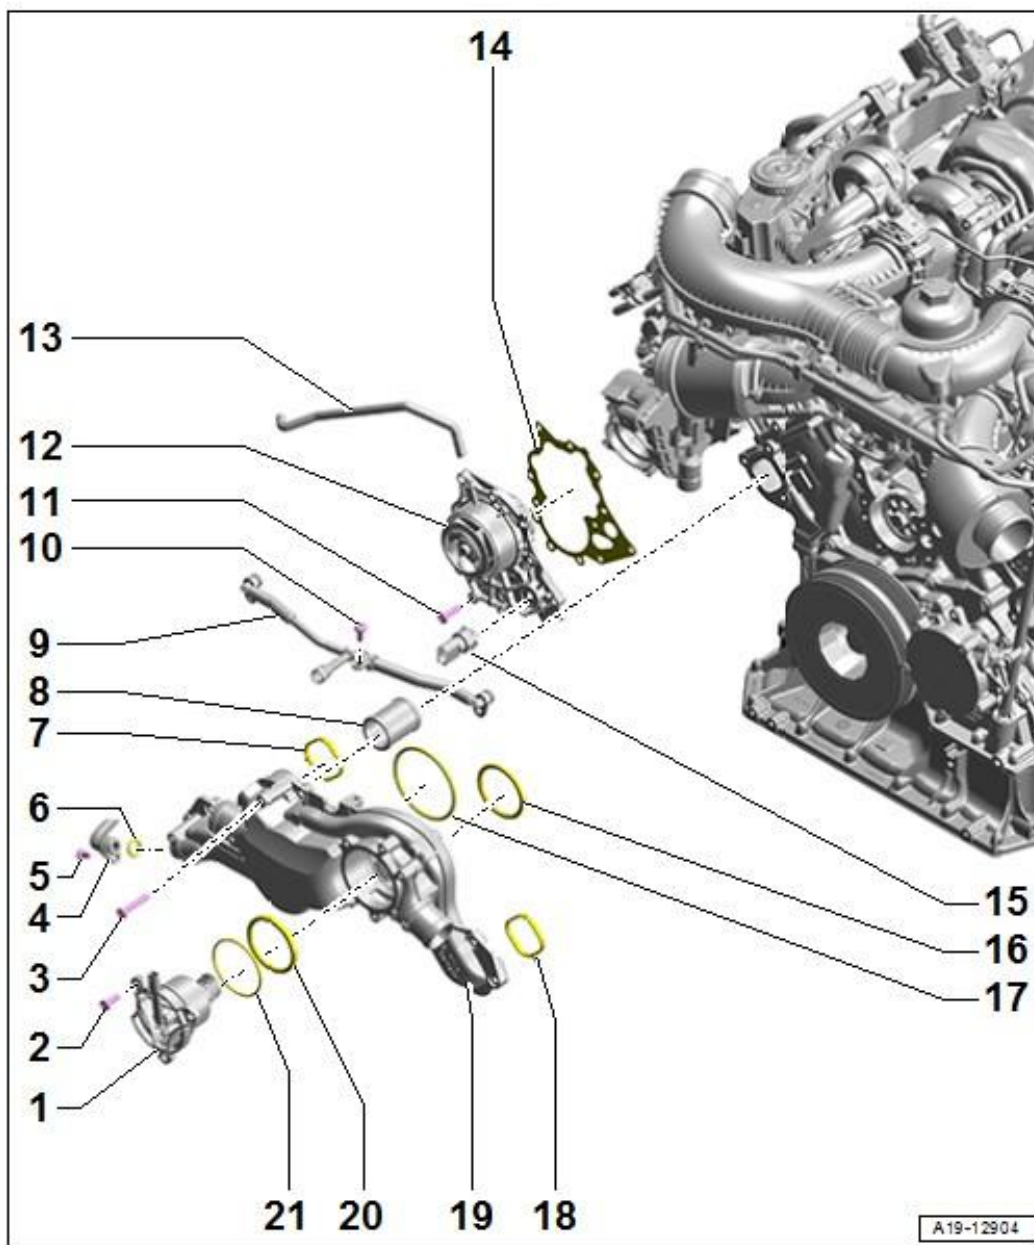
**Figure 5.** Assembly overview – coolant pump/thermostat incl. switchable mechanical coolant pump, number 12.

Also, always check whether a coolant leak has occurred at the vacuum connection of the mechanical coolant pump towards N649. If there is any coolant in the vacuum connection of N649 or in the vacuum hose between the mechanical coolant pump and N649, replace N649, the mechanical coolant pump, and the vacuum hose between N649 and the mechanical coolant pump (Figure 5, item 13).
