## Technical Service Bulletin

| <b>Topic</b> | 19 Engine: cooling system - red coolant temperature/coolant level warning lamp on - 4.0 ltr. V8 TFSI |
| <b>Transaction No.</b> | 2074303/9 |
| <b>Release date</b> | Jun 27, 2025 |

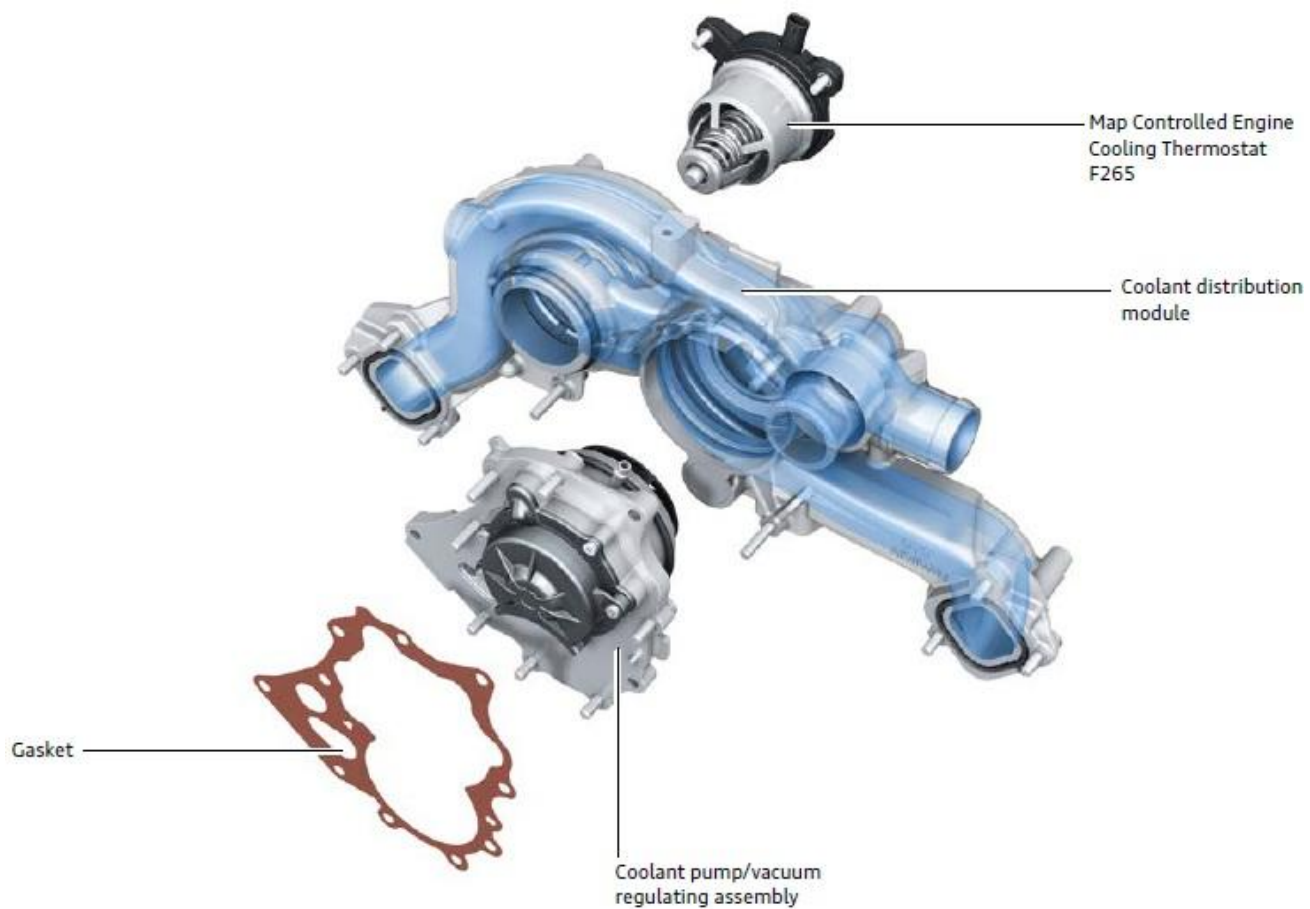
**Figure 1.** Coolant distribution

A fresh coolant leak in the area of the mechanical coolant pump can take the form of fresh drops on the underside of the coolant distributor or the leakage reservoir (See figures 1 and 2 or attachment “Overview of coolant distributors”). If necessary, perform a pressure test of the cooling system according to ELSA.

**If a fresh leak is detected**, please note that it is not necessary to replace the coolant distributor. In this case, replacing the mechanical coolant pump, per the workshop manual, is sufficient.
