# Service Bulletin

Bulletin No.: 24-NA-166

**Subject: DTC C1171 C1172 C1173 C1174 Tire Pressure Monitor Sensor Unable to Relearn Ethernet Cable Overlay for TCP OnStar Module**

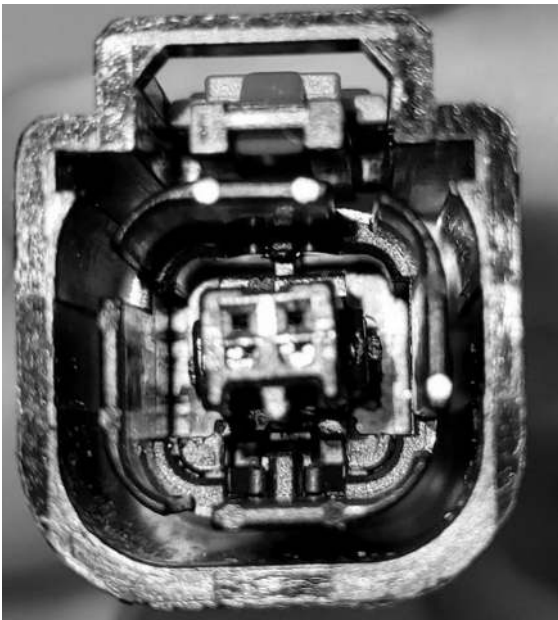
6720432

Following the middle ridge to the back, this is where the housing locks onto the cable.
