# Service Bulletin

Bulletin No.: 25-NA-014

**Subject: No Reverse, No Shift Past Third Gear - DTC P2732 Set**

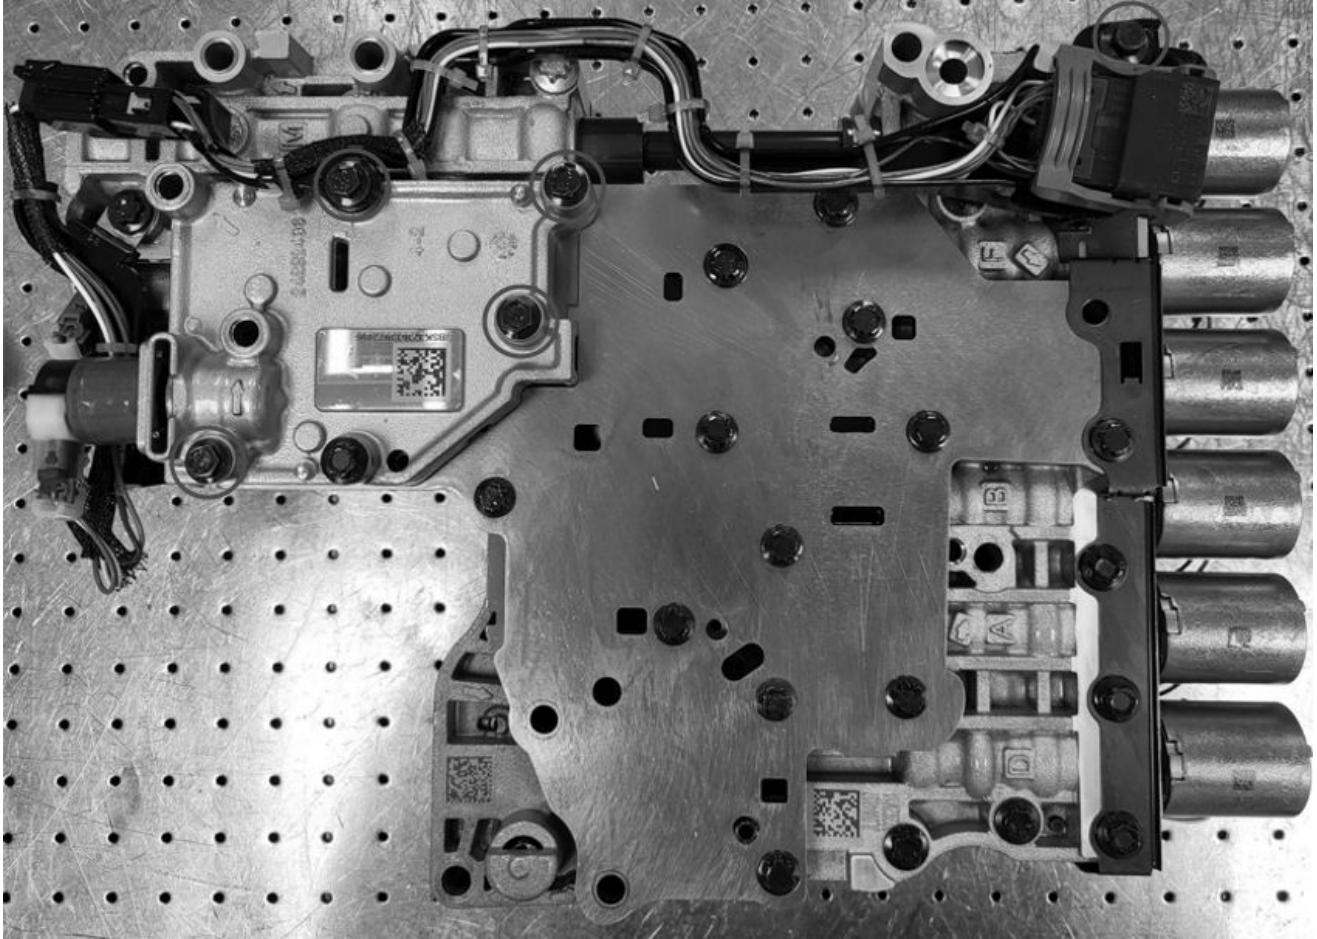
6804421

1. Remove the control valve *Control Valve Body Replacement*.

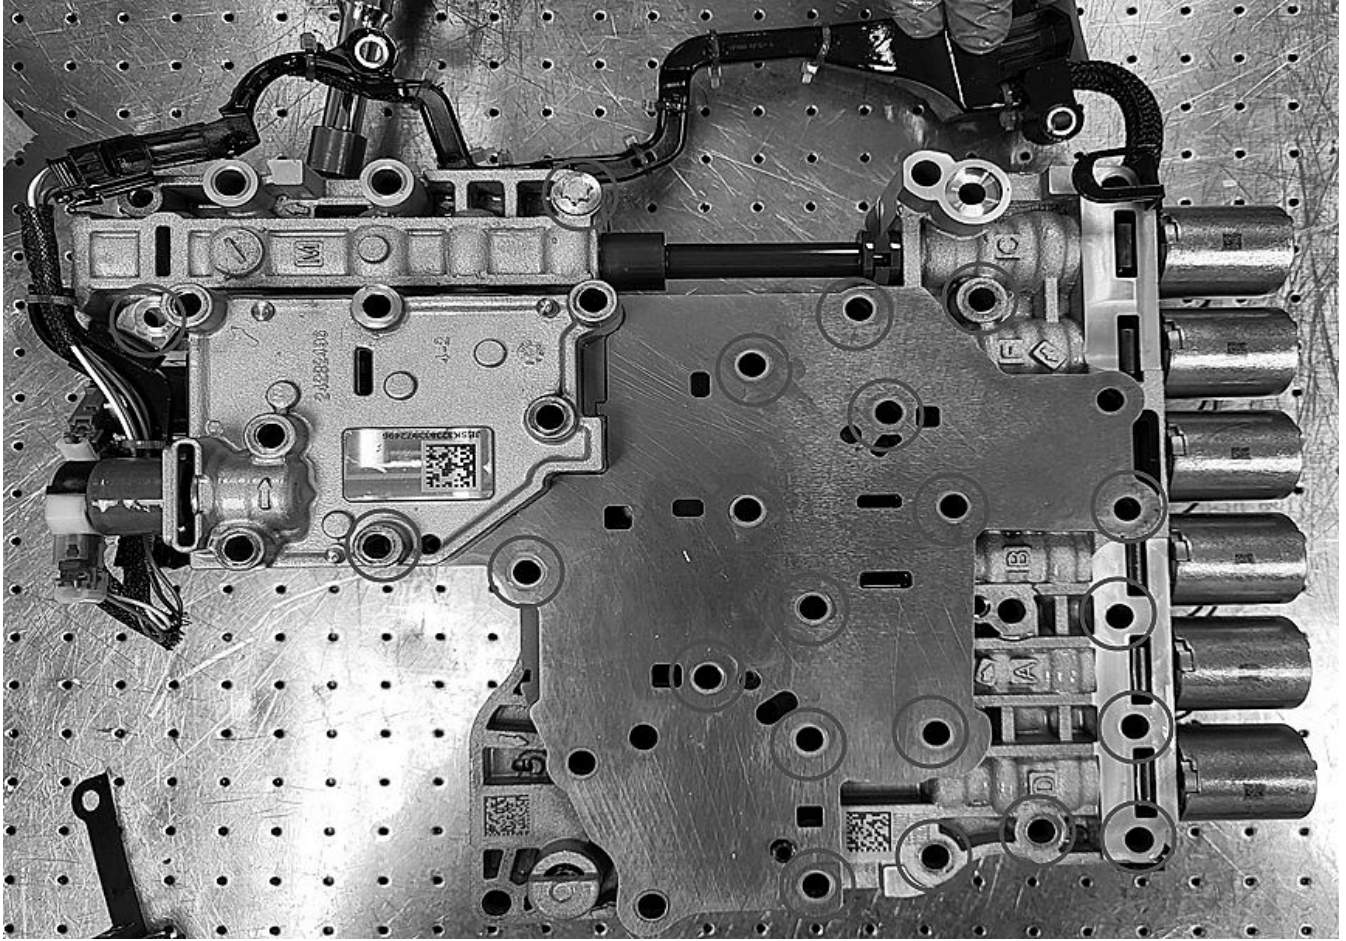
6804426

2. Remove the bolts that secure the auxiliary body to the solenoid cover.
3. Remove the bolt that secures the wiring harness to the control valve body.

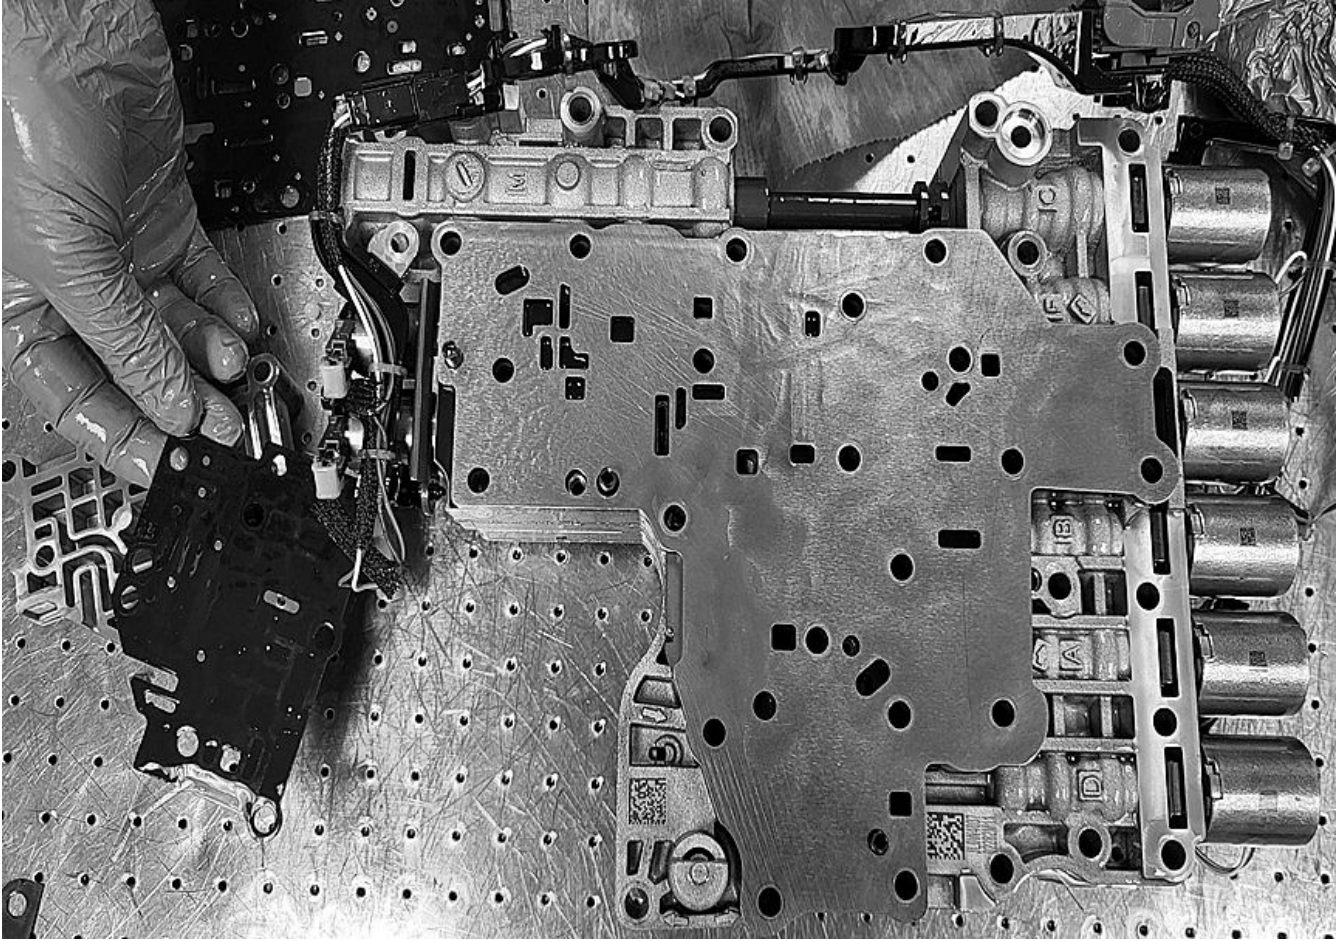
6804446

4. Position the wiring harness aside.
5. Remove the remainder of the bolts that secure the solenoid cover.

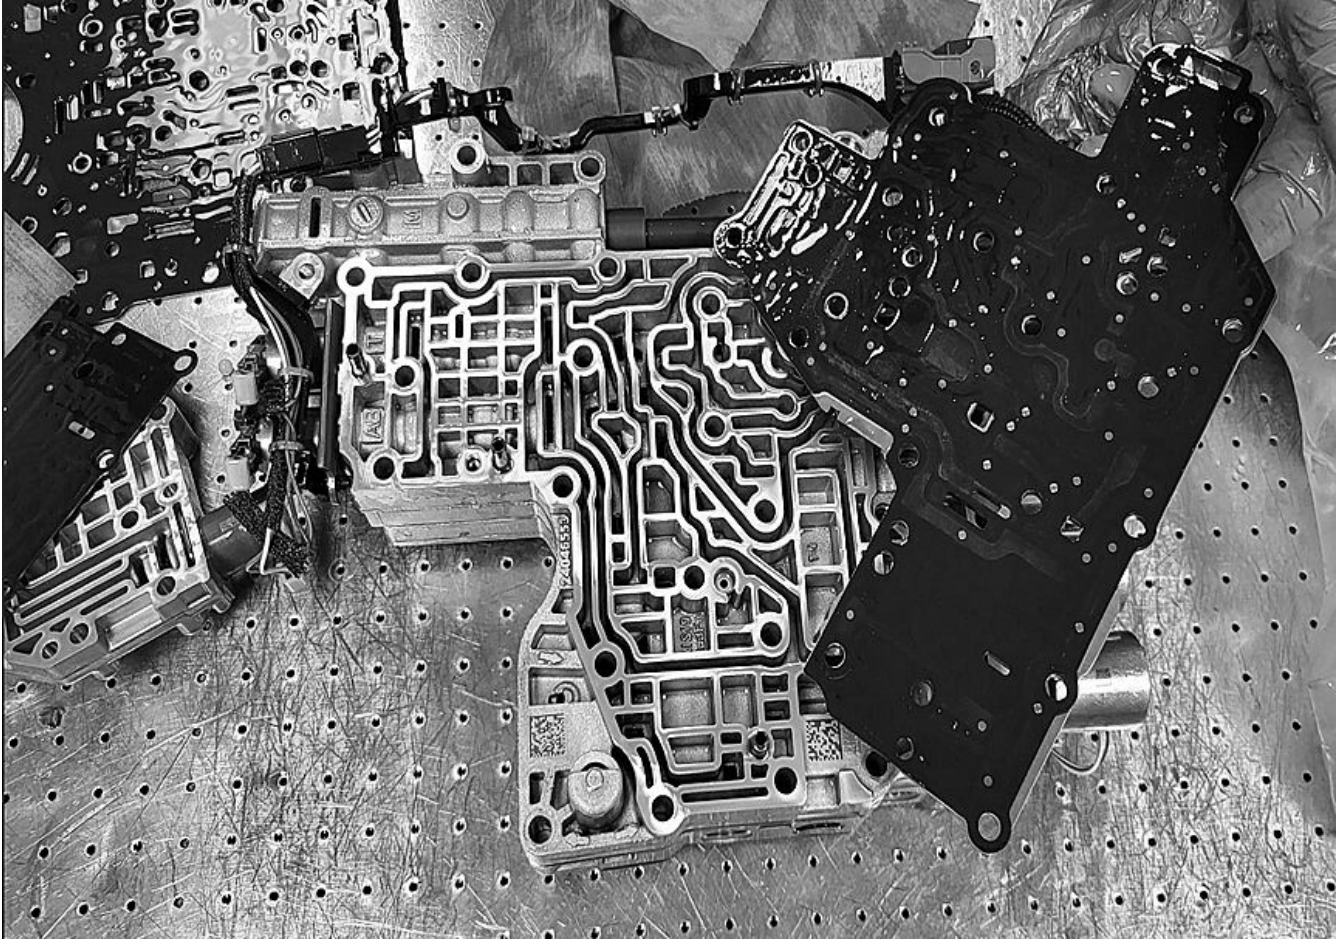
6804481

6. Separate the Auxiliary and Auxiliary plate.

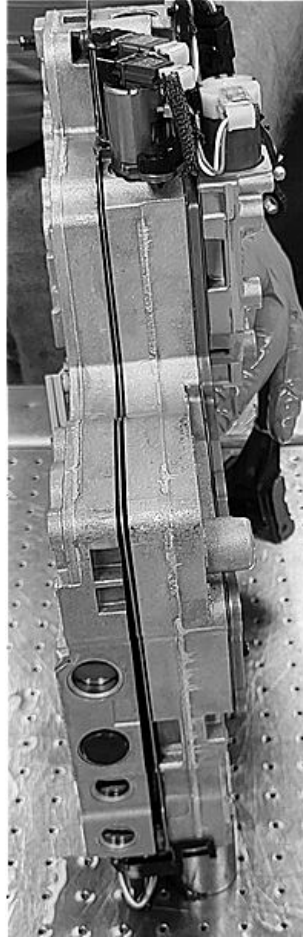
6804487

7. Separate the control valve body and thick plate from the solenoid body.

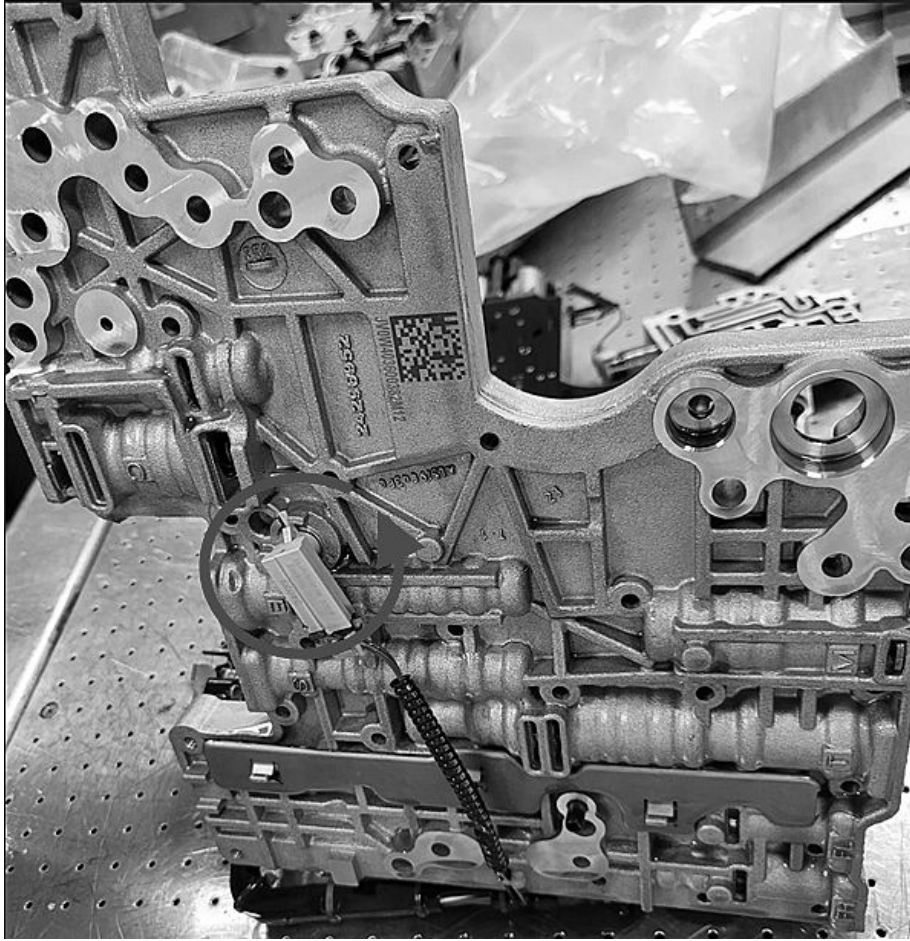
6804509

8. Stand valve body on its side with the solenoids on the base.
9. Using care, begin separating the valve body from the solenoid body.
  - ⇒ Lower the valve body keeping the worm trail face pointing up. There are 5 check balls in the valve body that are loose and can fall out.

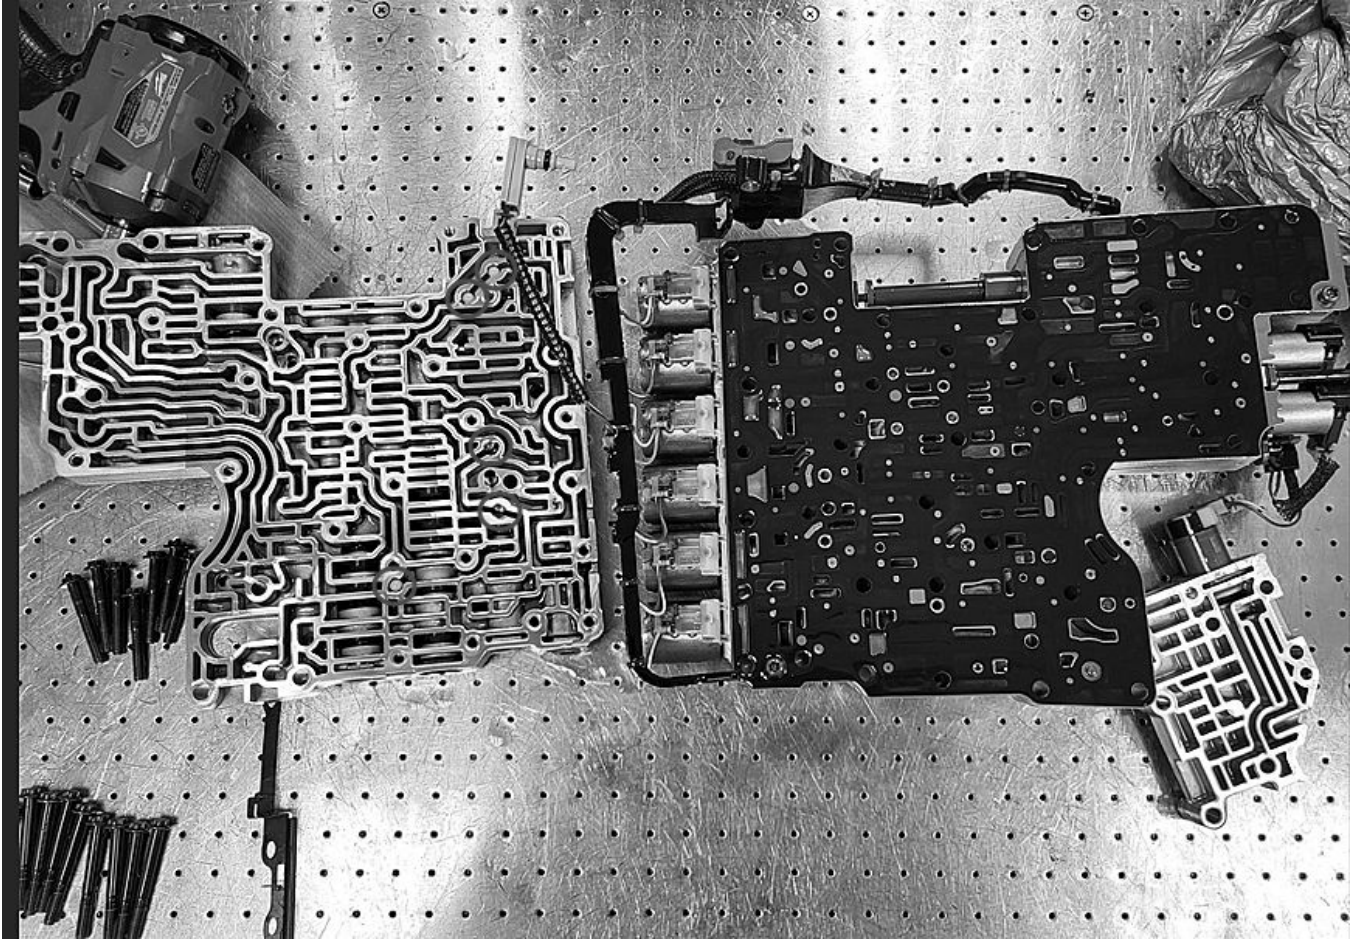
6804511

10. Once body is partially split, twist thermocouple and pull to remove from the valve body assembly.

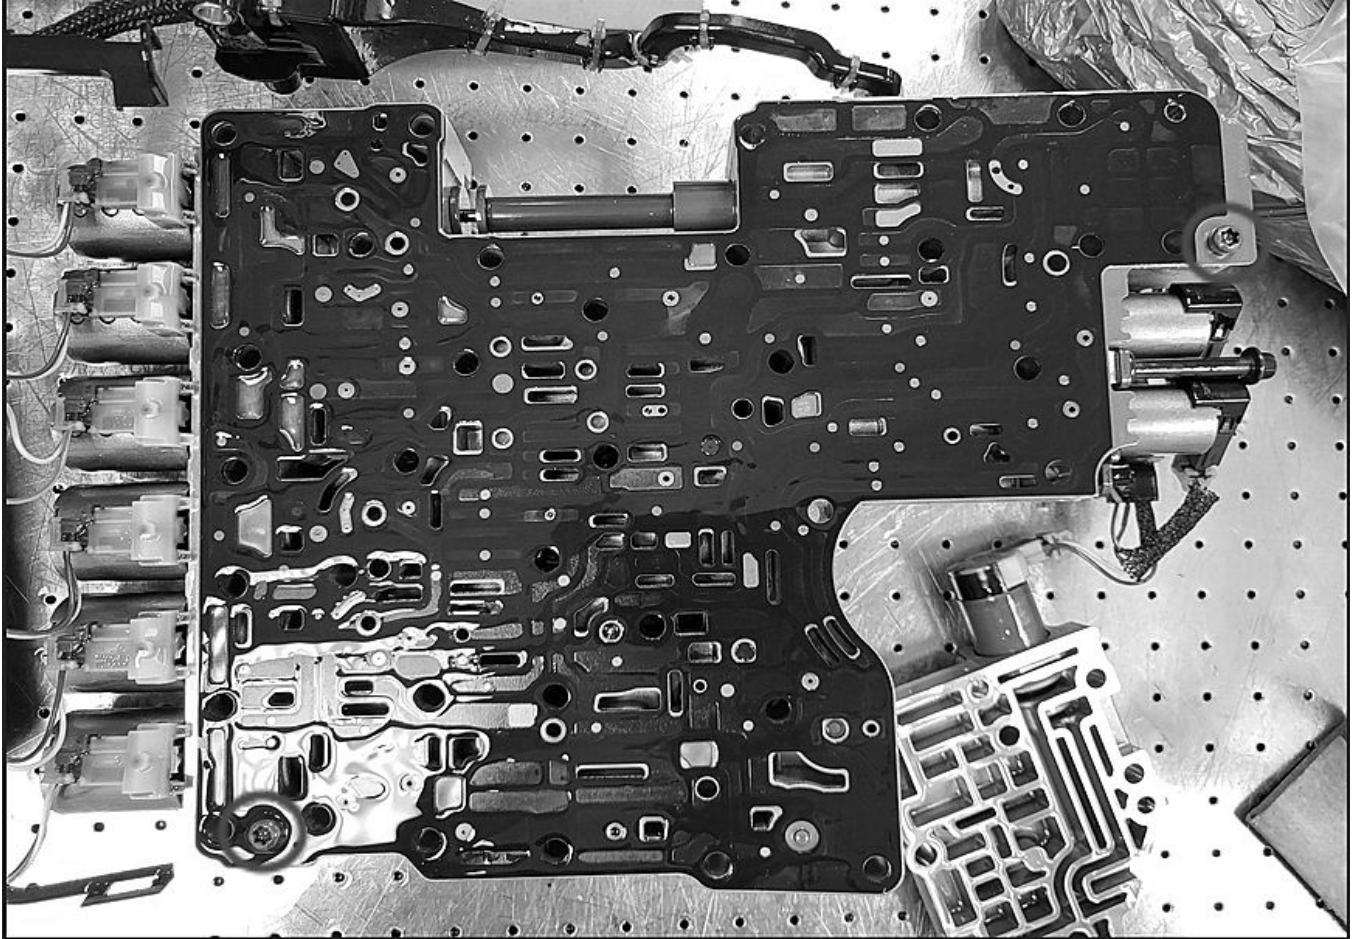
6804467

11. Split the assembly in half.
12. Verify that the 5 check balls remain in the control valve body.

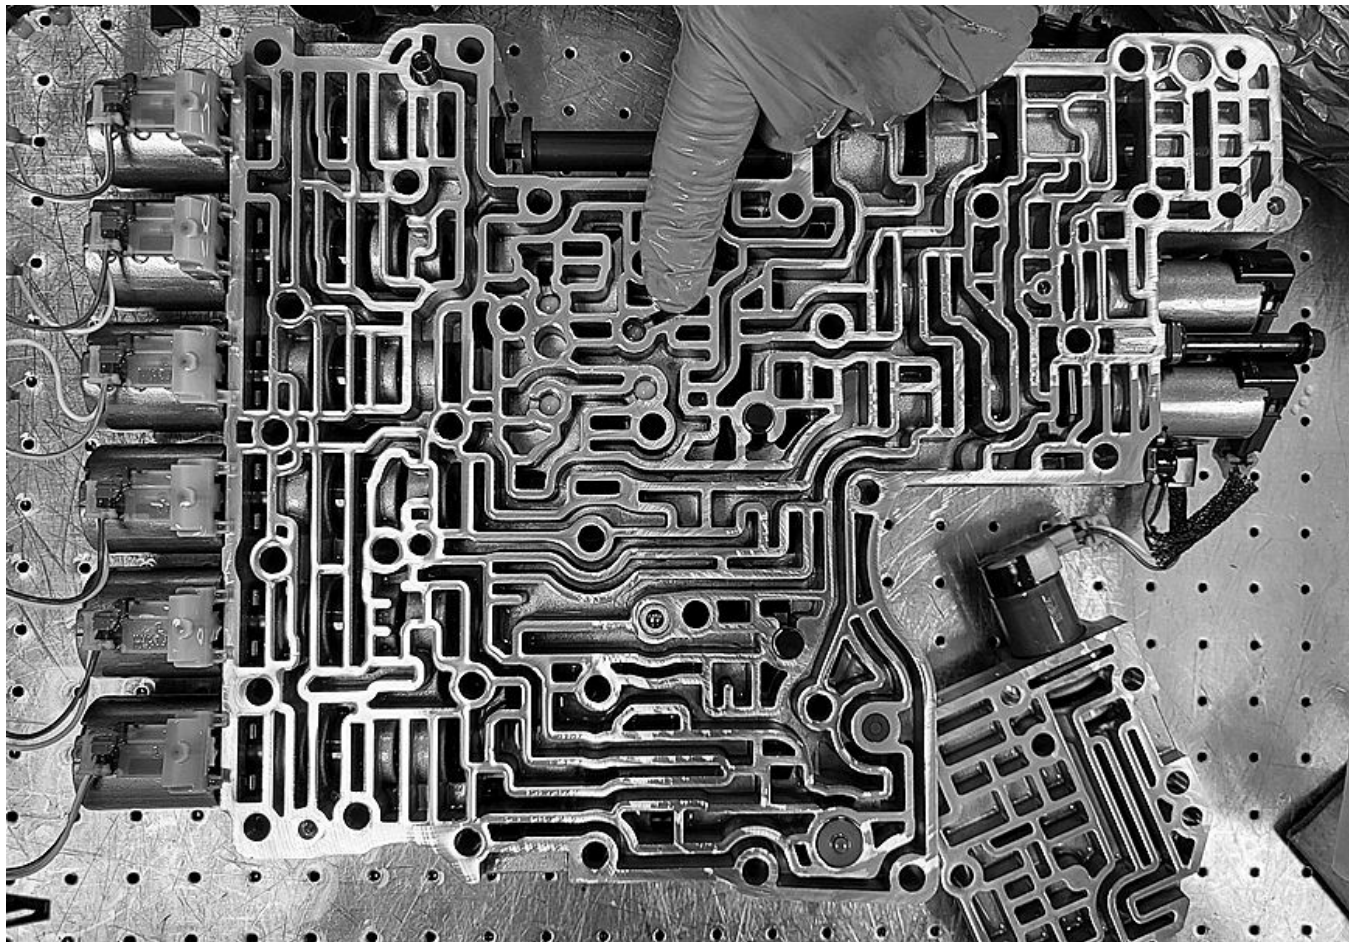
6858665

13. Ensure solenoid body is lying flat on table with spacer plate up.
  - There are check balls/check valves that can fall out once removed.
14. Remove the 2 bolts holding the spacer plate to solenoid body.
15. Once spacer plate is removed, discard Spacer Plate.

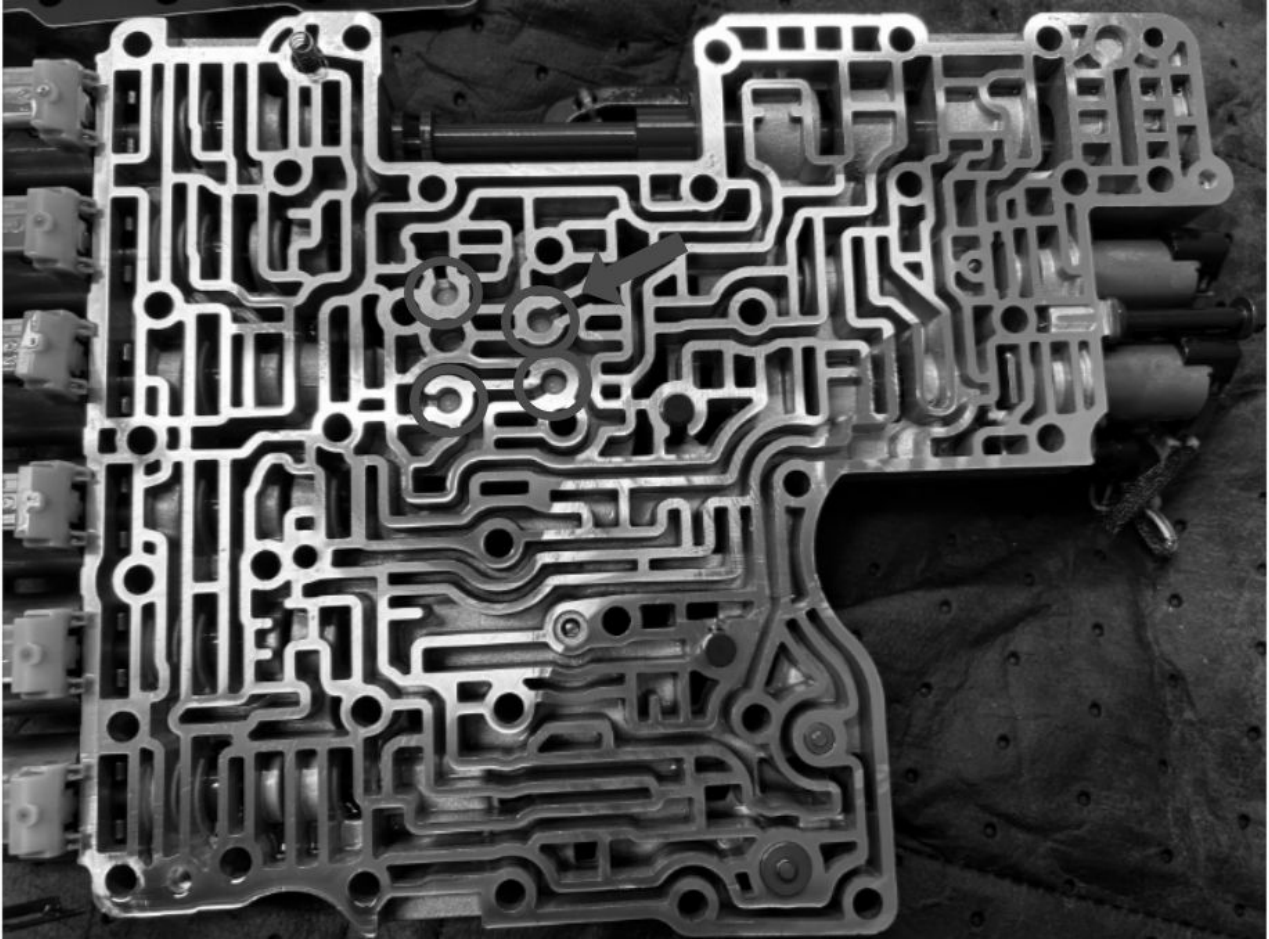
6804538

16. Utilizing a pick or equivalent, remove the undersized check ball from the seat and discard.

17. Install the new check ball into the solenoid housing.

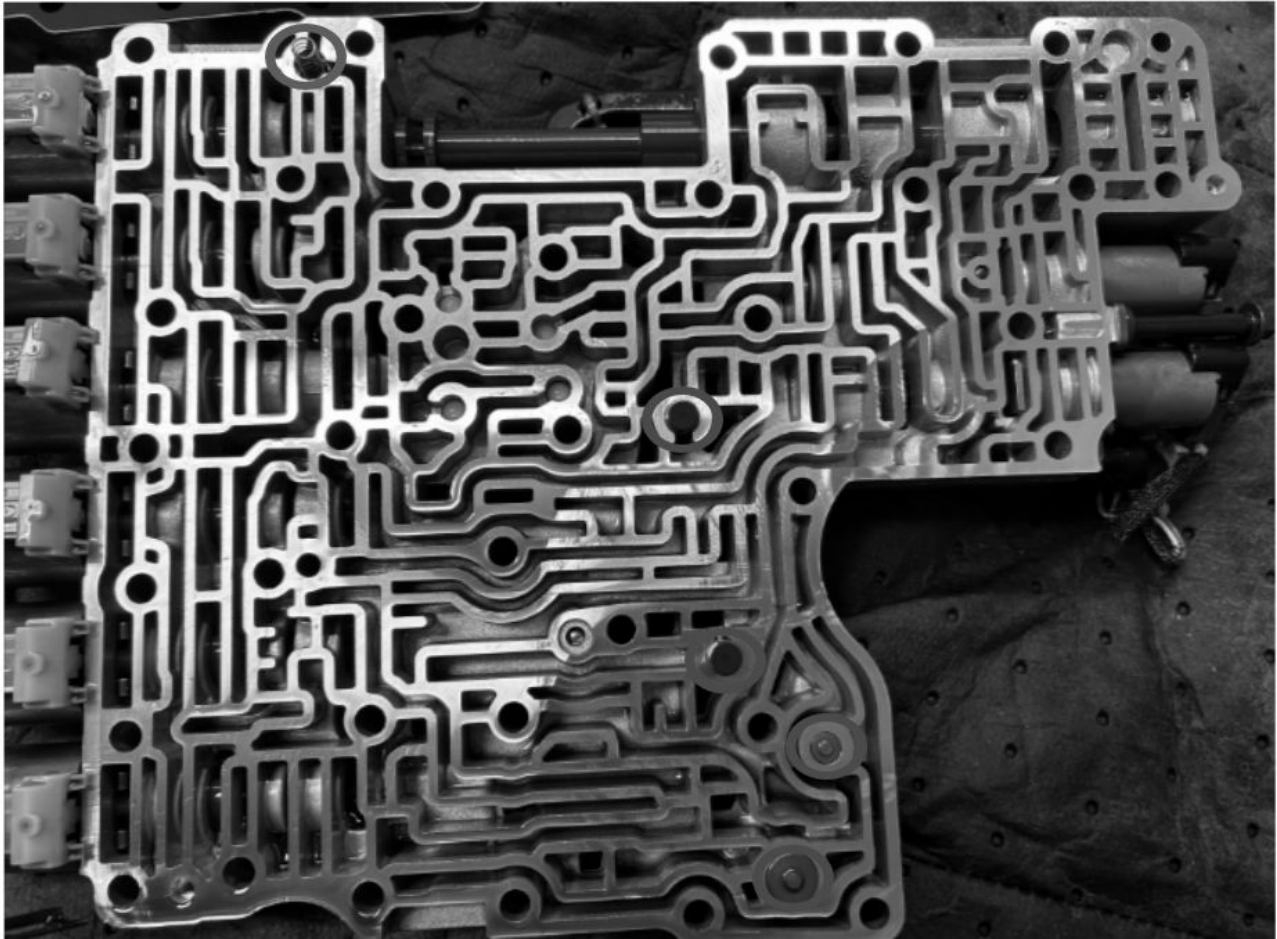
6858662

18. Ensure all check balls are in place in solenoid body.

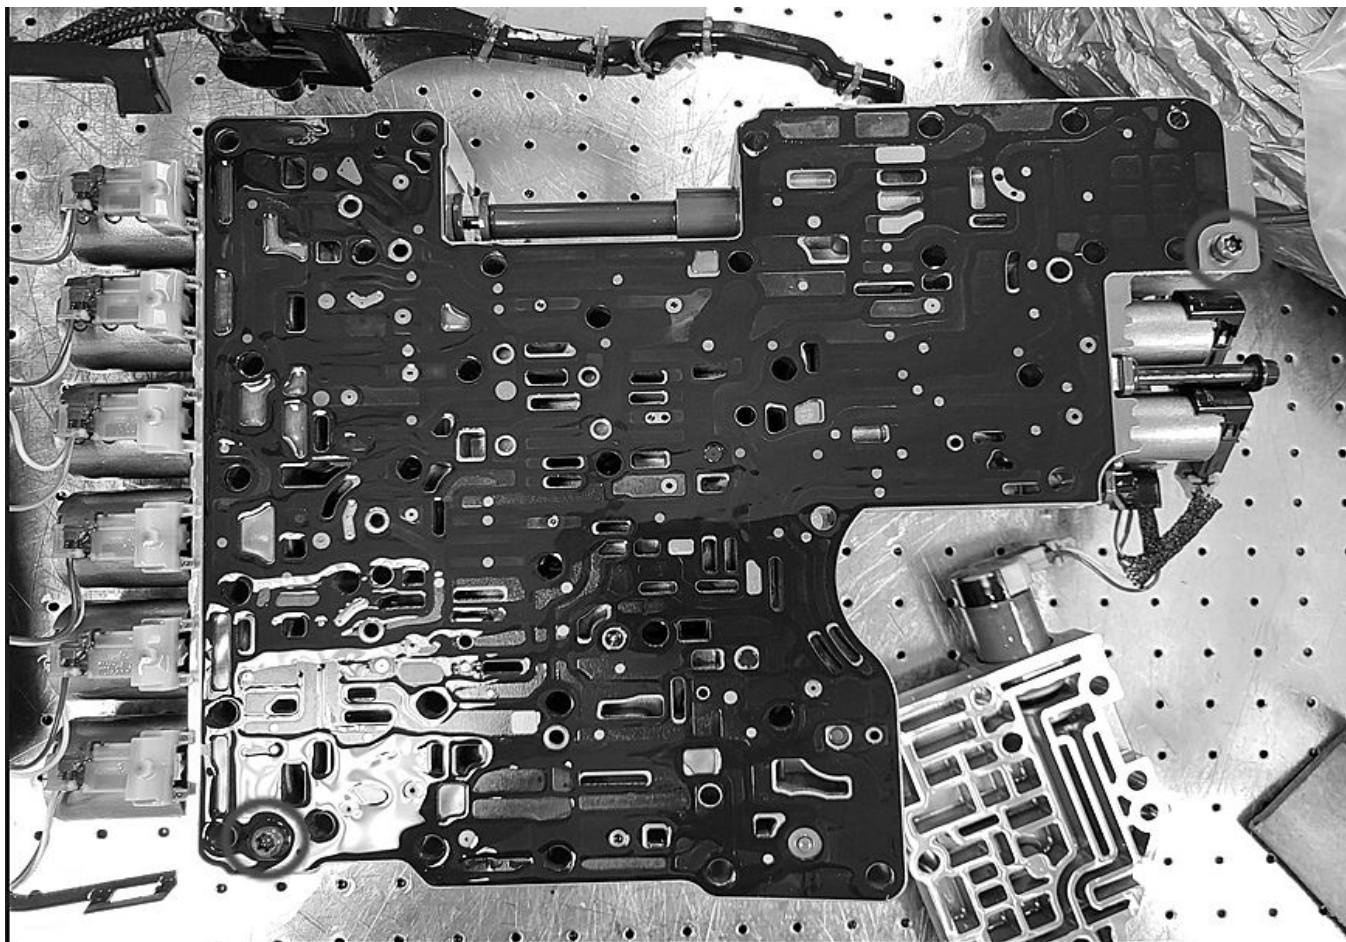
6804467

19. Ensure the spring check valves and the VFS damper are in place in solenoid body prior to putting on replacement spacer plate.

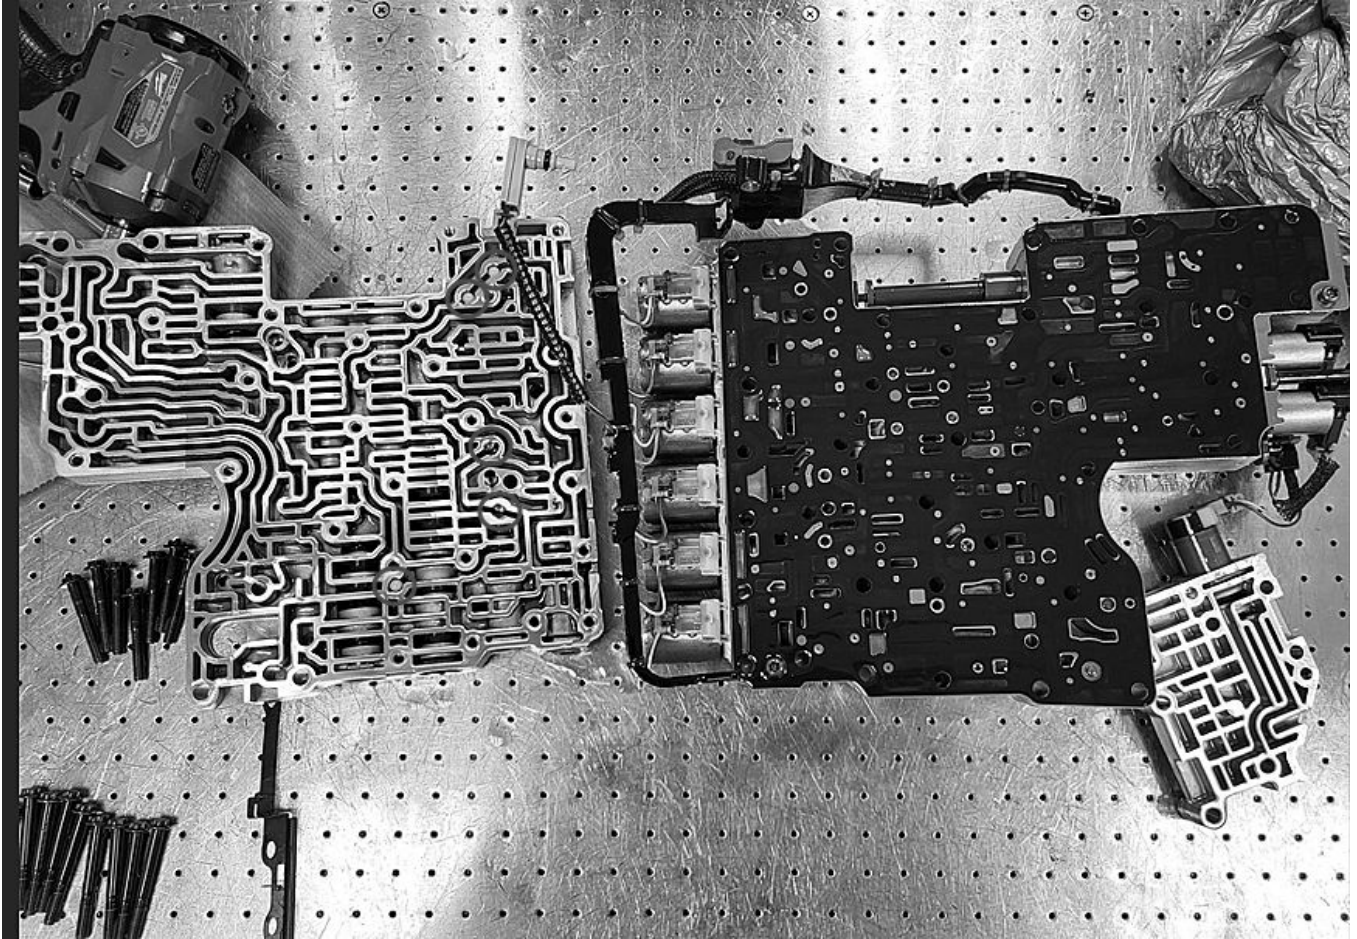
6804511

20. Place new spacer plate on solenoid body and run down spacer plate bolts.

⇒ Torque the fasteners to 9 N•m (80 lb-in).

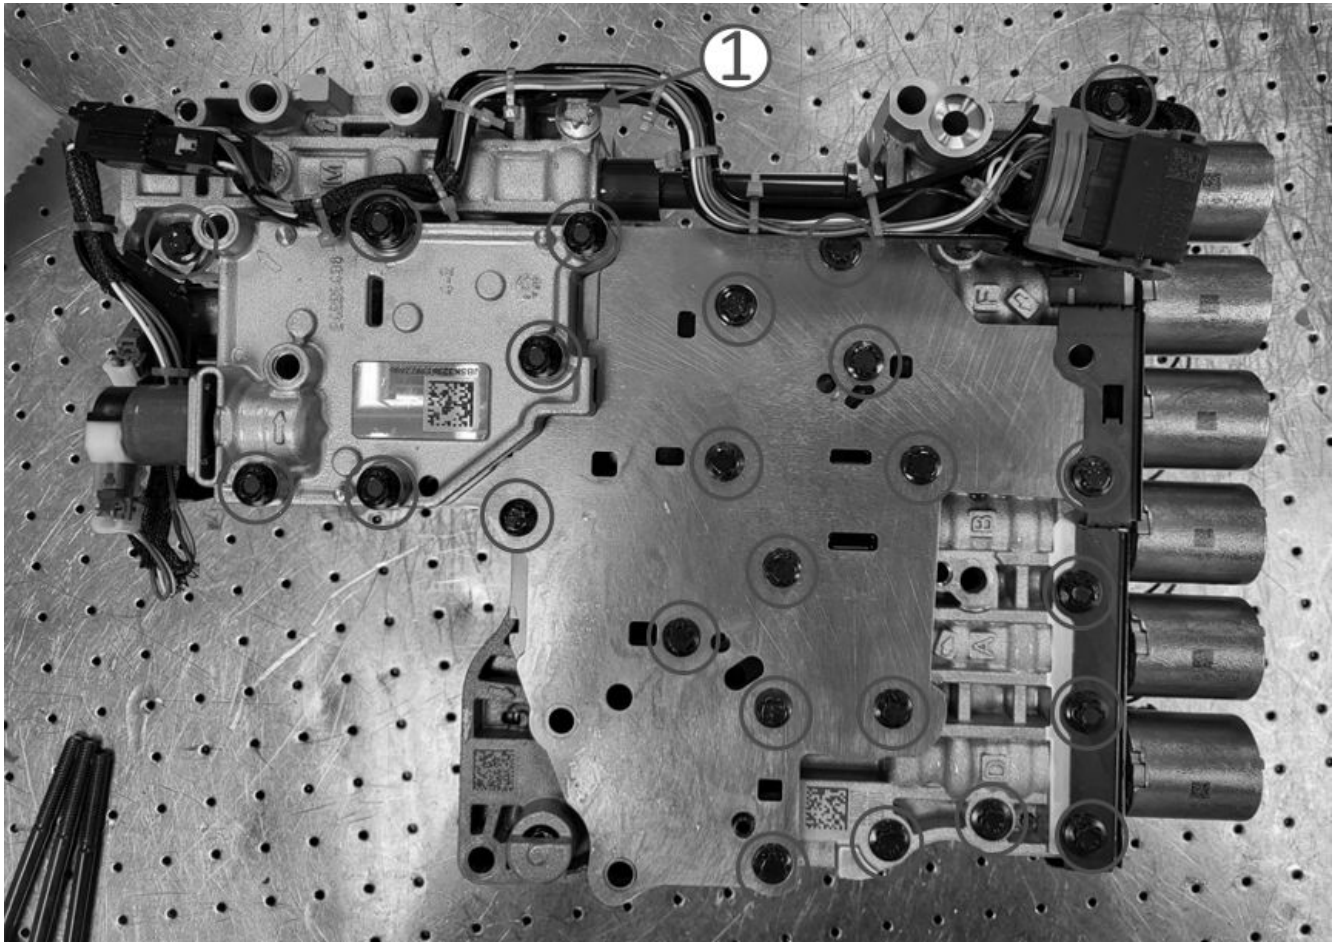
6814198

21. Take solenoid body half and set on top of valve body half – make sure harness is out of the way. There are 2 locating dowels on the valve body used for alignment.
22. Stand valve body on its side with the solenoids on the base.
23. Place thermistor back into cover side and rotate until anti-rotation feature is aligned into cast slot.
24. Place thick plate and thick plate spacer plate back on top of solenoid body cover side.
  - There are 3 locating dowels to align.

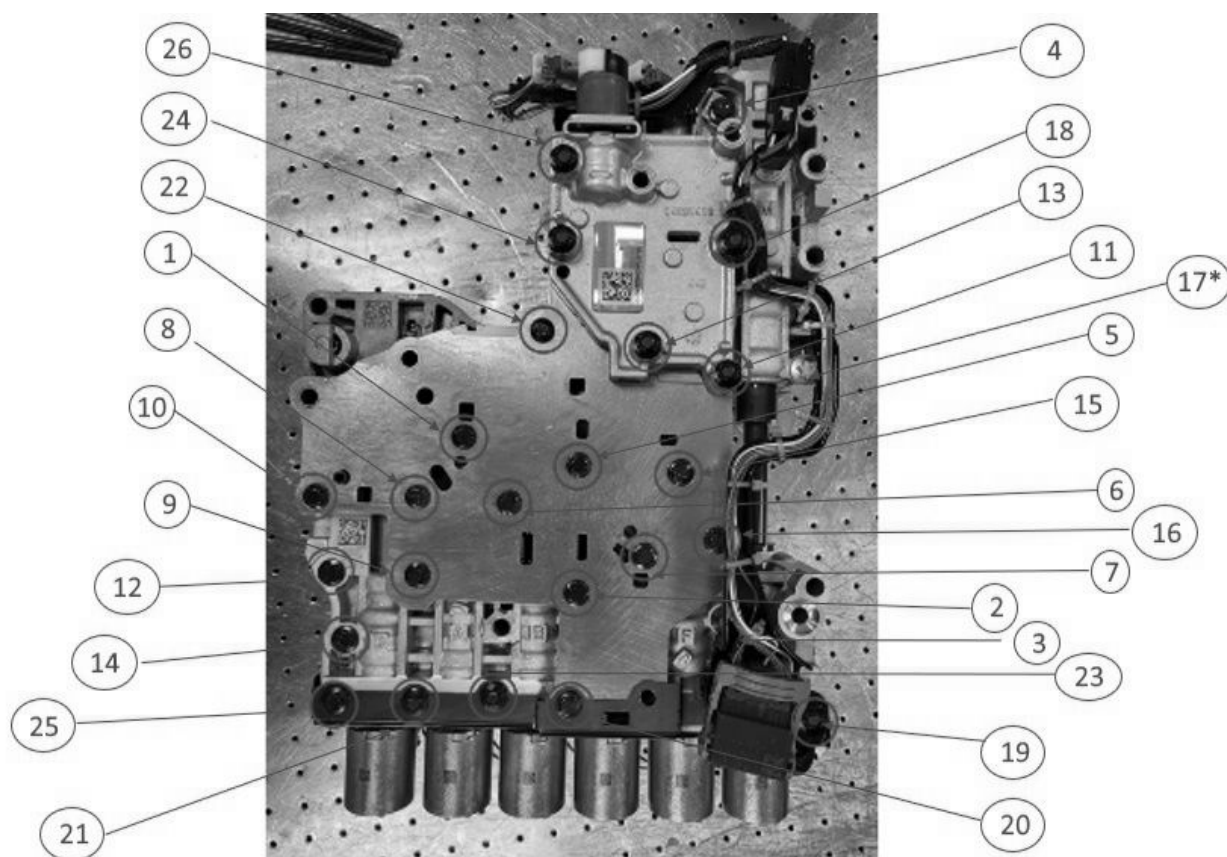
6837102

25. Place aux body spacer plate and aux body back on top of thick plate.

- There are 2 locating dowels to align.
