# Symptom-based workshop manual

37/25 ENU 9709

## Red Warning Message "Vehicle Electrical System Malfunctioning" in the Instrument Cluster in Conjunction with the Fault Memory Entry "B114811" in the Rear-End Electronics Control Unit (SY 37/25)

Model Line: **Cayenne (9YA / 9YB)**

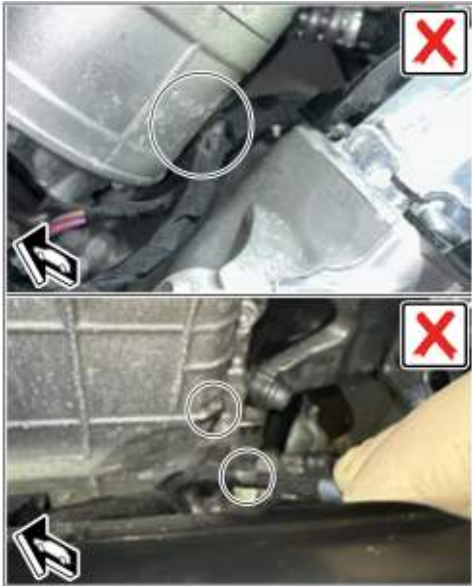
Cause: The signal line for terminal 15 may be resting on the air-conditioning compressor and the oil pan due to the line routing. This can lead to damage to the bandaging of the wire harness and the electrical lines over the service life.

| Assessment | | Action |
|---|---|---|
| (x) | Wire harness is <b>damaged</b> .<br><br> <p>Abrasion point for air-conditioning compressor and oil pan</p> | The wire harness is <b>not OK</b> .<br><br><b>Repair wire harness.</b><br><br>Then continue with Step ⇒ 3. |
